Natural Disasters and Risk Assessment in Uttarakhand with special reference to Uttarkashi Earthquake.

Dr. Ranju Joshi Panday

Uttarkashi Earthquake:

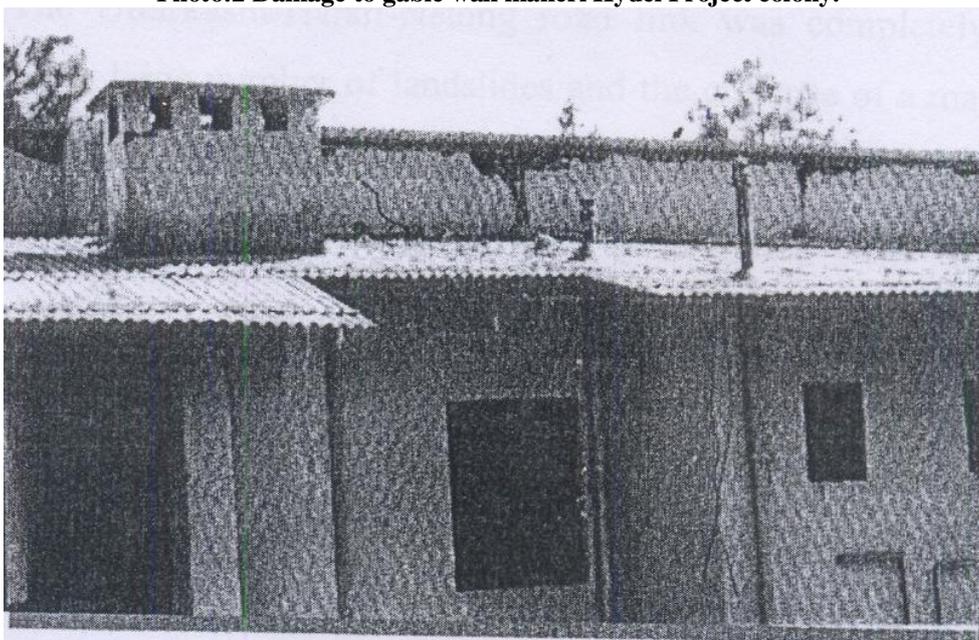
The Maneri Hydel Power project colony campus has two-storey buildings with concrete block masonry bearing walls of poorer quality construction. Many buildings were damaged beyond repair. Damage consisted of (i) severe damage to gable walls photo 2 and (ii) diagonal cracks in ground story walls.

Photo:2 Damage to gable wall maneri Hydel Project colony.

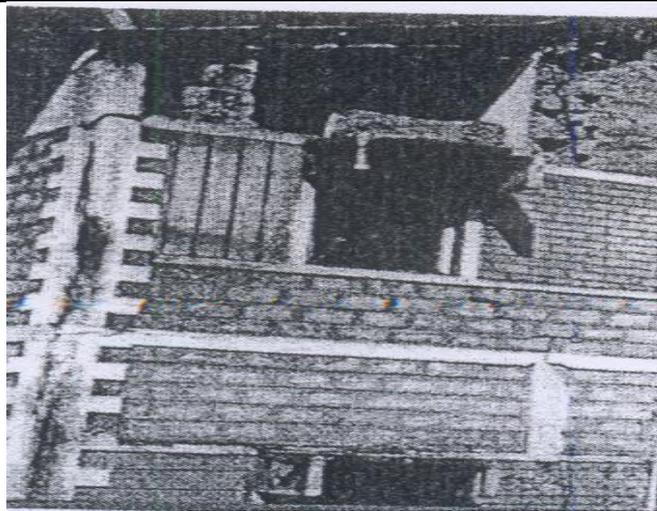
The ITBP Paramilitary campus at Mahidanda consists a large number of two story residential buildings with load bearing walls of concrete masonry. All have RC lintel bands, but no roof bands or gable bands. The construction is about 10 years old . The damage to buildings consisted of (i) diagonal cracks below window sills, (ii) damage at the connection between masonry walls and RC roof slabs, (iii) in buildings with corrugated iron sheet roofs, damage at seat of purlings on the gable end walls and (iv) damage to walls supporting roofs at different heights at either end(Photo 3). Roof and gable bands would have prevented damage of types (ii), (iii) and (iv) .

Photo 3 Damage to wall supporting split level roof – ITBP Campus, Mahidanda.

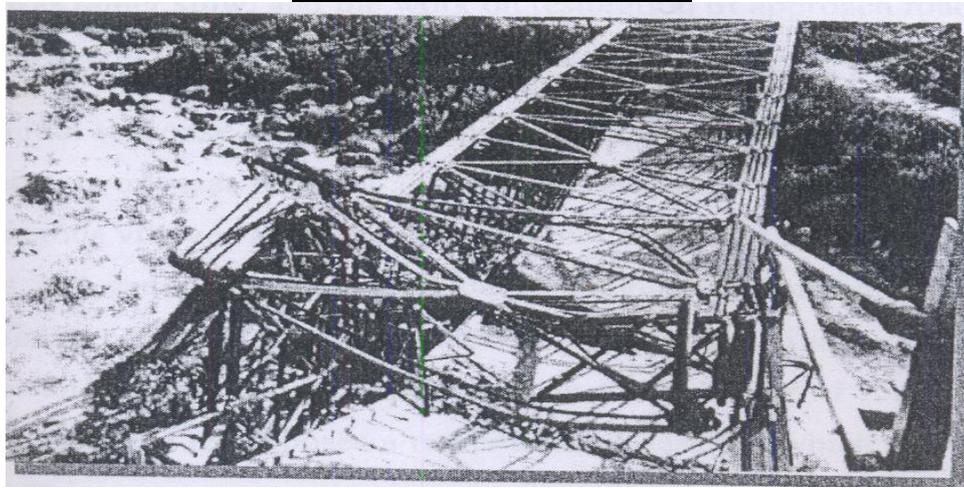
The Gawana Bridge is a 56.0m. span steel truss bridge build in 1974 and located at 6 Km. from Uttarkashi towards maneri. The entire bridge came off the abutments and fell into river (Photo 4) causing the entire area beyond Uttarkashi to be cut off from the rest of the country Inadequate design of the bearings and anchor bolts as well as absence of any suitable means of preventing the span from falling of the supports were responsible for the damage.

Photo 4 Collapsed Gawana Bridge

The peak horizontal ground acceleration in the region was about 0.30 g. The Indian codes specifies the design seismic force for bridges in the range of 0.05 to 0.075 g for zone IV. This is obviously inadequate. It is hoped that the bridge failures caused by this earthquake will provide the necessary impetus to revise the code.
