Forensic Investigation of Fire-affected Reinforced Concrete Buildings

Awoyera, P.O.¹, Akinwumi, I.I.², Ede, A.N.³, Olofinnade, M.O.⁴

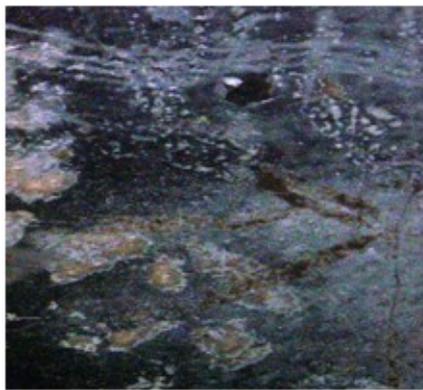
Fig. 5a: Spalled concrete surface

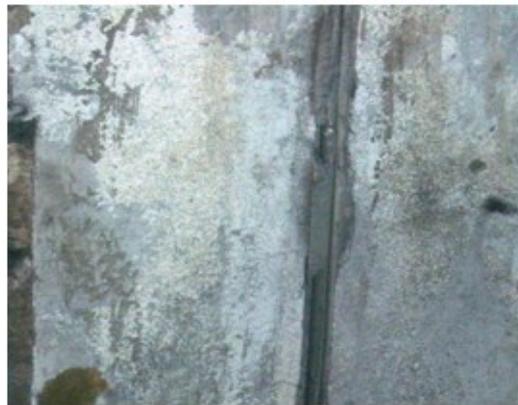
Fig. 5b: Blemished concrete surface

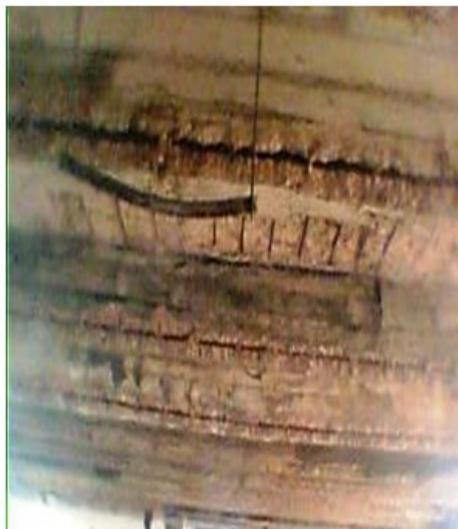
Fig 5c: Exposed reinforcement in slab and beams

changes observed in the physical appearance of the concrete surface includes; removal of concrete cover in beams and slabs which exposed reinforcements and aggregates, pop-out and delamination of concrete in slabs, beams and columns. Figures 5c and 5d shows the defects observed at the site C and figure 9 shows the result of the NDT conducted at site C.

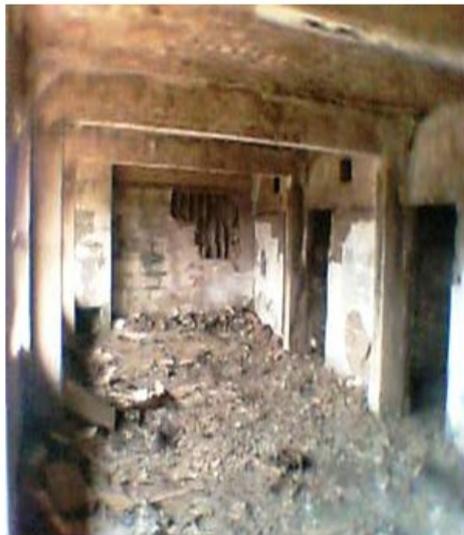
Fig. 5d: Delaminated slabs, beams and columns

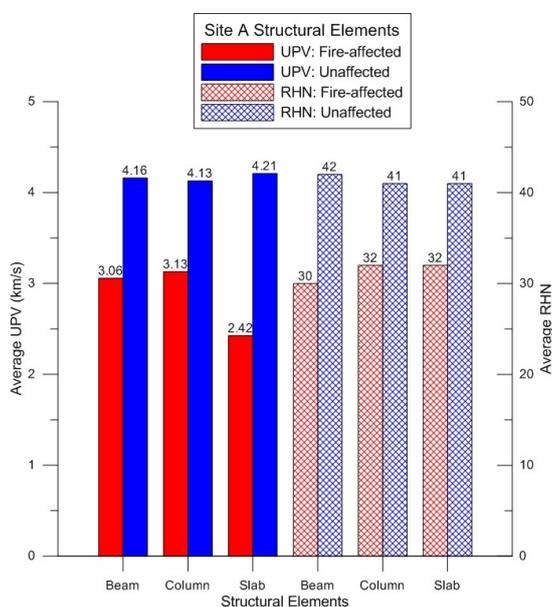
Fig. 7. Nondestructive Test Results for Site A

Using the average UPV and RHN results obtained for site A, it was deduced that the fire-affected part of the building lost 26 – 40% of its strength. The model used for estimating the temperature revealed that the building might have been subjected to a temperature range of $280^{\circ}\text{C} - 450^{\circ}\text{C}$. Figure 7 shows the result of NDT conducted at Site A. More so, the observed physical defects on the building includes spalling and blemishes on concrete surface, cracks and delamination of plaster of slab in some areas, fig. (5a and 5b). Considering the BS [10], [11] and [12] recommendation for NDT, It was deduced that the affected concrete members are still good but requires plastering. Site B concrete elements were not as affected by fire as those at site A, in that, only about 30% of the strength was lost which occurred at a suggested temperature range of $250^{\circ}\text{C} - 350^{\circ}\text{C}$.

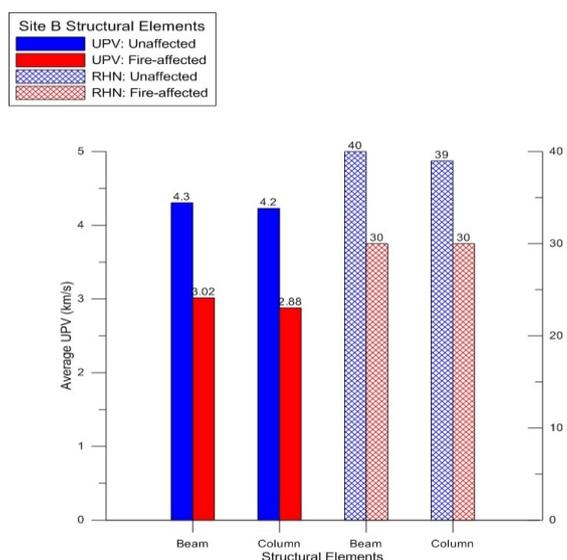
Fig. 8. Nondestructive Test Results for Site B

Observed physical changes include dark and whitish colour due to smoke and some instance of cracks. The NDT results obtained indicated that the concrete members are still good for use but only requires adequate renovation. Figure 8 shows the result of NDT conducted on site B.

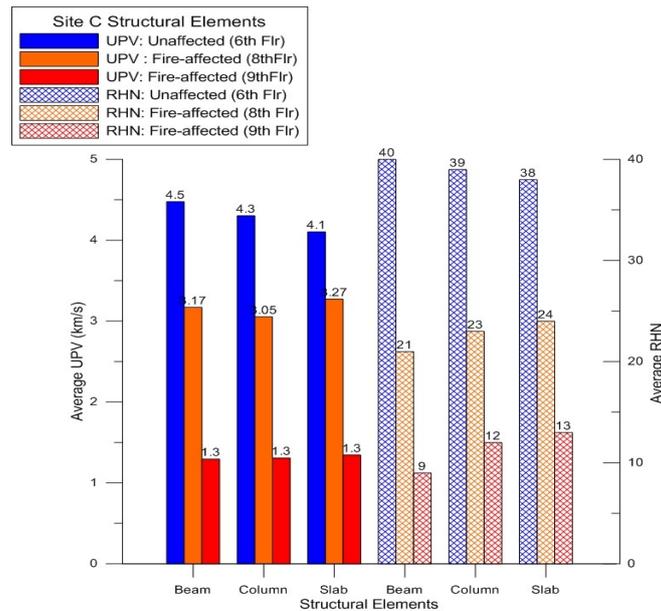
Fig.9. Nondestructive Test Results for Site C

Site C was the most severely affected by fire, most especially at the ninth floor where about 70% of strength of members were lost. This part of the building might have been subjected to temperature range of 600°C and above. The strength loss in the concrete members at the ninth floor was so affected by the fire that members were vibrating during testing. It is an indication that concrete elements subjected to temperature above 600°C are to be considered not useful. However, in the eighth floor, strength loss in the members was about 20 – 30%. This part of the building might have been subjected to temperature range of $250^{\circ} - 350^{\circ}\text{C}$. Moreover,
