Geophysical perspective of road pavement failure: a case study of Ikot Ekpene- Umuahia road, Nigeria

Geophysical survey using two dimensional resistivity methods was undertaken to investigate the causes of pavement failure along the Ikot Ekpene - Umuahia road. The study was centered on some perennial failed parts of the road namely Ariam, Awomnkwu, Ekebedi Oboro, Ogbubule Oboro, Okwe-ukwu Oboro, Ndoro Oboro, Umudike, Ahiaeke Ndume, Ehimiri using subsurface electrical method, which reveals the subsurface geology(lithology) at each location after interpretation. Abem Terrameter SAS 1000 was employed and the apparent resistivity values were used. The lithology of the subsurface reveals that their resistivity falls between $>83\Omega m$ to 103Ω . The geoelectric zones constructed from the VES resistivity structures shows that the pavement segments were founded on a shallow basement near low resistive layer bereft of vital geological features. This made it impossible for the pavement to withstand stress as a result of load from road users.

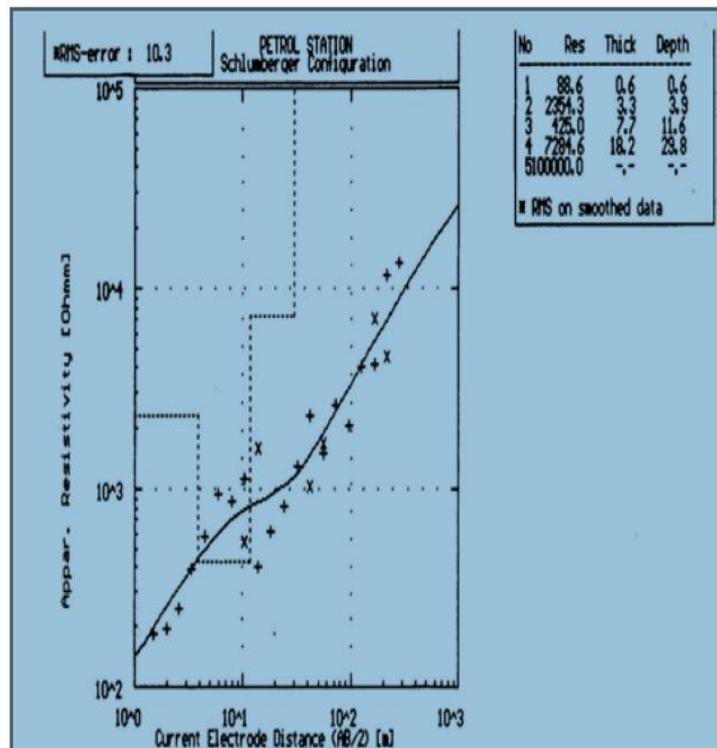
Fig 2: VES for MOUAU Umudike.

Location7: (Umudike VES 7). Profile 7 spreads over a distance of 66m adjacent the University (MOUUAU) gate from the surface with a resistivity of $88.6\Omega\text{m}$. Weathered/fractured segments and cracked portions were prevalent. Four lithological sections comprising laterite, shale/clay and fine sand were delineated. The failed portion of the pavement has a layer with thickness varying from $0.7 - 29.8\text{m}$ (fig.2)

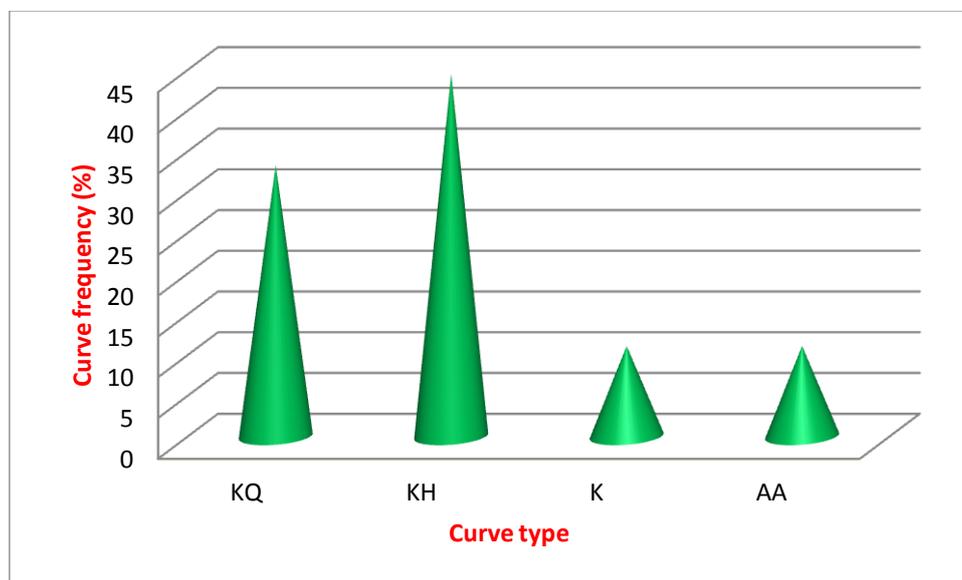
Figure 3: Significant curve type spread in the study area.

In the nine locations considered, four group of curves(table 2) were delineated, which show high degree of variability of geologic units. The curve types are: KQ ($\rho_1 < \rho_2 > \rho_3 < \rho_4$) with 44.5%; KQ ($\rho_1 < \rho_2 > \rho_3 > \rho_4$) with 33.3% and K ($\rho_1 < \rho_2 > \rho_3$) and AA ($\rho_1 < \rho_2 < \rho_3 < \rho_4$) which respectively 11.1%. The spread is as given in Fig. 3. Generally, the knowledge of the resistivity values for different types of subsurface materials (table 1) and the geology of the study locations is significant in converting resistivity picture into geologic formations. Table 1 shows the geologic sections distributed along the different profiles chosen along the study area.
