Investigation of Poor Performance of a Demethanizer Column using Gamma Scanning

Gaurav Agrahari¹, Vikrant Dhakar¹, C.B. Tiwari¹, M.C. Panicker¹, Vinay Bhawe¹,
Ramakant Sahu¹, Pradip Mukherjee¹

¹Board of Radiation and Isotope Technology, Vashi Complex, Navi Mumbai-400703, India

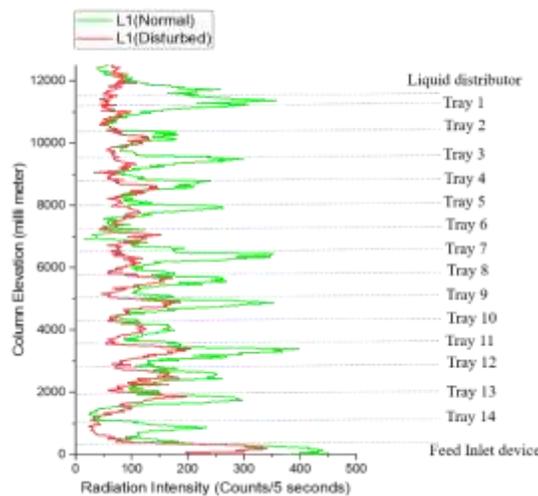
Fig.4: Superimposed scan profiles of top section (L1)

Shifting of the scan profile towards Y-axis indicates increased liquid level above all the trays in disturbed condition as compared to normal condition throughout the top section. Tray 1 seems to be damaged as there was absence of peak towards Y-axis in its location. The space between liquid distributor and tray 2 is completely submerged in liquid during disturbed condition as heavy flow of liquid was observed from the distributor. Overall liquid level on the trays 1 to 8 was increased in the disturbed condition, while these trays were showing adequate vapor space in the normal condition. Liquid level on the tray 14 was maximum in the top section as lowest radiation intensity was recorded for this tray.

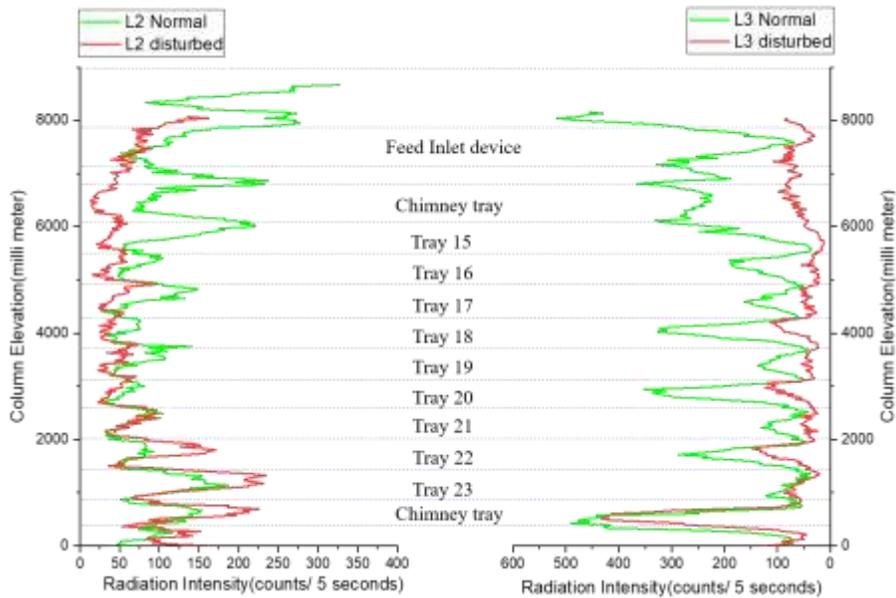
Fig. 5 Superimposed scan profiles of middle section (L2 and L3)

Liquid holdup above tray 19 was increased in disturbed condition and flooding observed above tray 17 in L3 portion. Chimney tray above the tray 15 was submerged in the liquid in the disturbed condition. Liquid level on the chimney tray below the tray 23 was almost similar in both the conditions. However, more liquid was seen falling from the feed inlet in L2 portion as compared to L3 in normal condition. It indicates uneven distribution of liquid from feed inlet device.

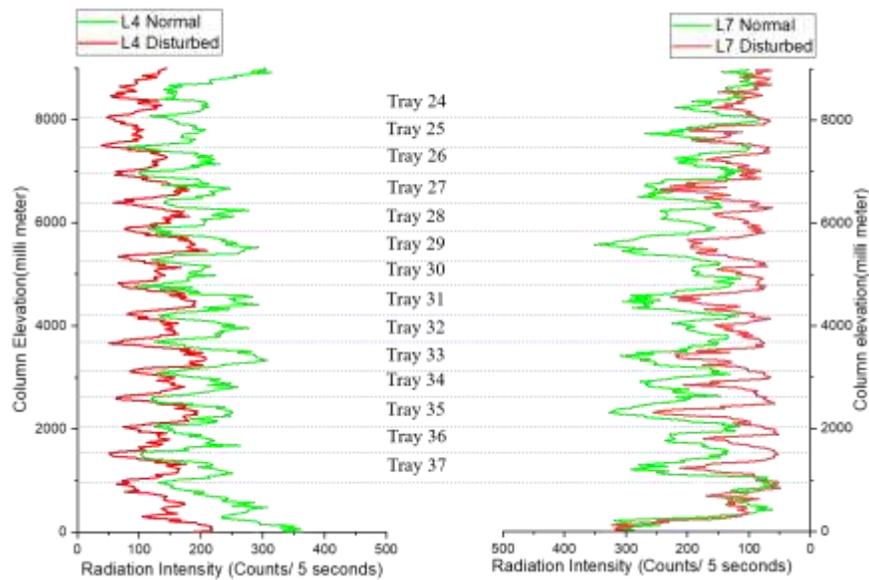
Comparison of scan profiles L4 with L7(Fig.6) and L5 with L6(Fig.7) was made as they were having similar chord length. Sharp peaks in the L4 scan profile shows intact trays and adequate liquid level in this portion of the tray. Shifting of these peaks towards Y-axis indicates higher liquid level. However, there are no any process related anomalies observed in L4 portion of the tray. In comparison of L4, scan profile L7 shows irregular peaks which indicates poor liquid vapor distribution in this portion. Scan profile L5 shows almost similar pattern in both the operating condition. Trays 31 and 30 were flooded in this portion. As per the scan profile L6, clear indication of flooding was observed on all the trays present above tray 31 in the disturbed condition. Extent of flooding was increased as attributed by decreasing radiation intensity from tray 31 to tray 24.

Fig. 6 Superimposed scan profiles L4 and L7 for bottom section four pass trays

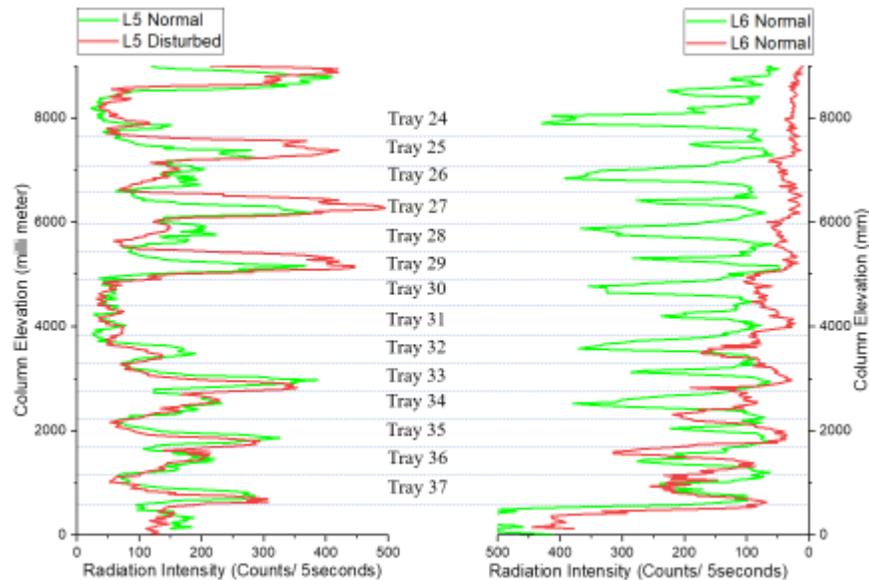
Fig. 7 Superimposed scan profiles L5 and L6 for bottom section four pass trays
