Common Problems in Bridges on Baddi-Nalagarh-Swarghat Road

N.P.Singh¹, Alok Panday²

¹Hamirpur Division, HPPWD, Himachal Pradesh, India)

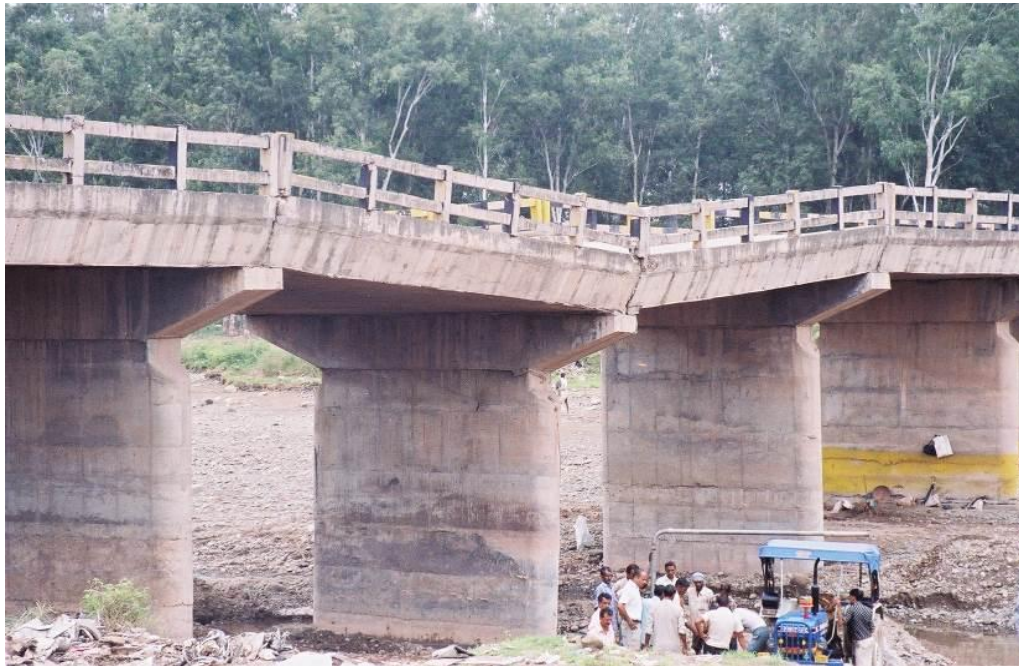
Photo.1. Settlement and tilting of the foundation and pier of Balad bridge

In addition to the deep scouring and sunken/tilted pier & foundation (Photo 1 & 2, Fig.1), the following were noticed at the bridge site:

- The next step involved was fabricating and erecting steel portals on each side of the sunken pier/foundation to support and hence release the superstructure loads over the piers/foundations (Photo 19). The portal foundations were placed away from the existing bridge foundation with a clear gap of 2000mm in such a way that difference in the founding levels of bridge and portal foundations is not more than 1000mm i.e. half the clear distance between the two.

- As the settlement was due to scouring below the founding level, there was possibility of sub-surface soil not fully in contact with foundations and hence voids below the founding level. The next step therefore was to drill 25mm diameter holes through the foundation and grout any such voids using free flowing, high early strength, non-shrink cement grout. The grouting was done in the presence of authorized representative of the grout supplier who ensured the effectiveness of the grouting and certified the quality of work. Here it would be worth mentioning that about 1.75m^3 grout was consumed in this process which shows considerably large size/number of voids below the foundation.

- As there was tilting of the pier/foundation, foundation was therefore extended (all around by 750mm) and shear key formed in the foundation to prevent any possible sliding in the future. The extension of the foundation was done using 12mm/16mm diameter (rebar) chemical fasteners (Fig.3 & 4).

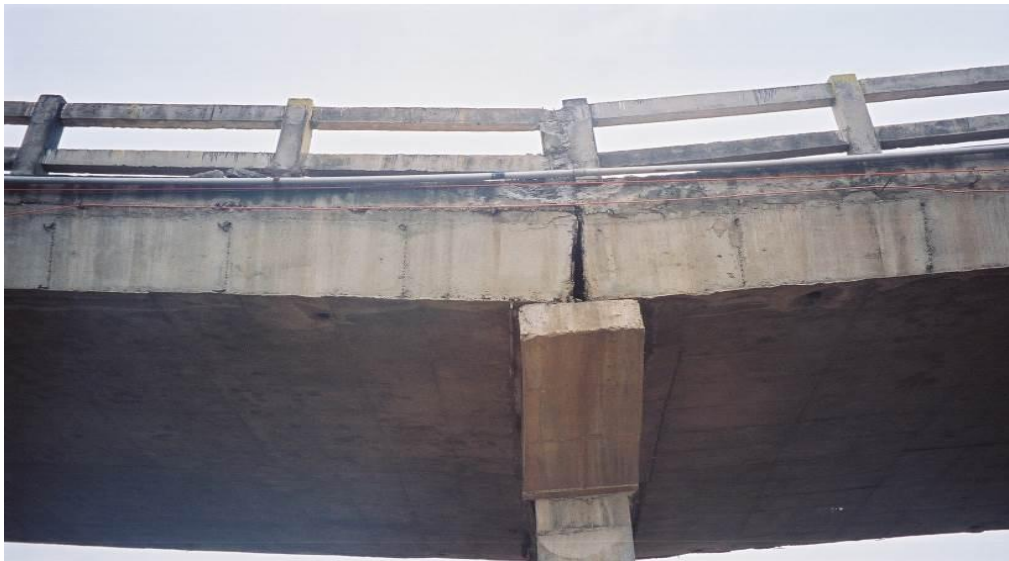
Photo.2. Close view of the settled pier at deck level

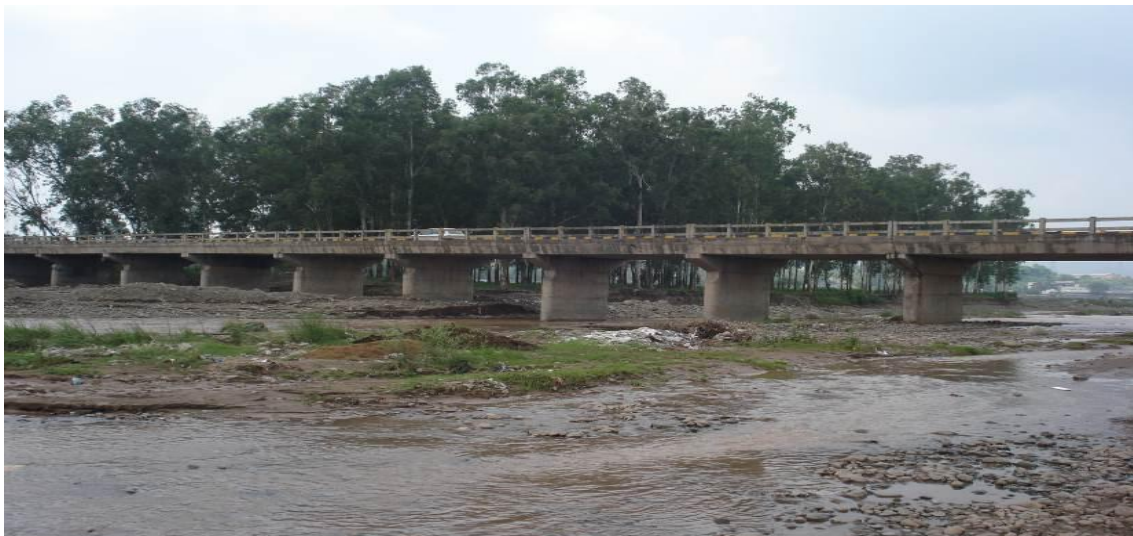
Photo.3. Presence of densely spaced trees on the upstream side

- The presence of densely spaced trees just on the upstream side of the Balad bridge also contributed towards the deep scouring as they restricted the available linear waterway resulting into increased discharge per unit length of the bridge and hence into the increased scour depth.

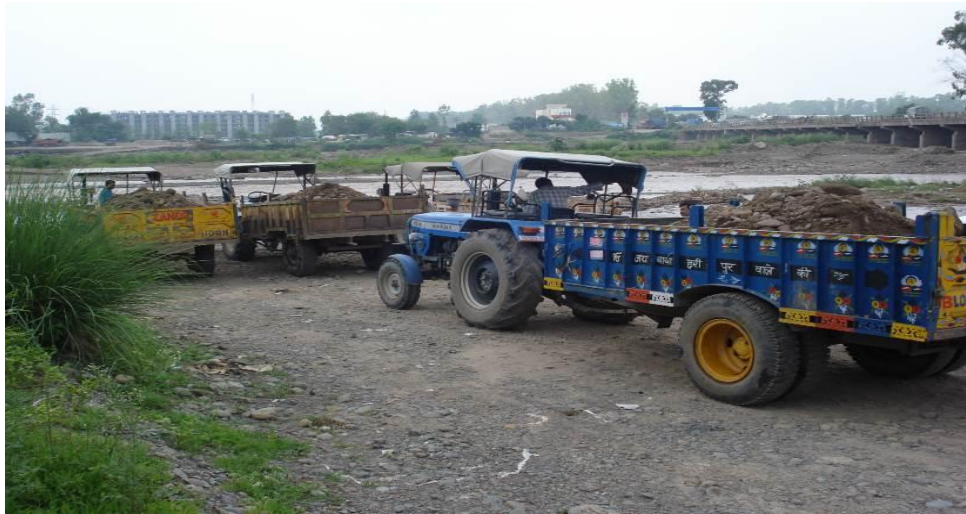
Photo.4. Mining taking place adjacent to the bridge site

- The prime reason for the scouring appeared to be mining near the bridge sites. As seen above, at the location of other nearby bridges, where protections works existed at the bridge sites, a sudden drop of the bed levels was noticed on the downstream side just after the protection works. On the upstream side of these bridge there were not even the nominal scouring noticed. This was because of the reason that protection works acted as a barrier to hold the bed on the upstream side. At the location of Balad bridge, where no protection work was found, a uniform lowering of the bed was noticed with almost same bed levels on the upstream and downstream sides of the bridge.

- As the traffic was stopped during the process of rehabilitation, wearing coat and expansion joints were also replaced simultaneously with the rehabilitation works.
- As there are no limits of scouring due to mining, it was recommended to take serious steps to stop the mining near the bridge sites and have a dedicated team for close monitoring of the same.

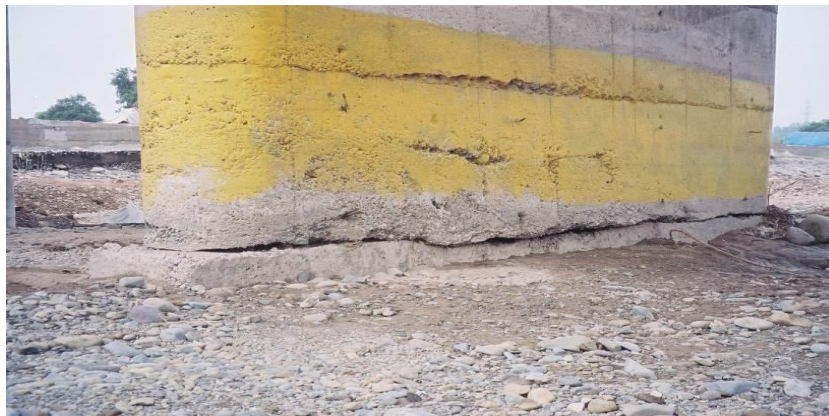
Photo.5. Wide crack at the base of one of the piers

- The deck slab was finally lowered over the raised and thickened pier cap once the concrete achieved the desired strength (Photo 21).
- The wide crack/gap at the base of the pier was filled with epoxy grouting before allowing the traffic over the deck slab.

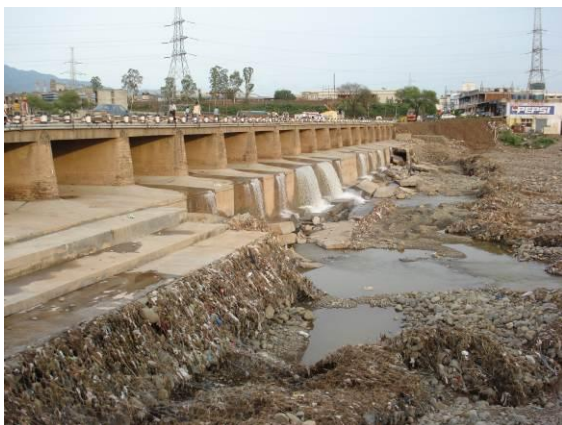
The main findings at the bridge site were deep scouring on the downstream side, failure of the bed protection works & launching apron and no scouring on the upstream side (Photo 6 & 7) of the bridge. It was important to note that the rigid flooring below the bridge remained intact due to the presence of a RCC retaining wall provided as curtain wall and probably having foundation at considerably lower depth (Photo 6).

Photo.6. D/S side of bridge across same river

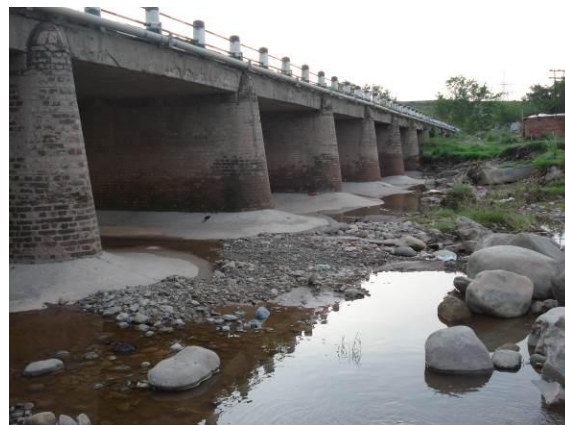
Photo.7. U/S side of bridge across same river

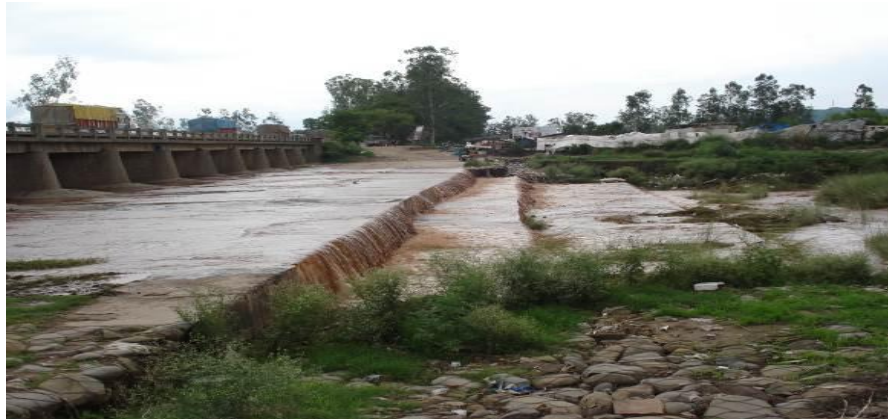
In the other existing bridges on the same national highway i.e. NH21A, deep scouring (about 5-8m) was noticed on the downstream side of the bridge. No scouring was noticed on the upstream side of these bridges. The floor protection work of bridges near km15, km24 & km44 appeared to be designed with due attention paid to actual the site conditions and was generally found intact in position (Photo 8 to 12). At the location of bridges near km49, km52 & km55, the floor protection work was found failed or at the verge of failure (Photo 13 to 18).

Photo.8. D/S side of bridge near km15 of NH21A

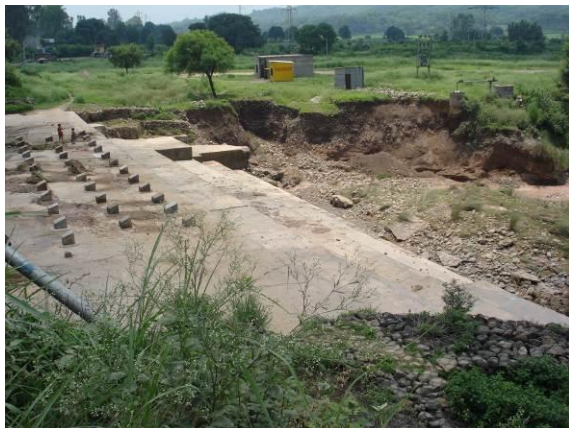
Photo.9. D/S side of bridge near km24 of NH21A

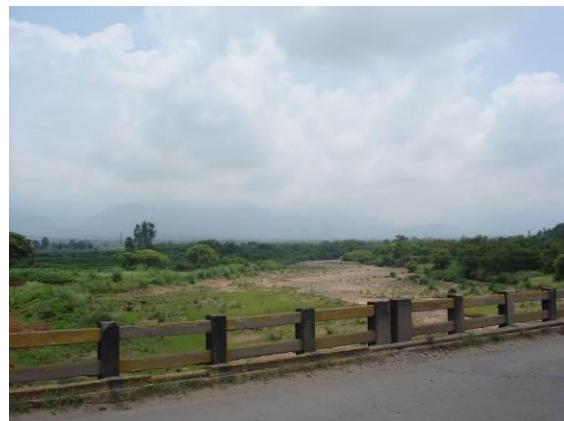
Photo.10. U/S side of bridge near km24 of NH21A

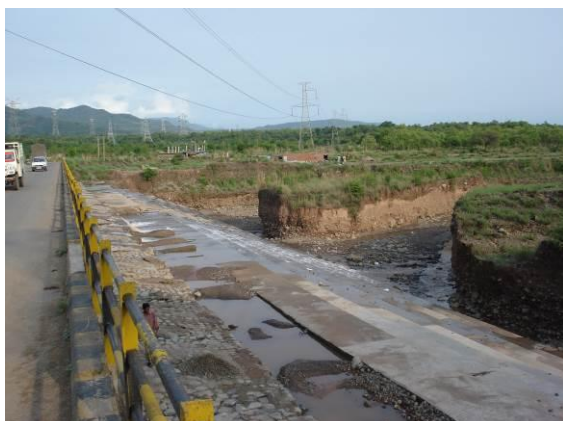
Photo.11. D/S side of bridge near km44 of NH21A

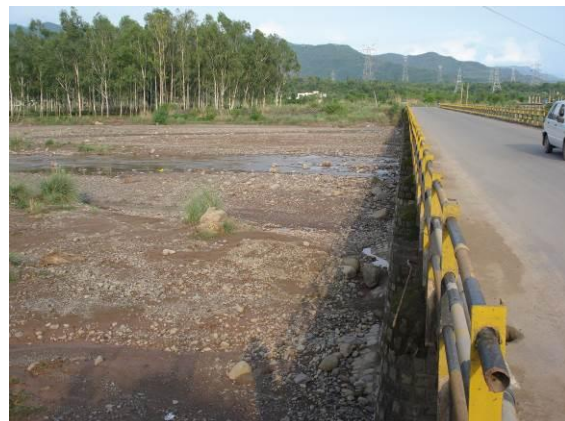
Photo.12. U/S side of bridge near km44 of NH21A

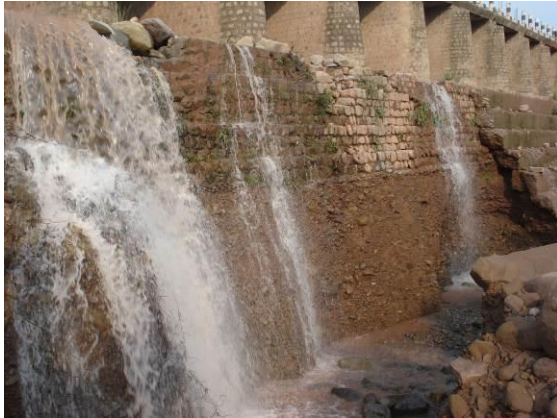
Photo.13. D/S side of bridge near km49 of NH21A

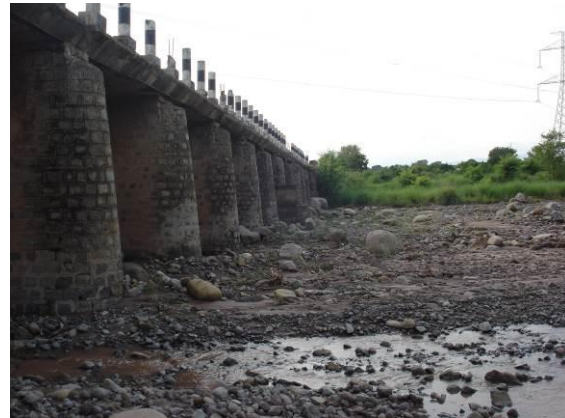
Photo.14. U/S side of bridge near km49 of NH21A

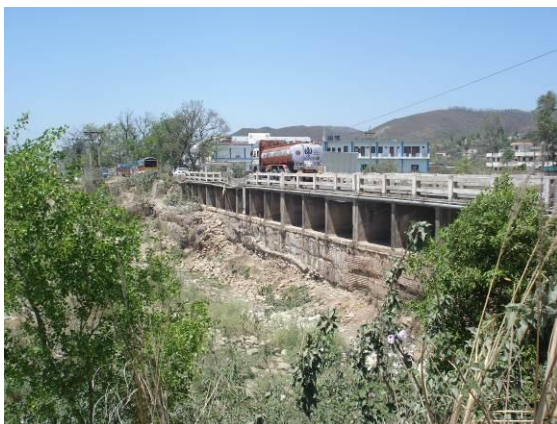
Photo.15. D/S side of bridge near km52 of NH21A

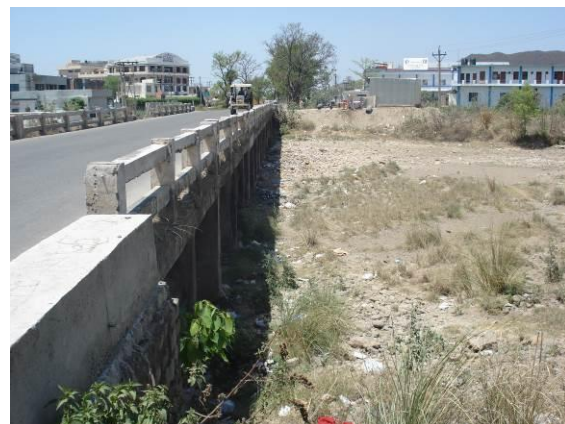
Photo.16. U/S side of bridge near km52 of NH21A

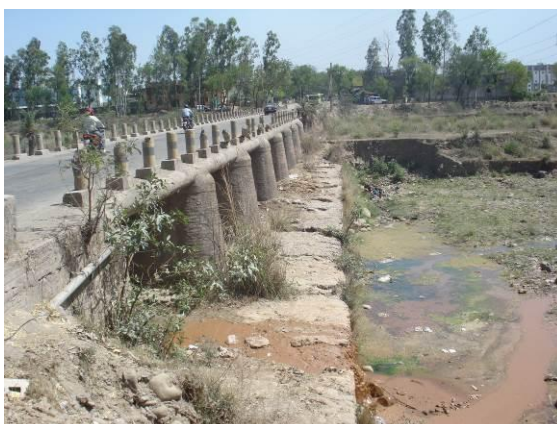
Photo.17. D/S side of bridge near km55 of NH21A

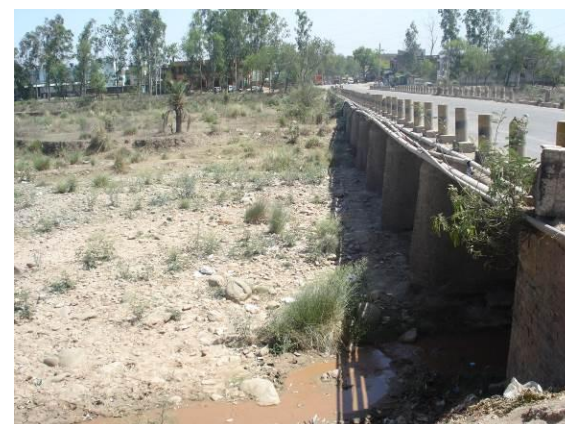
Photo.18. U/S side of bridge near km55 of NH21A
