Failure Analysis on Conveyor Chain Links of a Central Bucket Elevator

Edward Yin¹, Onumus Muvengei², John Kihui³, Kenneth Njoroge⁴

Abstract: Failure of chain links of a bucket elevator is inevitable. For this reason, analysis of failure is very crucial to the continuous improvement on the chain links which as a result will minimize down-time therefore increasing productivity. Whenever the chain link of the bucket elevator fail, it takes the technicians a minimum of three days depending on the severity of damage. This results in increased down-time which reduces production time coupled with damaged buckets and links which increases maintenance cost. The objective of this research was to analysis the cause of failure of the chain link of a bucket elevator by carrying out visual examination, chemical analysis and metallurgical analysis on failed chain link samples. Preliminary examination using stereo microscope revealed the type of fracture is a brittle fracture and chevron marks showed that the fracture began from the core of the fractured surface and progressed through the material until eventual fracture occurred. Metallurgical analysis revealed that the micro-structure is a tem

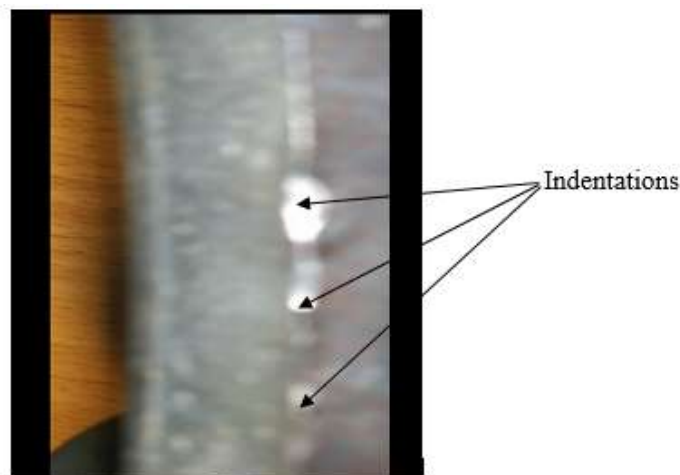
Fig. 5 Indentations on Chain Link

The preliminary examination done on the factory site revealed indentations on the chain links which is as a result of the sprocket impacting on the chain link as shown in the Fig 5.

This indicates misalignment and vibrations within the bucket elevator system. Examining the sample under the stereo microscope revealed that the grains at the fractured surface were fine pointing to the fact that it's a brittle fracture. Brittle fracture also occur as a result of induced inclusions at the grain boundaries [12]. Fig 10 and 11 shows that the fracture was induced by inclusions which emphasizes that it's a brittle fracture

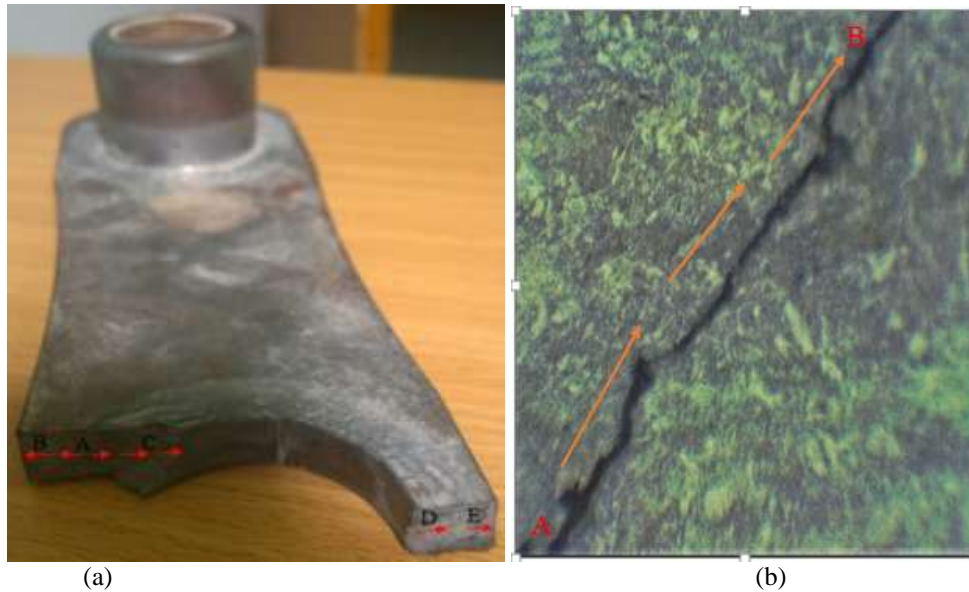
Fig. 6 Fracture Mechanism

Also the mechanism of failure was obtained by tracing the chevron mark on the surface. The fracture started from the core of the fractured surface B of the link and proceeded until it snapped i.e. A → B → C → D → E. The mechanism of failure is as shown in the Fig 6. Fig 6 (a) shows that the crack begun at point A and progressed gradually to the surface at point B. Since the chain link is under tensile loading and the crack had already been initiated at A and grown to B, it then progressed from C to D and finally fractured at E. The initiation and growth of the crack from A to B is as shown in Fig 6 (b)

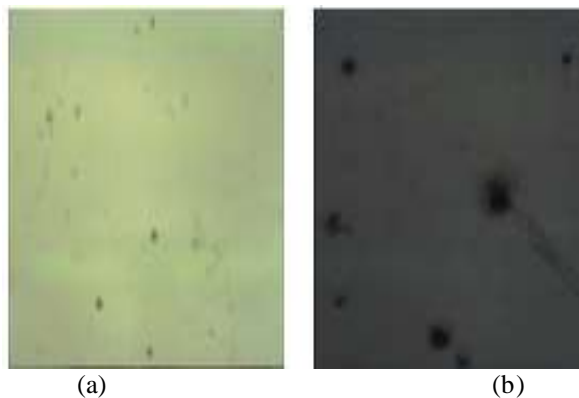
Fig. 7 Blow holes and oxide formation

After polishing of the samples was completed, it was viewed under light microscope both etched and unetched. The unetched polished sample showed a lot of blow holes which is a casting defect as shown in figure 7 (a) and oxide formation within the material as shown in figure 7 (b) within the material as shown in the figure below;

The type of oxide will be determined by using SEM equipped with Energy Dispersive X-Ray (EDX) to verify if the oxide is detrimental to the steel material or not.

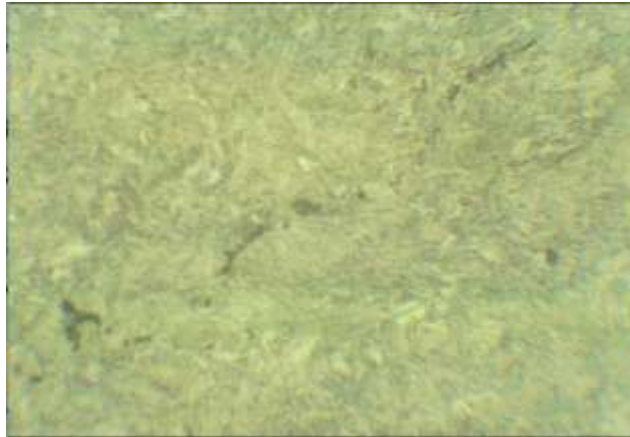
Fig. 8 Microstructure

The micro structure is martensitic which accounts for high strength and wear resistance because of its application. From the micro structure it can be deduced that the material has undergone heat treatment. The micro structure showed a lot of existing cracks within the material introduced during manufacturing as shown in the fig 9. These cracks then propagated during loading leading to the eventual fracture of the material.

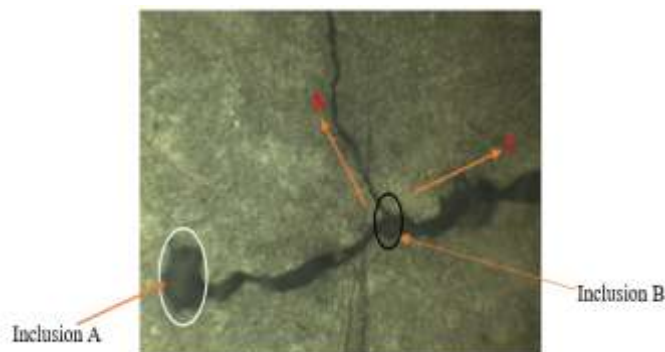
Fig. 10 Crack initiation

The crack began from inclusion A and progressed until it reached inclusion B. From inclusion B, two cracks emerged, one in the direction of X and the other in the direction of Y as shown in the figure 10.

These cracks had initiated from an inclusion as shown in figure 10 and 11 under magnification of 500x. Inclusions are produced when the quantity of metal added is greater than necessary to kill steel. The remaining metals combine with oxygen to form inclusions [10]. The metal usually used in killing steels is aluminum. Inclusions are known to have low formability and during loading they produce cracks in the steel. Since inclusions cannot be eliminated completely from steels it is imperative to modify them in terms of chemical composition to minimize their harmful effect with calcium so they become harmless [11]. Calcium (modifier) addition is therefore the solution to eliminating these inclusions by chemically reacting with the inclusion to form calcium aluminate. Calcium aluminate improves machinability, toughness and surface quality rather than being a crack initiation point.
