Earthen Dam Failure and Recommendation- A Case Study

Abstract: Nishnap dam located in Radhanagri Tahesil, district Kolhapur, and was built in 1999-2001. Water was stored in the dam till 2004 but due to some reasons, dam did not fulfil the function of storing water. Considering dam has failed in 2004 central portion of the dam was removed due to fear of overtopping of dam. The dam is about to restore and reconstruct to serve its purpose. Geological investigations and meteorological investigations are done in order to know the feasibility and subsurface details of hard stratum. Remedial measures are suggested to avoid further failure of dam. The remedial measures include providing cut-off trench, filters, seepage control measures.

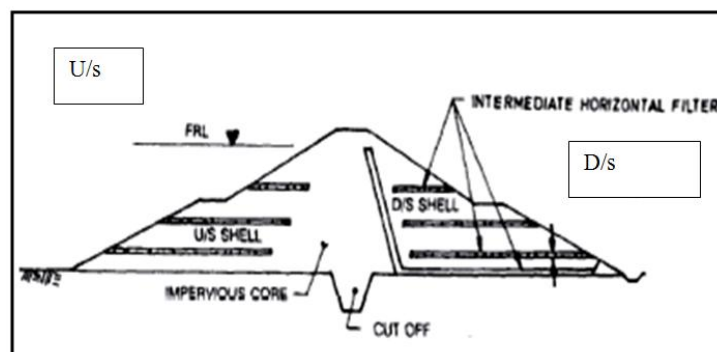
Fig No. 6.3 Protection on Upstream and Downstream (Horizontal Filter)

Pore pressure can be reduced in dam by providing filters at upstream and downstream side. The water can be collected from the upstream side of the dam and can be discharged through filters on downstream side. The horizontal filters and inclined filters may help in reducing the internal erosion and piping in the dam body. In the design of the filter previously there were provisions been made for longitudinal drain and impervious core. Horizontal and intermediate filters are provided so as to reduce pore pressure during prolonged rainfall. The reason behind providing these filters is this site lie in heavy rainfall zone and needs a proper drainage surface for the increasing pore pressure.

The thickness and vertical interval between the filter layers are to be decided depending upon the height of the dam and the range of permeability values of shell material and filter material. This avoids excessive flattening of upstream slope from considerations of stability.

The thickness of intermediate filter provided should be 50 cm. On the abutments, seepage through the dam travels towards the foot of the embankment mainly through the inclined filter. Seepage water may not travel through horizontal filter and toe drain. However, horizontal filter should be provided to take care of rainwater and some part of the seepage through dam and abutment.

1. Horizontal filter should be provided at minimum slope of 1 in 100 towards the toe drain is desirable for quick disposal of seepage water.
2. Provision of 0.6 m thick layers at about 6-m intervals, according to permeability of the core.

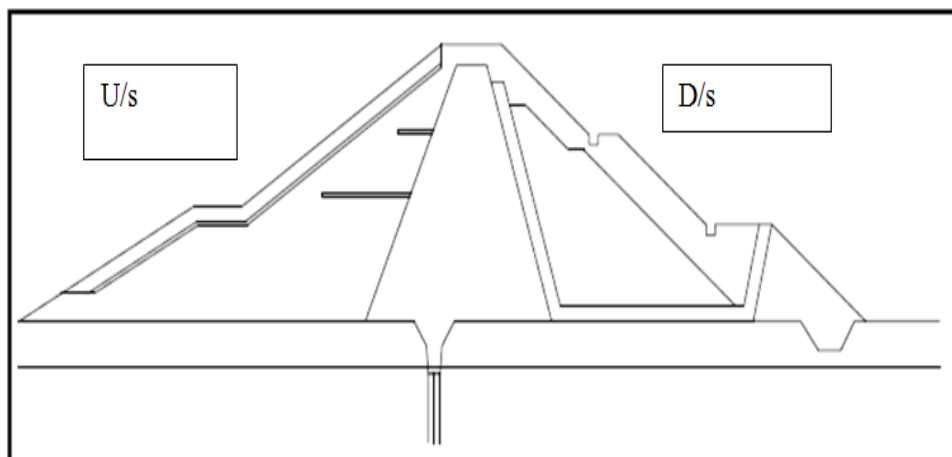
Fig No. 6.4 Positive Cut-Off with horizontal filters

The geological strata present on Nishnap site has fractured and fissured rocks .The water loss obtained water intact test were about greater than 50 lugeons. White Quartzite rock present in the subsurface strata .The hard impervious stratum is present below 10m of depth. Flatter slopes are generally provided for stability of c.o.t. Impervious blanket is generally proposed for the purpose of avoiding piping and seepage through dam. Partial cut-off is a trench where it does not penetrate through impervious stratum and provided to a certain depth. This partial cut-off can be provided at u/s toe of hearting to avoid seepage of water through dam. On site it was seen that there was a passage of flowing water which appears at upstream 270m u/s in a well and later appears at downstream 80m d/s which means there is no trace of flowing of water on surface in between these two points. The pore pressure because of this water may be high due to fractured and fissured rocks.

The depth of the positive cut-off trench is governed by the geological features influencing the configuration of the impervious substratum and the profile of unweathered mass of bed rock. Depth of positive c.o.t is 0.4m into impervious strata. For positive cut off slope should be ½:1 and ¼: 1 or flatter is provided.

The width end side slopes are generally selected according to convenience of construction and to ensure stability of excavated slopes. Detailing of the positive cut-off near abutments and junctions with structures needs careful consideration, since the efficacy and continuity of the impervious filling (both in the cut-off trench and in the core) are compromised by differential settlement cracks developed near junctions, abutments and foundation irregularities .Minimum width is 4 m and bottom width is 10 to 30% of hydraulic head .

In addition to that an impervious blanket of 1.20m thick laid over the top width of this C.O.T is also proposed .The surface shall be stripped off by minimum 0.50m then this surface shall be covered by impervious material of 1.20m thick which is then shall be covered by 1.50m thick casing material. Before doing new earthwork proper stepping and deep benching should be done to have good bond between old and new earthwork.
