## Assessment of water supply facilities in Owo Local Government Area, Ondo State, Nigeria

**Abstract:** The current study was carryout to investigate the status of water supply facilities in 24 rural communities of Owo local government area of Ondo State, Nigeria. Former and informer interview, questionnaire and physical assessment conducted. Secondary data from Nigeria National Population Commission (NNPC) were used in this study. The major water supply facilities used by the communities were mostly hand dug well and boreholes which in most cases were fitted with either electric or hand pump. It was observed that all the boreholes fitted with hand pump were failed while 86 % of those fitted with electrics pump were also failed. In the case of the hand dug well more than 37 % of all the hand dug well were failed. Borehole failure was due to people ignorance, non availability of spare parts, constant water failure, poor maintenance skills and attitude of the communities. The failures of the hand dug well were mainly due to low water table or aquifer region. The survey assessment results revealed that sustainable water supply to the community could be enhancing through the use of h

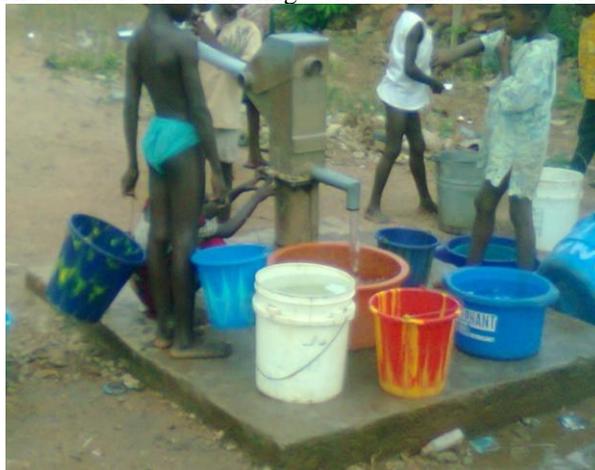
Plate 2: Hand pump borehole at Emure-Ile

The boreholes with hand pump visited were 87 (Plate 2-4) in numbers; some were operational while some were not operational. The numbers of functioning were 38 while the rest were not functioning.

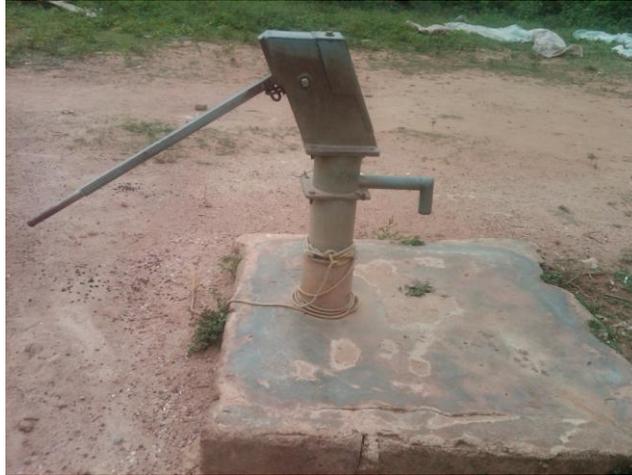
Plate 3: Hand Pump Borehole at Ipele Owo.

From observation, all the 87 boreholes fitted with hand pump available in the communities 49 were functioning while, 38 were none functioning as shown in Fig 2 and Plate 3.

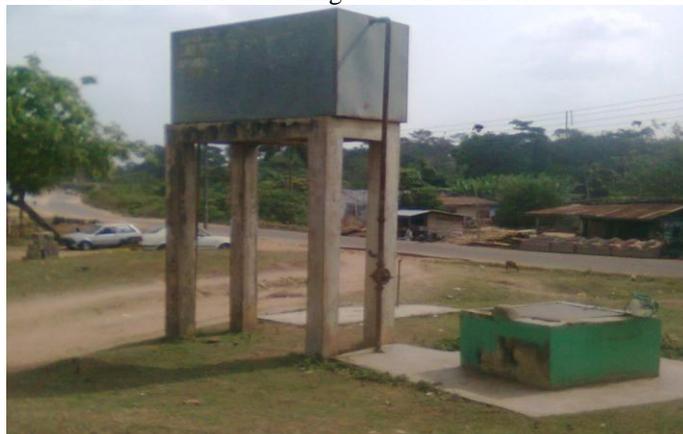
Plate 5: Electric Pump borehole at Idasen Owo

The boreholes with electric pump visited were 24 (Plates 5-7) in numbers, some were operational while some were not operational. The numbers of functioning were 12 while the rest were not functioning.

Common reason for failure include faulty pumps, no source of power, absence of pumping machine, uncompleted and abandoned as shown in plate 5.

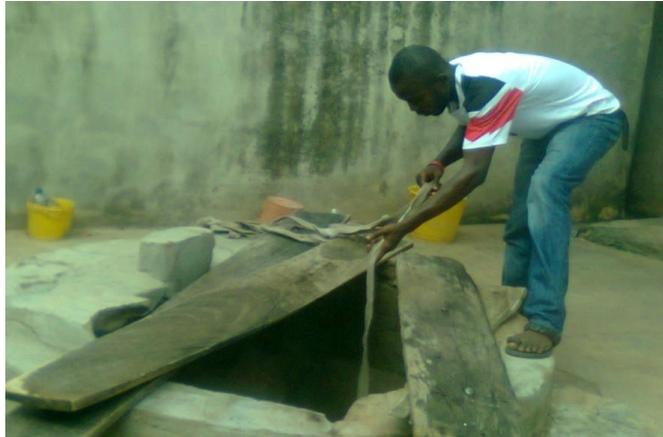
Plate 8: Hand Dug Well at Okedogbon Owo

The hand dug well visited were 882 (Plate 8-10) in numbers some were operational while some were not operational. The numbers of functioning were 237 while the rest were not functioning

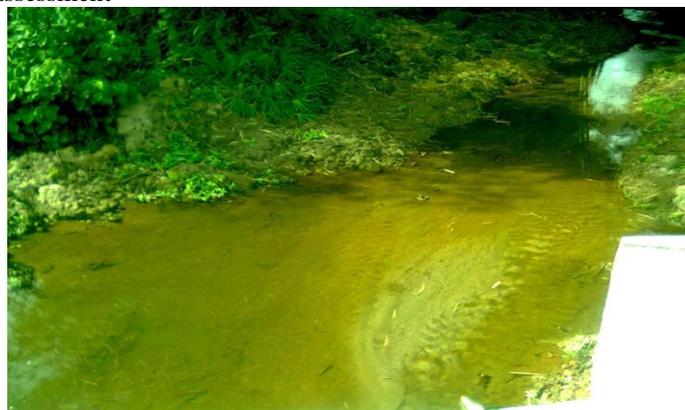
Plate 11: A Stream at Molege Owo

Rivers and Streams were also visited during the course of this assessment, most of the streams and rivers visited were polluted and not good for drinking. However, Rivers and Streams (Plates 11-13) were mostly used for domestic purpose particularly in most of the rural communities visited, but were not considered as source of water in this assessment

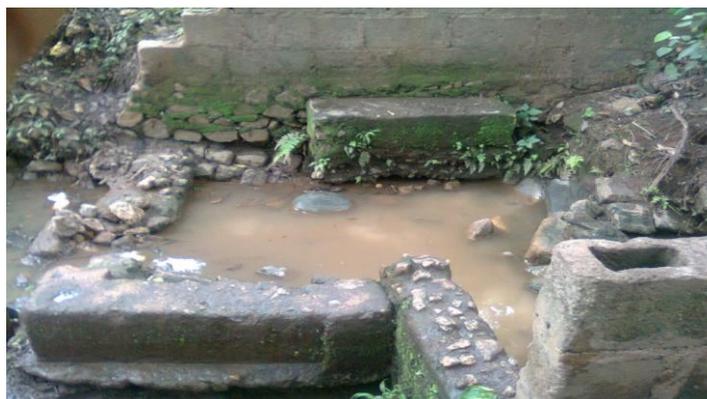
Plate 12: Water used as domestic purpose from Isun Stream at Ago-Ibira Owo

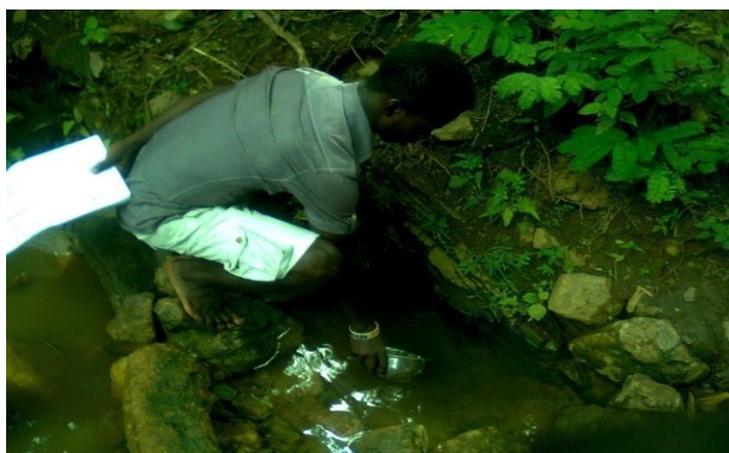
Plate 13: Water used as domestic purpose from Omituntun Stream at Ago-Panu Owo
