Reducing and Optimizing Tailgate Closing Effort in Automotive Car

S.Thavamani¹, G.Devaradjene¹, K.Yogeshkumar²

¹(Dept. of Automobile Engineering, Madras Institute of Technology, Anna University, Chennai, India ²FORD India P Ltd, Chennai, India

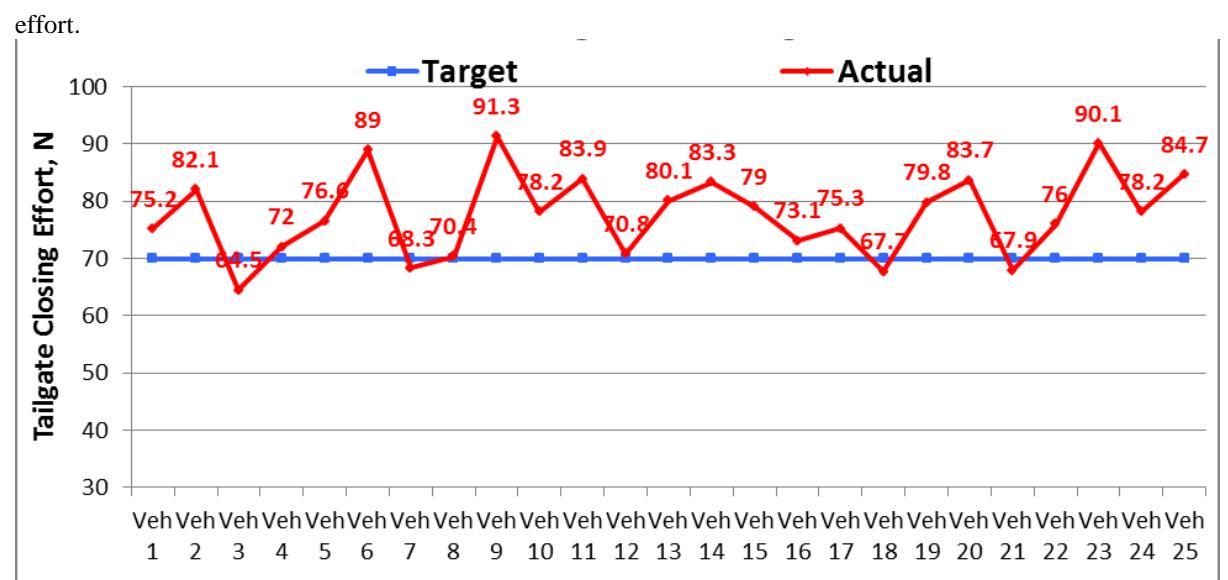
Figure 1 – Tialgate Closing Effort trend in Master car Model

Master car Model Car Tailgate closing effort trend is shown in Fig 1, which is initial state of investigation. It describes Vehicle not meeting the desired state of 70N of tailgate closing

Reducing tailgate closing effort to 70N to achieve Desired State by addressing all possible root causes.

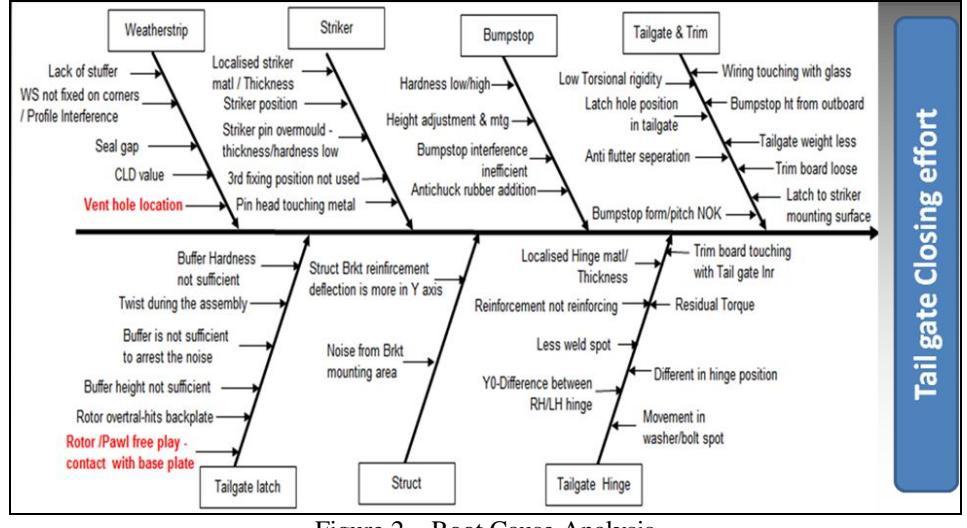
Figure 2 – Root Cause Analysis

All possible root causes can be identified with the aid of 7 QC tools, one the tool Cause and Effect Diagram as shown in Fig 2.

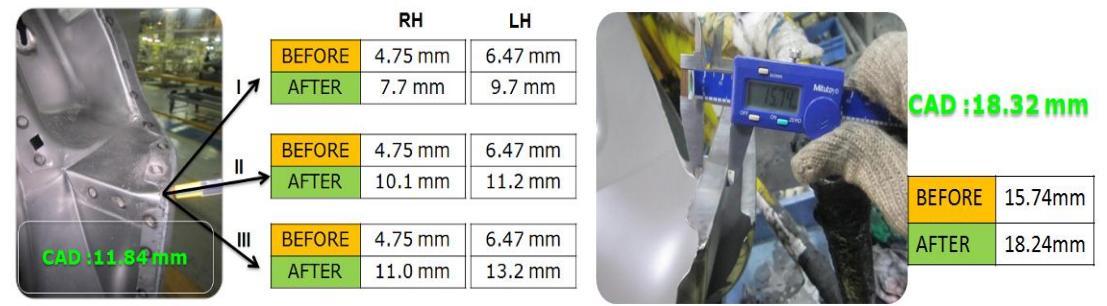
Figure 3 - Body Sides Measurement Data

Body sides stamping panel flange length is too short compared to CAD value shown in Fig 3, which has been measured for continuous 3 bodies since to fix the root cause as stamped panel batch production. It has been observed in batch to batch samples tells that die repetitiveness. Iterative Die correction done to increase flange length as per CAD value so that panel pulling will not happen while welding so that flushness at paint band area can be achieved.

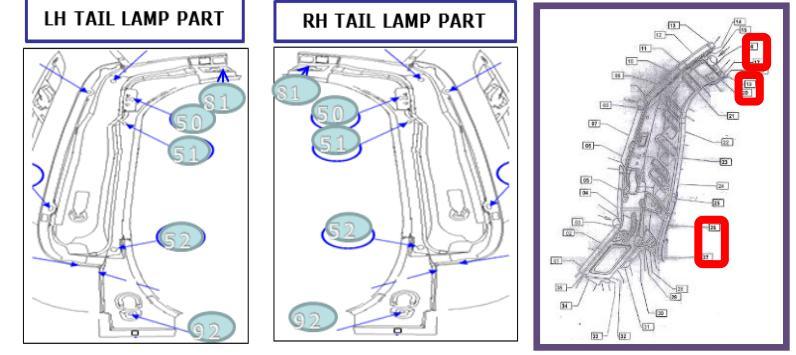
Figure 4 - Tail lamp part and Lower pillar

Tail Lamp part and lower panel as shown in Fig 4, is base panel to the tail lamp trim part which is being welded with body sides outer panel. Tail lamp mounting hole decides the tail lamp location in car so that system

can ensure the tail lamp rubbing with tailgate relation. Supplier end Tail lamp part deviates at gas stamper mounting sphere as shown in Table 1, hence tail lamp mounting points and bump stopper position and lower pillar deviations are corrected at incoming fixtures.

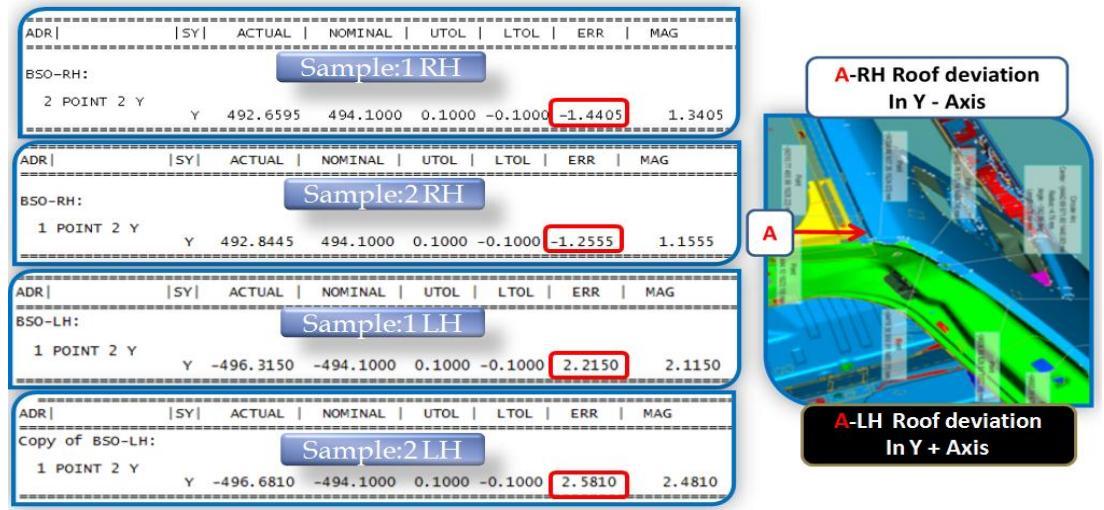
Figure 5 – Body Sides CMM Measurement

Body sides assembly tail lamp mounting surface is checked with PCF and shows RH roof header point deviated in -2mm in Y direction and LH roof header point deviated in +3mm in Y direction which indicates root cause of assembly level deviation. To identify the actual deviation, the same two bodies are measured in CMM.

Based on CMM report shown in Fig 5, Shim correction is done to bring the roof header points towards nominal.

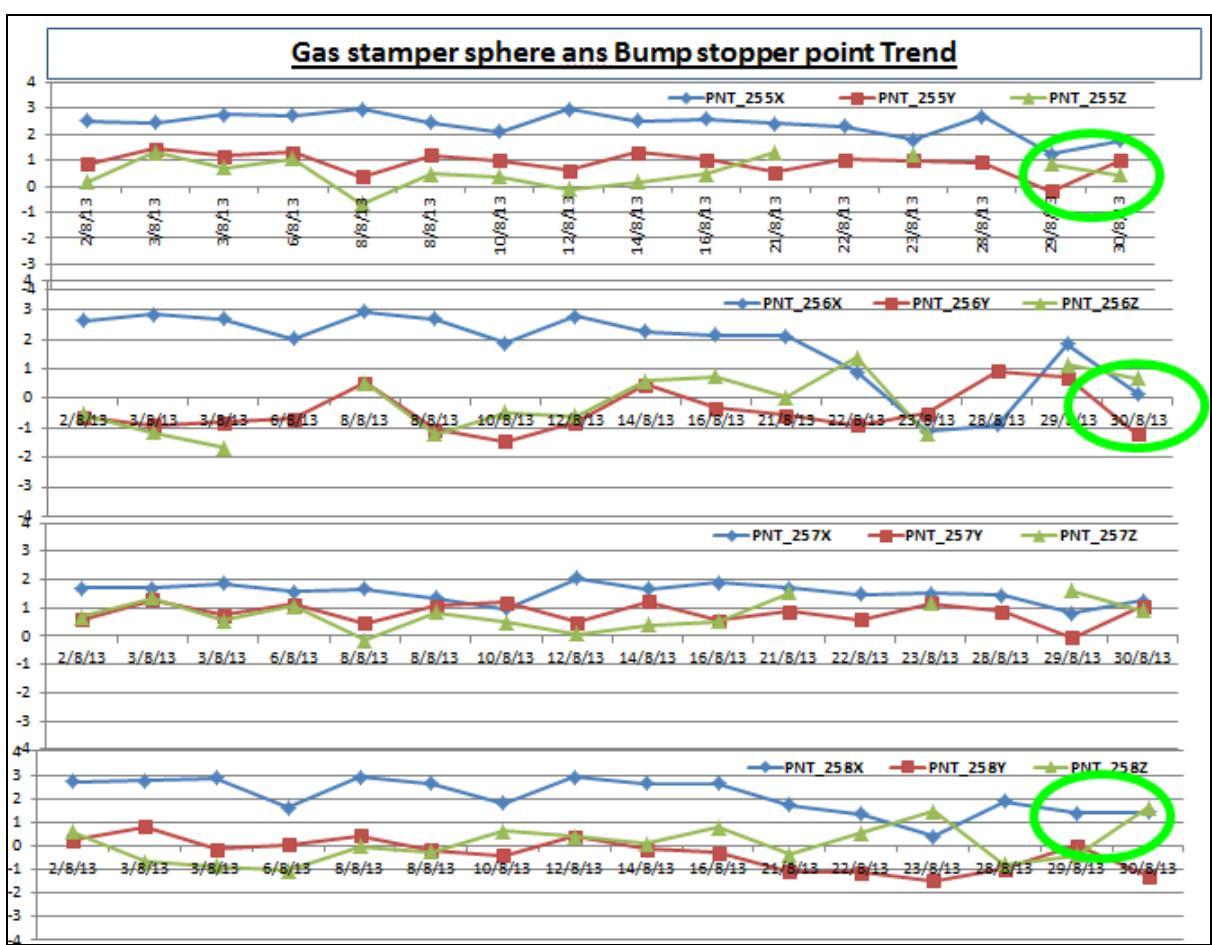
Figure 7 - Body Sides Points trend - After correction

Above dimensional deviation in gas stamper sphere and bump stopper points is because of incoming level child part deviation which has been corrected at supplier end parts fixtures results shared in Fig 7. Gas stamper mounting deviation restricts easy piston movement results hard to close tailgate.

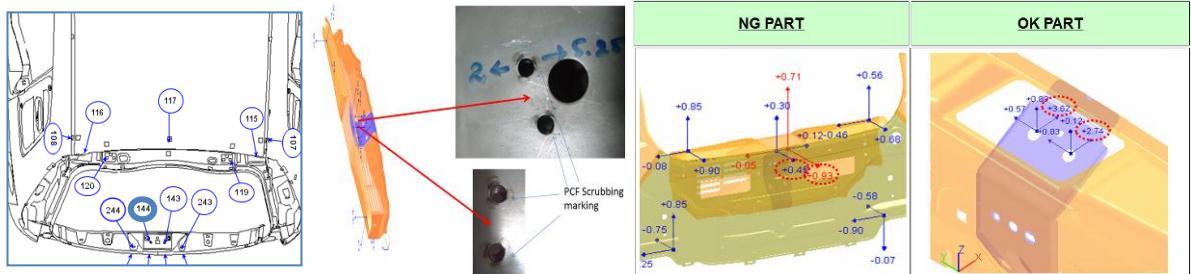
Figure 8 - Back Panel PCF Scrubbing and Scan Report

Underbody back panel striker mounting hole position and back panel flange place an important role for seal gap. PCF scrubbing shows that back panel striker mounting hole have deviation at X+ direction as shown in Fig 8. which is corrected at Rear Floor panel. X+ deviation results long travel of tailgate and improper latching.

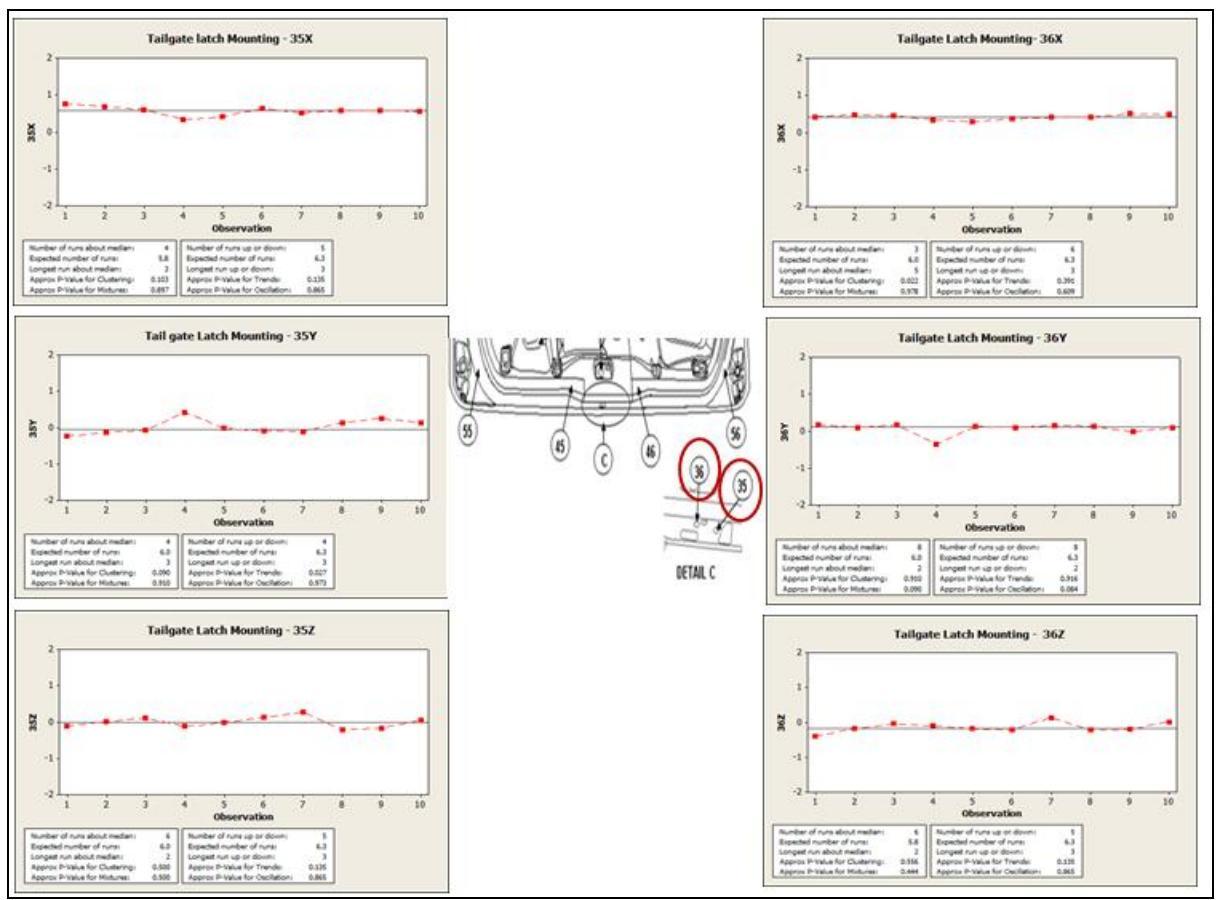
Figure 9 - Tailgate points Trend Chart

Tailgate Latch mounting point is important parameter in Tailgate and those points are well within specification as shown in Fig 9. Latch is the Plastic member and the fulcrum in Latch will hit against the striker so that locking will happen. Uneven latching results improper closing and rattle noise.

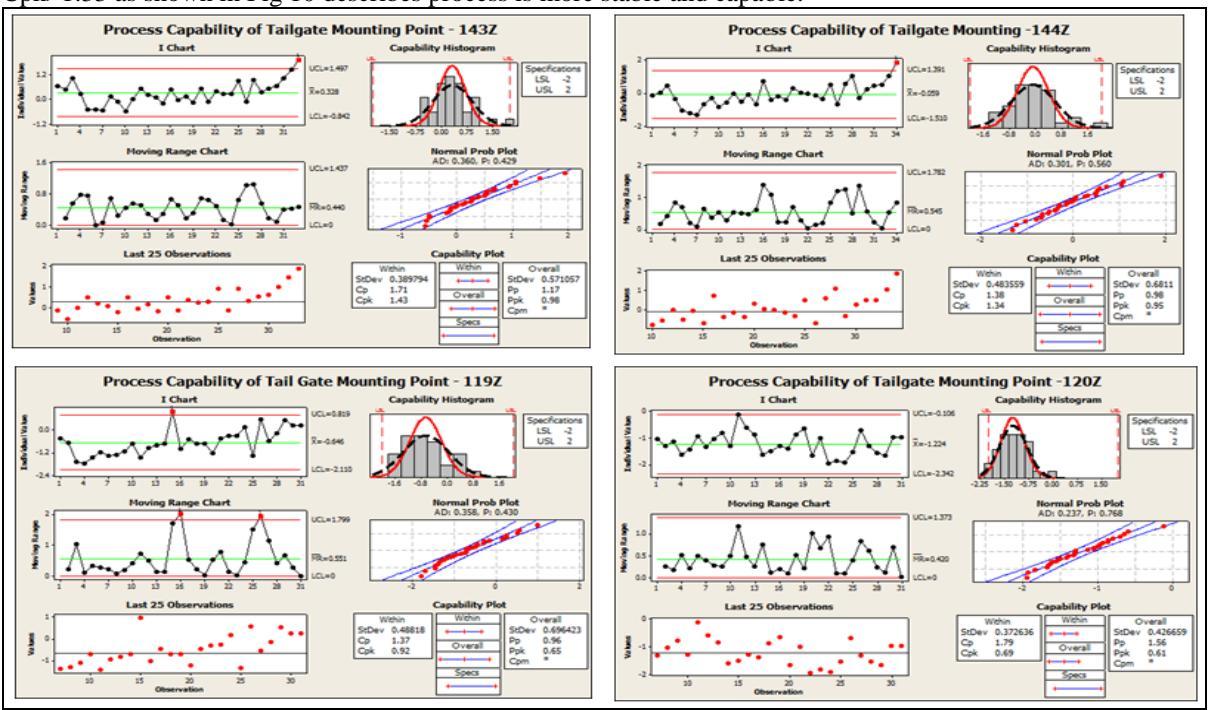
Figure 10 - Roof Points Six Pack Chart

Roof is flimsy panel reinforce with thicker panel is called Roof bow. Roof bow is having tail gate hinge mounting Master control Hole. Tailgate hinge mounting point at Roof bow dimensional capability Cp, Cpk>1.33 as shown in Fig 10 describes process is more stable and capable.

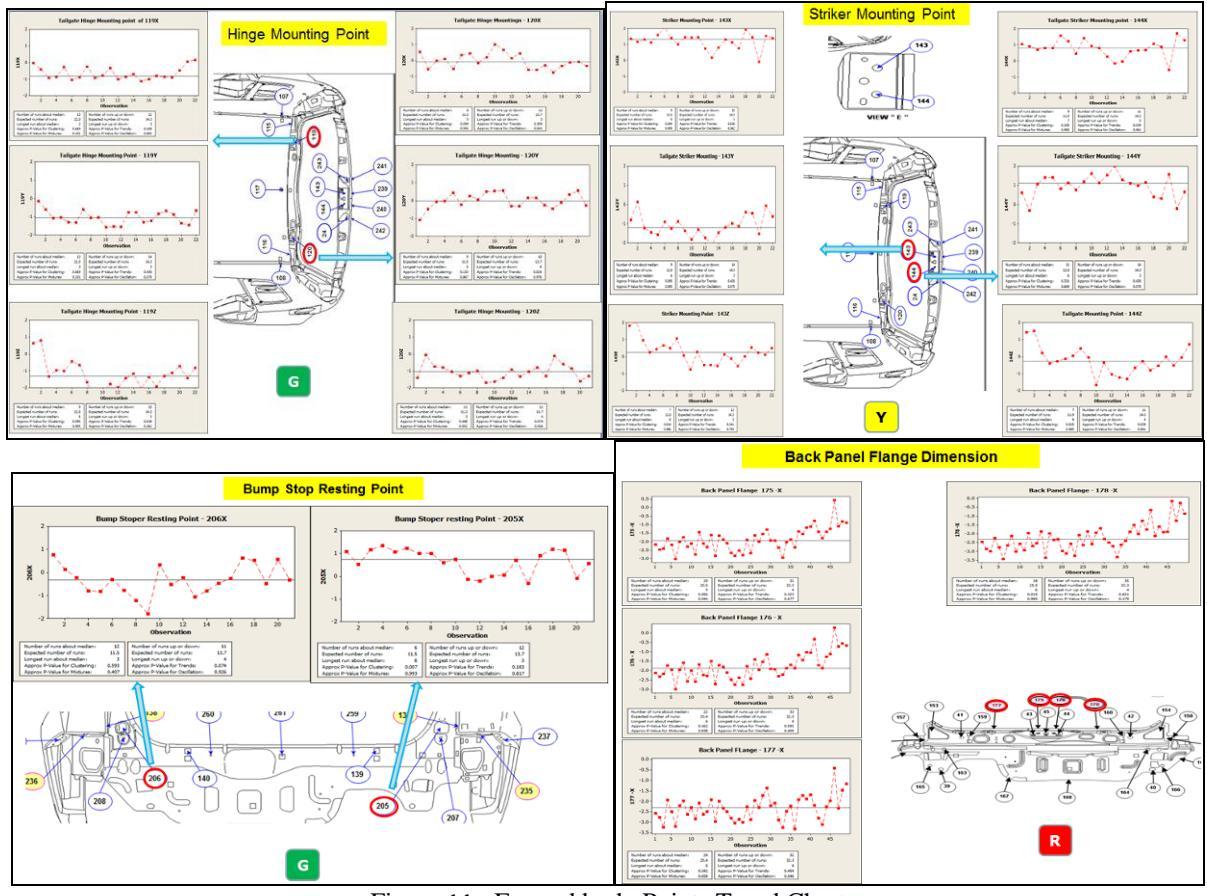
Figure 11 - Framed body Points Trend Chart

Framed body is final body shell where sub-assemblies like body sides LH, body sides RH, Underbody and roof, are welded together, when it located in framing gripper. As a framed body level Tailgate hinge mounting, sticker mounting, bump stopper resting surface, Back panel flange trend will play the important role for seal gap. Back panel flange is having higher deviation and others are within specification indicated in Fig 11.

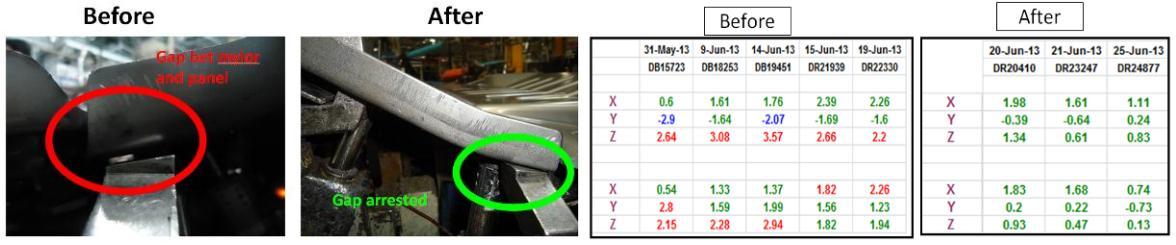
Figure 12 - Back Panel Fixture and correction results

To bring the Back panel deviated points, shim correction done at rear floor fixture RF40 in 1.5mm in Z direction since there is a panel gap between mylor to panel shown in Fig 12, which caused improper resting of panel on locating fixture.

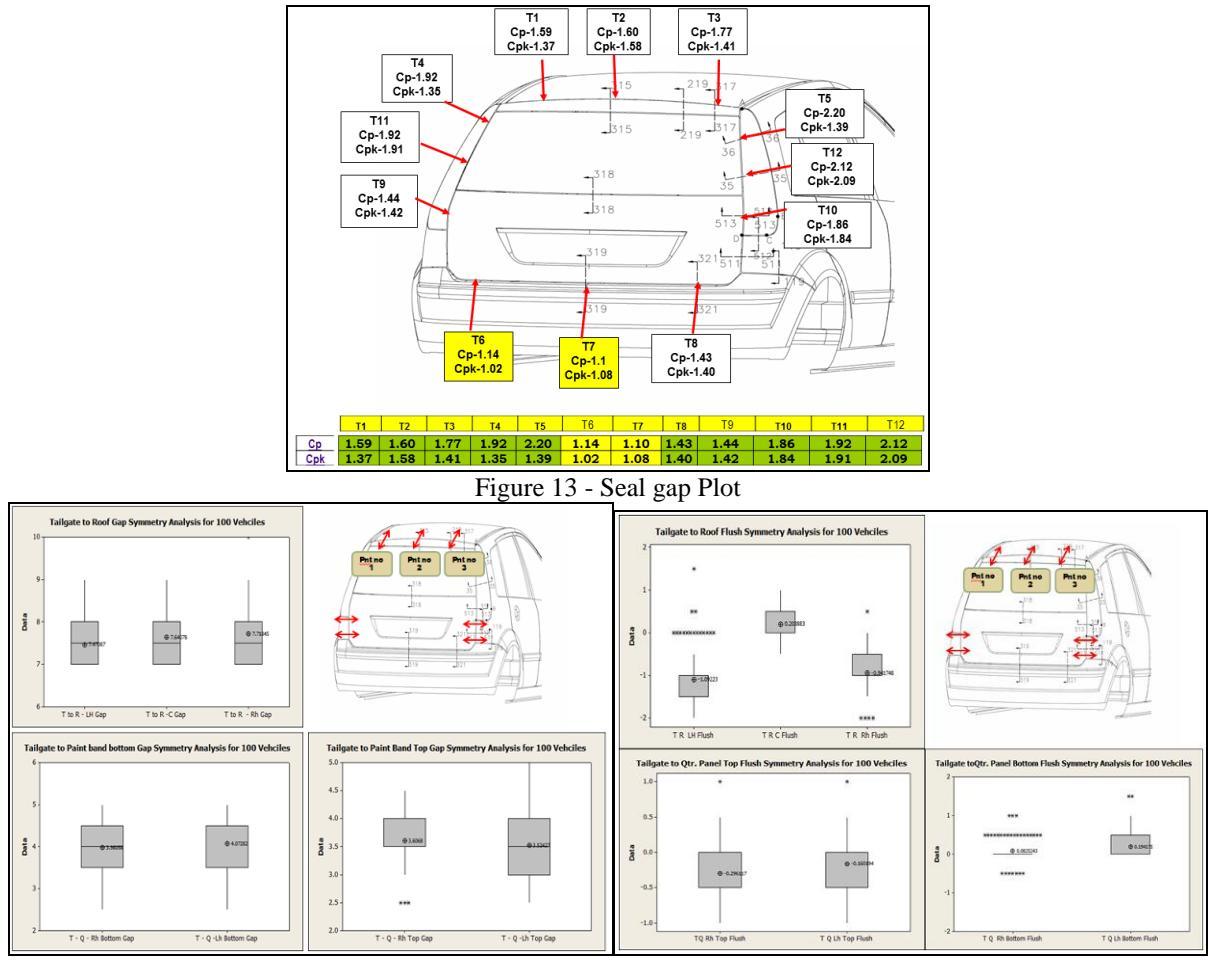
Gap and flushness is the outer appearance and wind noise parameters. These will contribute to seal gap tendency also. Tail gate to paint band area, tail gate more under flush leads to less seal gap. As shown in Fig 13, rear end seal gap points meeting the capability with above action.

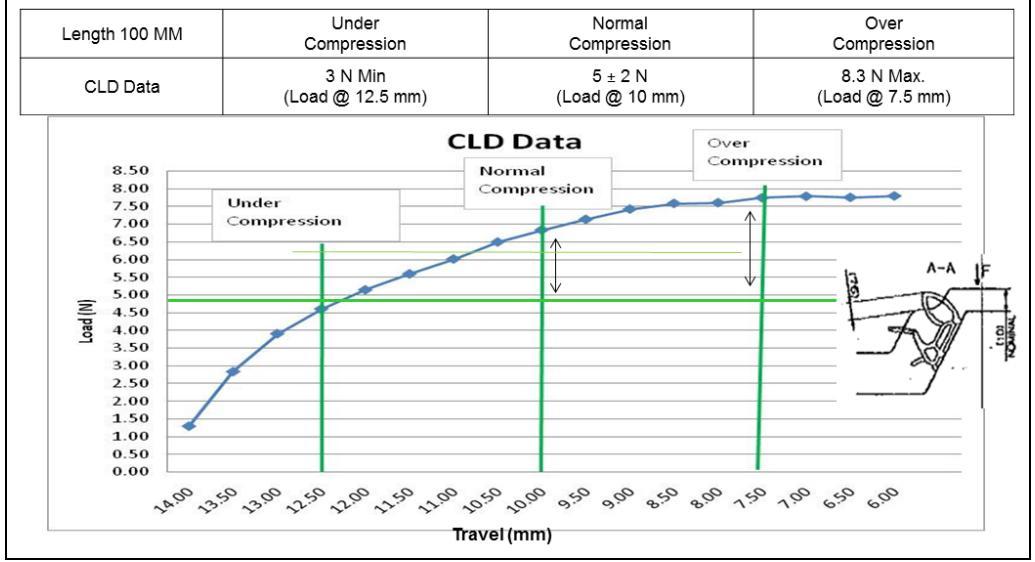
Figure 15 – Weather strip CLD Performance

Weather strip is fitted in vehicle for multiple reasons which are air leak, water leak, wind noise, road noise, closing effort. Graph shown in Fig 15 is Performance curve of weather strip which is fitted in tailgate and framed body flange area as against Seal gap. Desired state of this cure should be flat in Y value at a given seal gap means irrespective of seal gap weather strip CLD should not change.

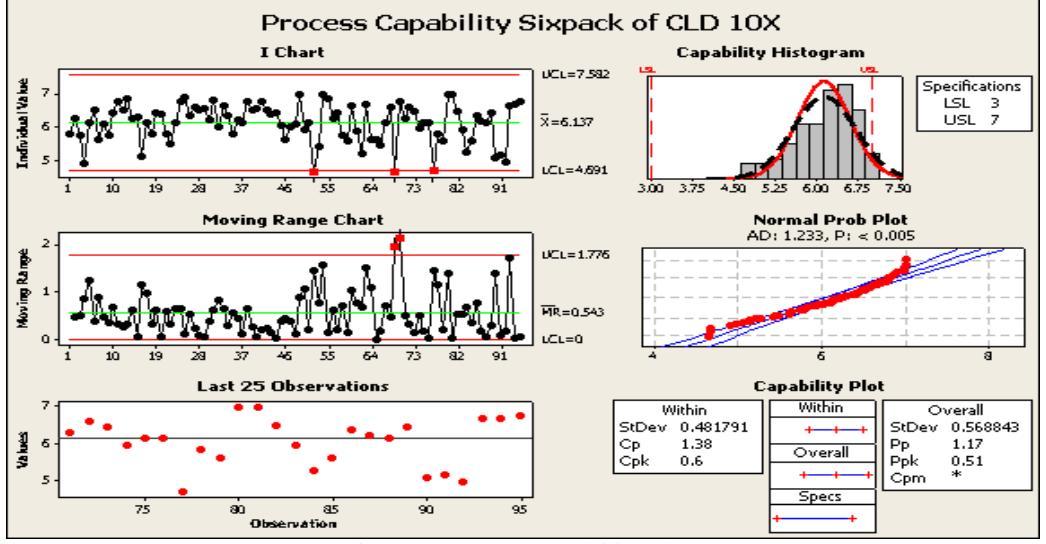
Figure 17 - CLD Capability chart

CLD data shown in Fig 16 describes 100 samples giving very good repatability but upper band of CLD range. Refer Fig 17. It can be brought to nominal by increasing number of gas out holes in weather strip pulb.

Weather strip CLD (Compression Load Deflection) reduced to nominal by adding extra gas out holes in Molding.

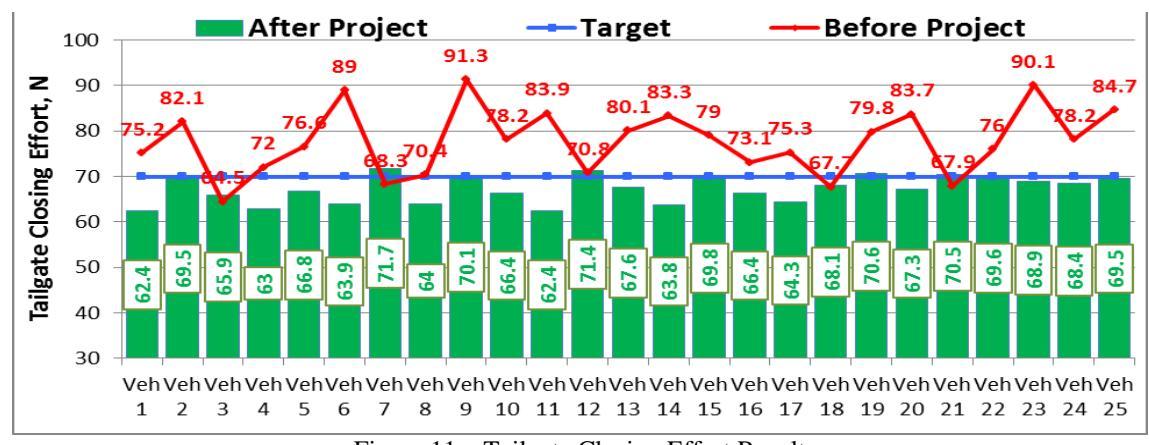
Figure 11 - Tailgate Closing Effort Result

With the above actions, BIW dimensional brought to specification at rear end and Weather strip CLD towards nominal correction done and tailgate closing effort is measured for running model. Project outcome helps to bring tailgate closing effort towards desired state as shown in Fig 11.
