Baseline characteristics, water quality assessment and sanitary surveillance of a man-made storm water lake and environs at Abakiliki, Ebonyi State

The challenge to meet water needs has provided impetus for the re-invention of old technologies for harvesting rainwater and storm (flood). One of such, is the development of large scale artificial storm water basin by the construction firm handling the "Ochudo" city Secretariat project in Abakiliki, Ebonyi State, Nigeria. The storm water reservoir which is an artificial water dam covers an expansive area of approximately 70,000m² with depths varying between 7ft and near 10ft and is fed by flood water from tributaries of riparian waterways and flood paths which drain into the excavation. Apart from flood, the reservoir is also fed by grey water from effluent receptacles from some parts of the city. As construction of the city estate nears completion with the prospects of occupation, the State Government raised serious concerns on the implications of the pond to public health. As a first step to inventing remedial strategy the State Government commissioned this study to assess the baseline characteristics and water quality of the pond a

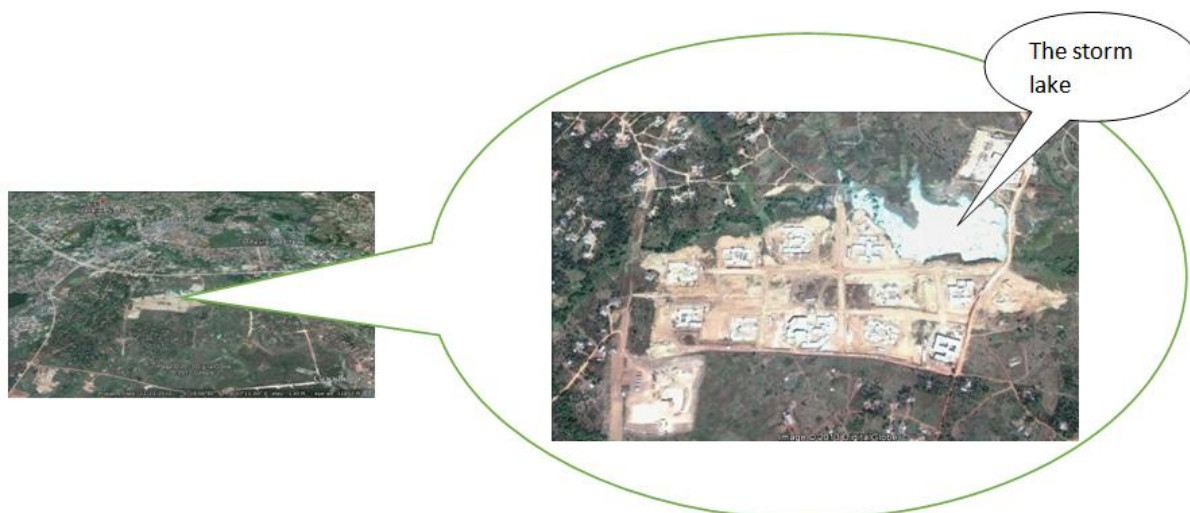
Fig. 2. Google satellite image of Abakiliki showing the project site enlarged.

Ebonyi State is one of the thirty six States of Nigeria, it is located in the Southeast. (See Fig 1.). Abakiliki, the capital of Ebonyi State lies within the Ebonyi (Aboine) River Basin. Its geological formation is of the Asu river group of Albian age (lower cretaceous) made up of shales, sandstones and siltstones. This sediment is folded to form the Abakiliki anticlinorium (Odunze and Obi 2013). The google satellite image of the study site is shown in figure 2.

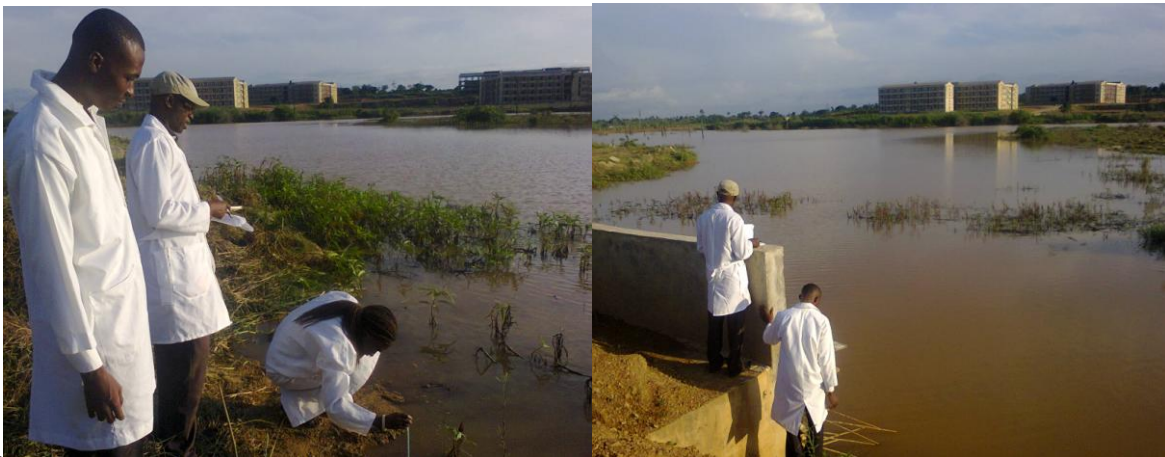
Plates 1&2. Different approaches of the project site showing massive ongoing construction and some members of the team taking on-site measurements and collecting samples.

Surface Water Characteristics: The storm water reservoir is an artificial water dam (see plates 1 & 2) and covers an expansive area of approximately 70,000sqmetres and depths vary between 7ft and near 10ft (see plates 3 & 4). It is fed by flood water from tributaries of riparian waterways and flood paths which drain into the excavation. Apart from flood, the reservoir is also fed by grey water from effluent receptacles from some parts of the city. The water is muddy brown in colour but becomes clearer during the dry season when there is less of storm water inflow.

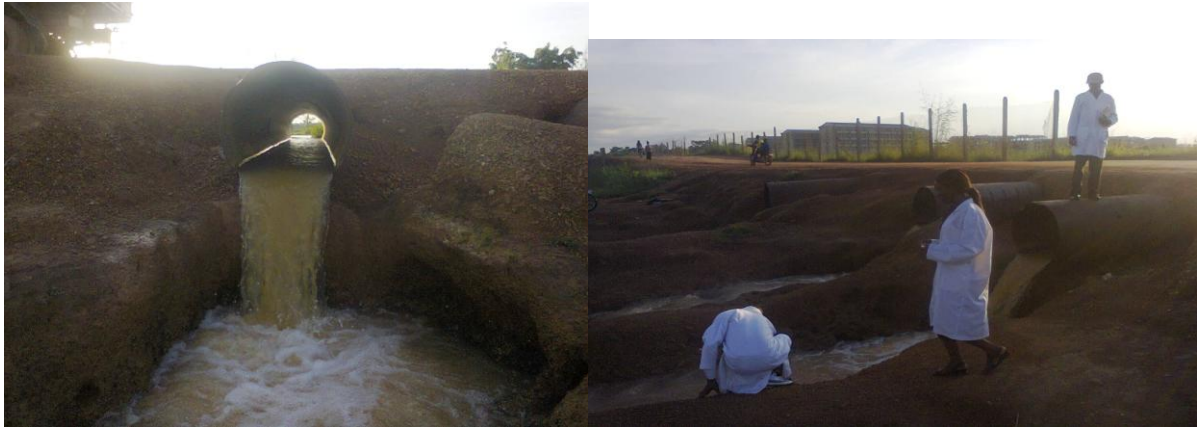
Plates 5&6. Underground storm channelization pipes at project site

The dammed water is released through underground channelization pipes into flood plains, helping to irrigate upland rice cultivation along its flow course and as well emptying into distant rivers. The outlet pipes releases water from the dam with sufficient force eroding the top soil (see plates 5 and 6) and exposing the geologic shale outcrops along the flood plain (see plates 7 and 8). The predominant shale formation of Abakiliki largely accounts for the low erodibility of the lithology, resulting in near absence of deep cut valleys and erosion channels along the flow path. However the sheath erosion that forms along the pathway devastates arable lands.

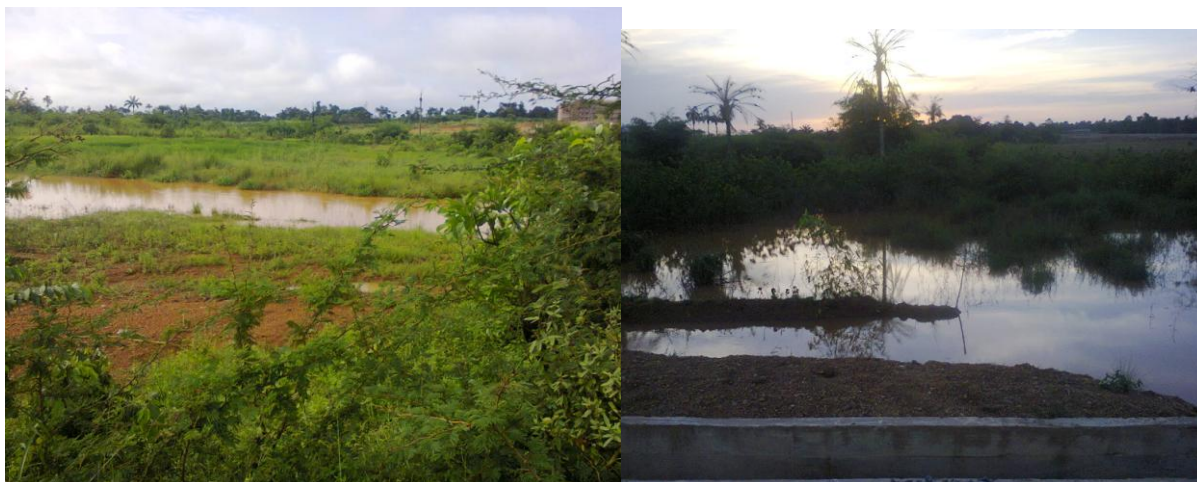
Plates 9 and 10. Dominant vegetation characterized by grasses and shrubs

Vegetation:The dominant vegetation is characterized by grasses and tree shrubs as shown in plates 9 and 10. The prominent vegetation are the herb layers (E-storey)and the D-storey (less than 2m). Within the immediate neighbourhood of the project site abound grasslands and vegetation with D- storey (10-15m) with sparsely populated palm trees (plates 11 and 12) most of which have been suffocated by the persistent storm water leading to loss of foliage and death. Within the lowland basins of the storm drain course are found subsistence rice farms irrigated by the storm flow. Stunted trees and pockets of derelict woodland exist where the lithology has undergone high degree of laterization. Elsewhere, typical characteristics of the tropical rain forest are displayed; multitude of evergreen trees, climbing plants, parasitic plants that live on the other plants, and creepers.

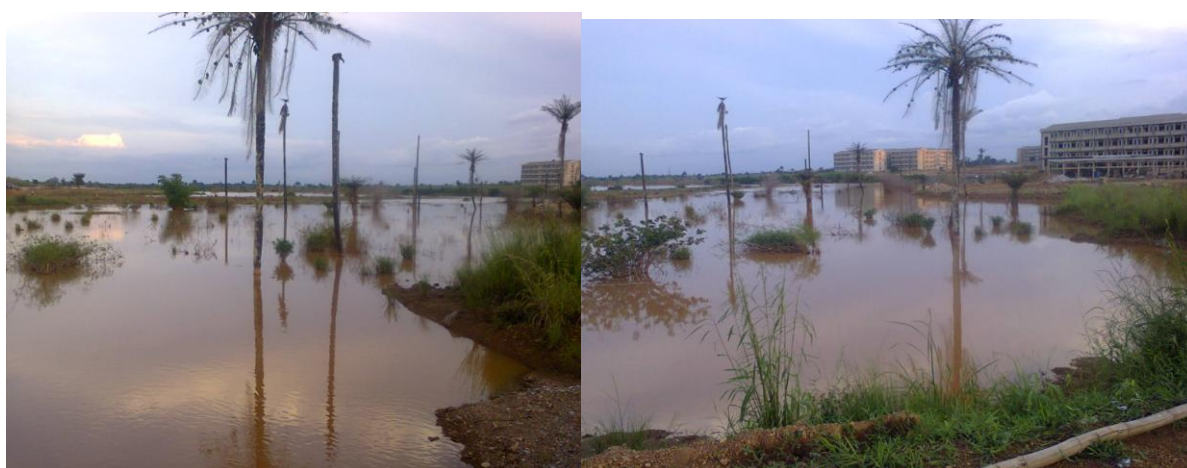
Plates 11 & 12. Suffocating palm trees with palm fronds bearing weaver birds' nests

The storm water overflows the reservoir into the neighbouring vegetations destroying farmlands, suffocating economic trees like the palm tree (see plates 11 and 12), threatening the population of weaver birds which is preponderant in the area, and which builds their nests on the palm fronds and devastates the entire ecosystem.

The government is apparently left with two choices; to let the storm lake remain or to fill up the basin and reclaim the site. The first option is desirable for land reclamation for further development. However it is a capital intensive venture requiring proper storm water reticulation with risk of occasional flooding posing a great danger to public health. The second option offers greater environmental stability. Apart from acting as a stabilization pond, along with the surrounding vegetation the lake will act as a carbon dioxide (CO₂) sink for the city estate as well as supply humid air. With the prospect of occupation of the Secretariat buildings, there will be increased commercial activity within and around the estate, presenting the challenge of the lake becoming a solid waste receptacle and a breeding ground for water-borne and air-borne diseases. With assured routine clean up action which guarantees environmental renewal, risk-benefit balancing no doubt confers greater desirability quotient on keeping and maintaining the lake.
