Preliminary Analysis Of Agricultural Irrigation Water Quality In Commune Of Cambamba I (Talatona)

Abstract:

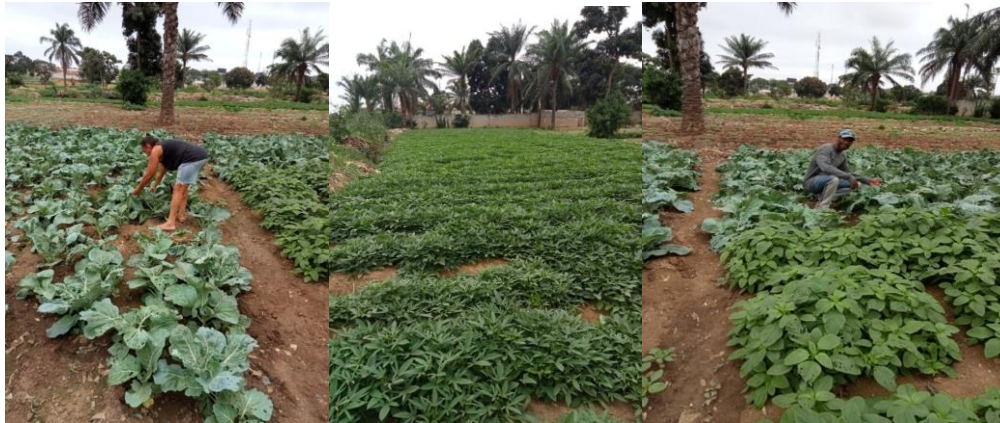
Figures 2, 3 and 4 – Agricultural study area with producer and consumer (source: by the authors)

Agricultural activity in the study area is moderate; the water is withdrawn through a system of motor pumps and hoses near the river. This agricultural activity is carried out exclusively by the aid of manual tools such as: machetes, hoes, shovels, among other means. The products obtained here are cabbage (*Brassica Carinata*), jimboa (*Amaranthus* spp), Kizaca (*Maniote Esculenta*), Use (*Hibiscus Sabdariffa*) and sweet potato (*Ipomoea Batatas* (L) Lam)⁵. These products are then distributed in markets adjacent to the neighbourhood.

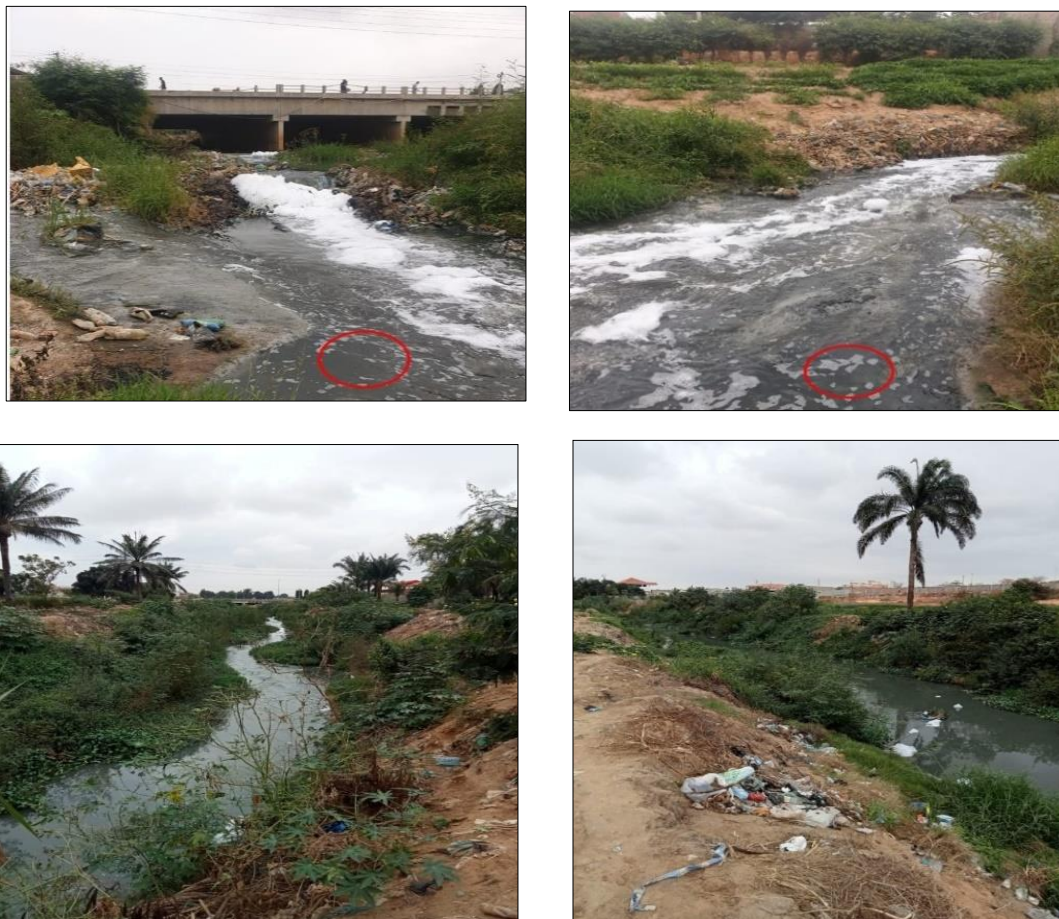
The followed action was collecting water samples from the river basin of the Cambamba river (fig. 5, 6, 7 and 8) in glass flasks, with the analyses carried out by the laboratories of the Química Verde Company and ISPTEC Institute. The methods used for analysis were: titration, of the Most Probable Number (multiple tube technique), thermometry, electrometry, nephelometry, Mohr, gravimetry and molecular absorption spectrometry.

Figures 5,6,7 and 8: Sample collection area on the Cambamba river (source: by the authors)
