Landslide Investigation of Ikwette, Obudu Local Government Area of Cross River State, Nigeria

Abstract: *This study investigates the causes of a slope failure at Ikwette, Obudu local Government Area of Cross River State, Nigeria in 2013. It also involves a slope stability analysis of the failed slope, which was OB1. To understand instability in the study area, a combination of field, geotechnical and statistical analysis were undertaken. Some obtained parameters were then applied in a slope/W Geostudio 2012 software program which uses the conventional limit equilibrium methods to simulate the dominant factors inducing instability. Results of the geotechnical investigations of the samples taken from Ikwette, showed an average maximum dry density value of 1.63kg/m³, which was a low to moderate value and average optimum moisture content value of 18%. Analysis from the particle size distribution, showed that the particle sizes were silty sand, with a Coefficient of uniformity (Cu) value of 1.8 and Coefficient of curvature (Cc) value of 0.968, indicating that the soil is uniformly or poorly graded. Triaxial compression test showed an angle of internal friction and cohesion values avera

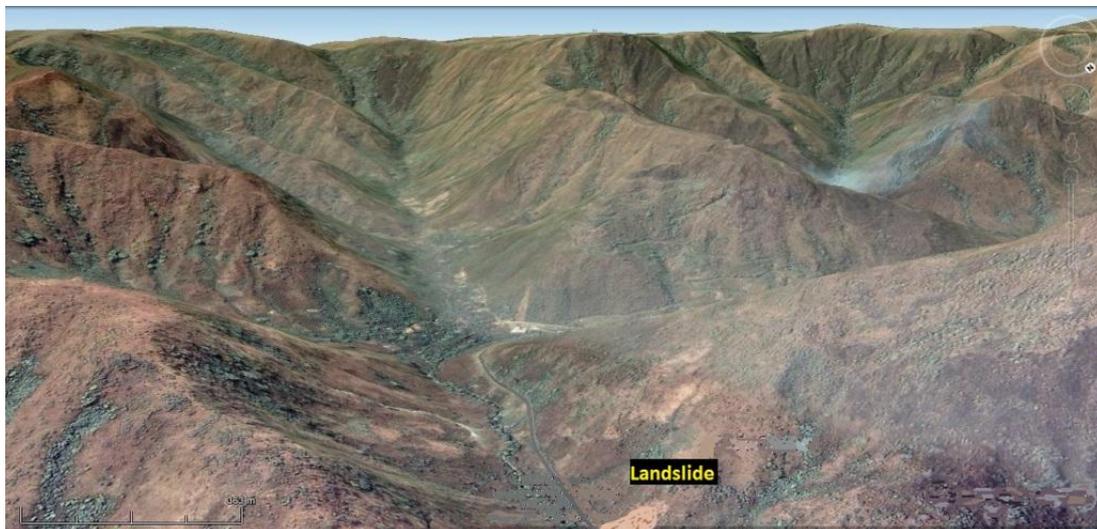
Fig. 6 Side view (from the right) of the google earth satellite image of the landslide.

Fig. 5 and 6 below shows Google Earth Satellite images of the landslide at OB1.

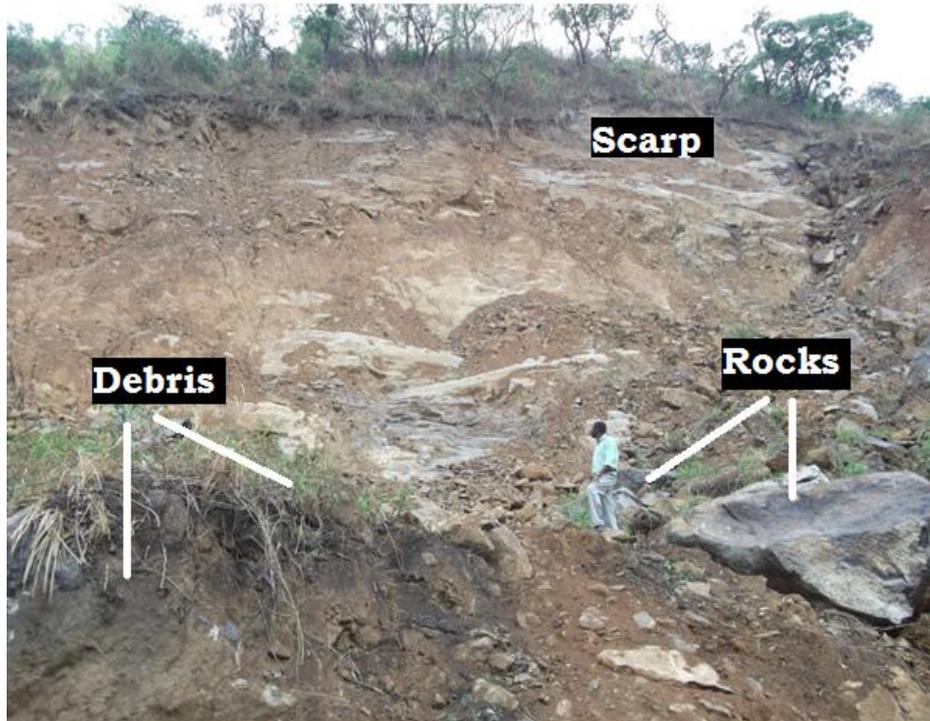
The rain-fall induced rock-fall debris avalanche at slope OB1 occurred at latitude $06^{\circ} 24' 16.5''$ N and longitude $09^{\circ} 24' 31.2''$ E. An estimated 50 tonnes of rock and debris was moved for up to 60metres from the scarp of the slide at 800 metres above sea level, to the toe below. The slide also had a run-out distance of 60 meters, with depth of sliding about 8 meters, while the width had a lateral extent of about 104 meters. The slip surface was rotational, having a slope angle of 60° , and according to Singh (2004), the critical angle of slope (angle of repose) value for unconsolidated sediments is 35° , and for jointed/ fracture crystalline rock ranges from 60° to 90° . Hence the slope angle of 60° indicates that the slope was at a critical value, and was already susceptible to sliding. Fig.7 and 8 below show the morphology and danger posed by the slope failure respectively.

Fig. 7 Picture of slope OB1 showing the scarp of the slide, as well as the rocks and debris moved.

The slopes should be improved on by methods like; drainage control, and slope flattening. The latter reduces the weight of the mass tending to slide, providing a support below the toe and this support also increases the resistance to sliding and hence increases the stability. Also, grouting and injection of cementing materials into weak zones also help in stability. This highlights the need for more rigorous analysis of the soil and subsequent adoption of appropriate prevention techniques.

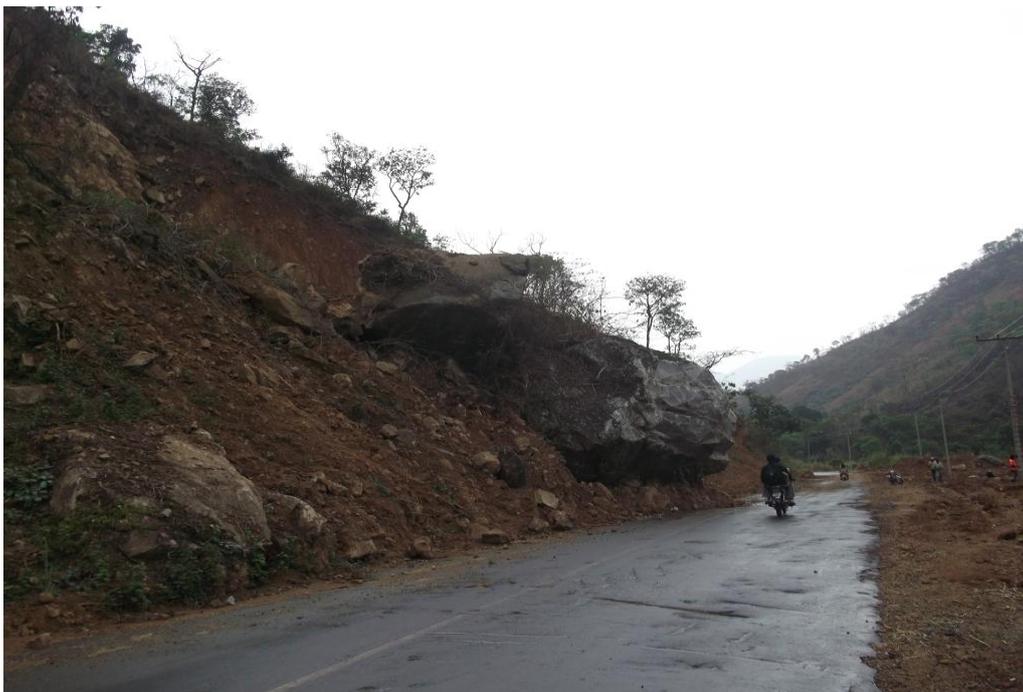
Fig. 8 Picture of slope OB1, showing the threat posed by this slope instability on road users.

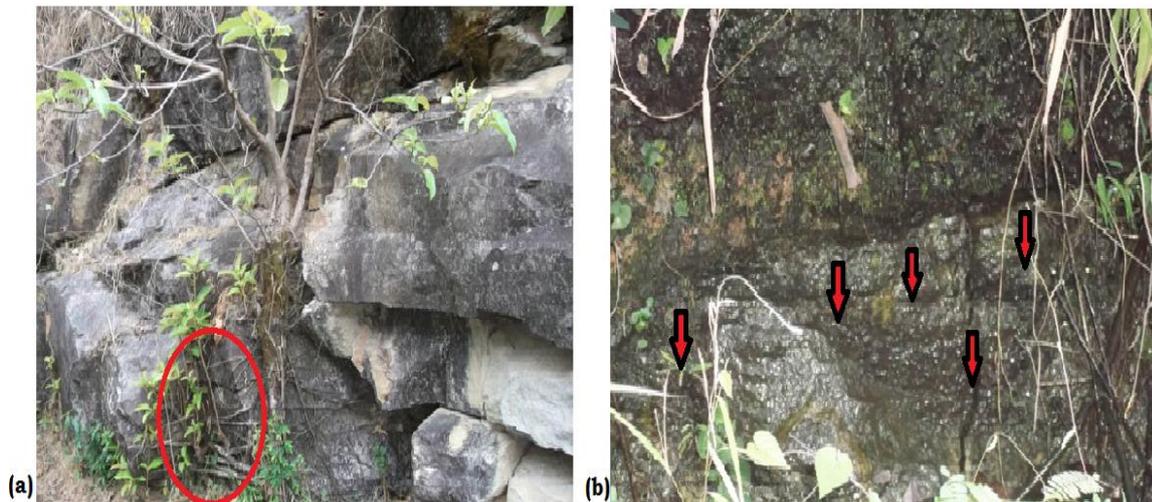
In some areas, these joints were further expanded, widened and lubricated by the activities of plant roots, and seepage of water through these joints, and this generally reduced the stability of the rock mass in such slopes. Fig. 10a and 10b shows these activities.

Fig. 10 Picture showing the activities of plant roots, and water on the joints.
