## Salvaging an Osseointegrated Implant after Abutment Screw Fracture- A Case Report

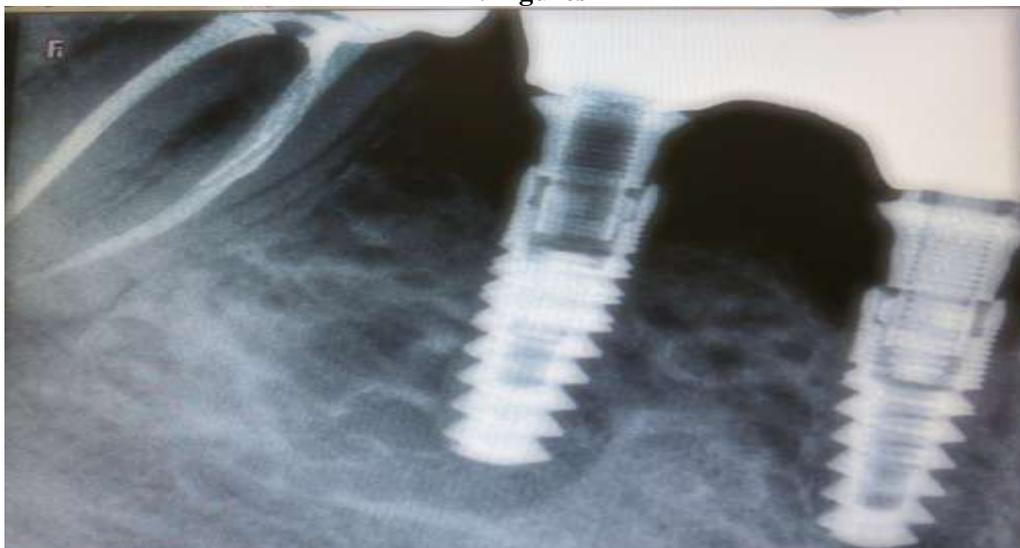
On intra-oral examination presence of implant supported prosthesis was seen in the 45 and 46 region with mobility of the prosthetic component which was suspected to be abutment screw loosening. The prosthesis of the implant in 45 and 46 were connected by a rigid connector. An intra oral radiograph was made to visualize the problem. Based on radiographic findings it was seen that the abutment was not seating properly on the implant abutment junction as compared to implant abutment with respect to 45. (Fig 1).

**Fig 1:** Pre-operative radiograph showing unseating of abutment with 45

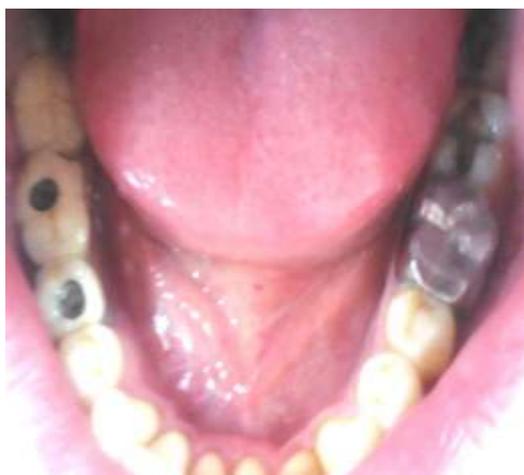
An access hole was made from the occlusal surface on 45 and 46 (Fig 2). An attempt was made to tighten the abutment screws. The abutment screw was tightened with respect to 45. Abutment screw on 46 was removed with the help of hex driver. On examination of the retrieved portion of the screw it was noted that the abutment screw was fractured and only a part of it was retrieved the remainder was present within the implant body. (Fig 3)

**Fig 2:** Access hole made on 45 and 46

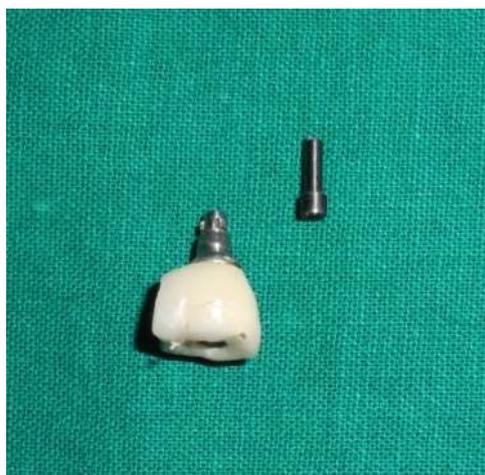
**Fig 3:** Abutment with fractured screw

Retrieval with screw retrieval kit and other methods was difficult in this case as the fragment was very small. Secondly fracturing the fragment with bur and removal was not used as this would have damaged the internal threads of the implant and making new prosthesis would have been difficult.

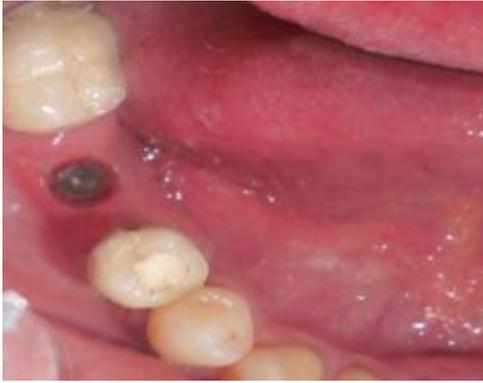
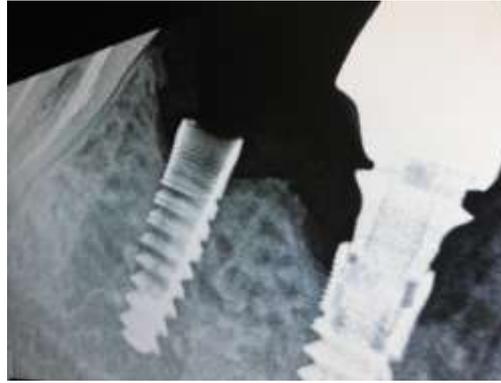
**Fig 4(a):** Post space preparation

**Fig 4(b):** Post space preparation –radiographic view

It was then decided to create a post space within the internal hex of the implant using a tungsten carbide bur (Endo-Z E0152, DENTSPLY) and air-rotor handpiece. The internal thread and undercuts in the preparation were removed. (Fig 4a and 4b)

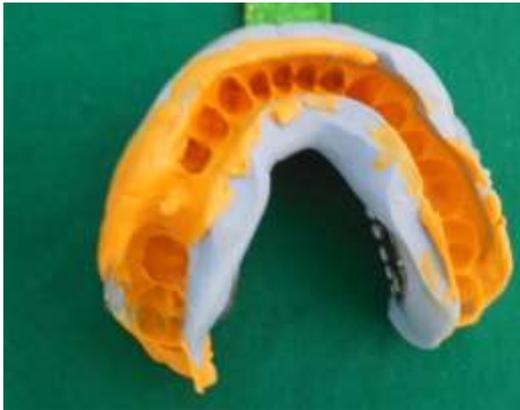
**Fig 5:** Post space preparation

Impressions of the post space were made using the indirect technique. Two stage putty relined technique (3M ESPE) was used for making impression of the post space (Fig 5). It was sent to the laboratory for cast post fabrication.

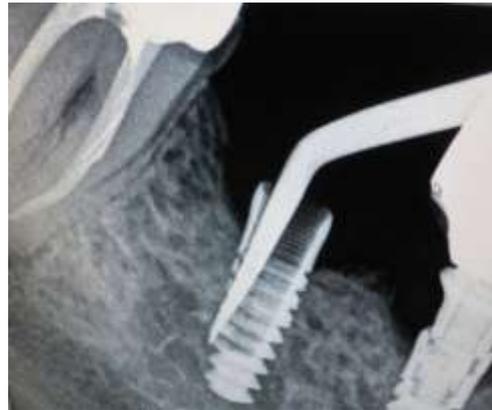
A day after the preparation the patient reported back with severe pain in the 46 region. Probing and radiographic examination revealed a perforation in the implant at the apical third. (Fig 6)

**Fig 6:** Perforation during preparation

The third treatment option was cost effective and time efficient. Internal wall of the implant is thin so perforation occurred during preparation and risk of perforation is always there. The definitive treatment in this case would have been implant removal but the patient was asymptomatic in subsequent follow up so the implant was not removed.

A routine endodontic sealer with epoxy resin (AH Plus, Dentsply) was used to close the perforation and rest of the post space was filled with Zinc oxide Eugenol cement. The patient was recalled the next day for evaluation. As the patient was asymptomatic, the cast post was evaluated for fitting in the mouth and cemented with zinc phosphate cement (Harvard Dental, Germany) and preparation on the core was done to receive the crown (Fig 7). An impression of the prepared core was made with putty light body used previously.

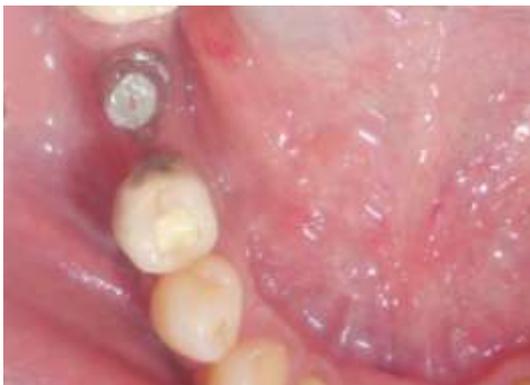
**Fig 7:** Post Cementation

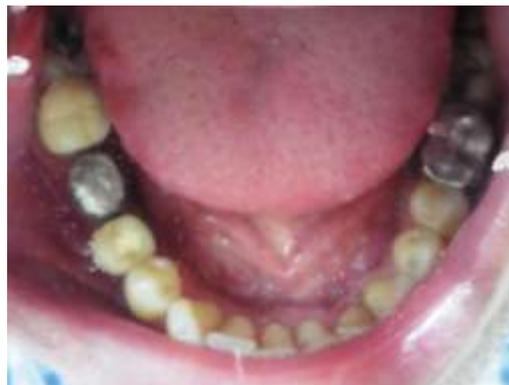
**Fig 8:** Coping Trial

After the coping trial was done (Fig 8) the coping was sent to the lab for final crown fabrication. The crown was luted to the post using zinc oxide eugenol temporary cement (DPI) (Fig 9a and 9b) and the patient was reviewed after 1 week (Fig 10) followed by a one month follow up. The patient has been asymptomatic and is efficiently using the 45, 46 region for mastication. Implant protective occlusion was given to the patient. Patient has been recalled after 3 weeks for evaluation.

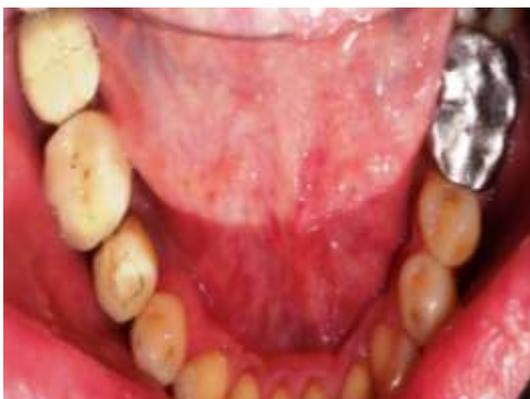
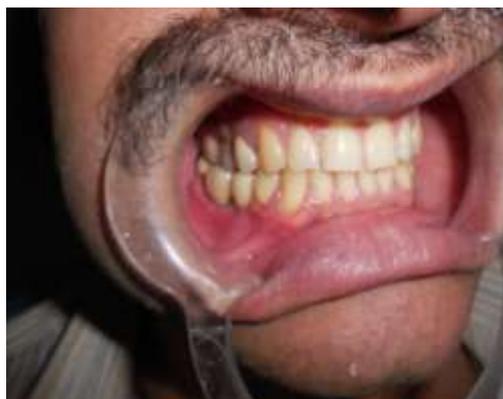
**Fig 9(a):** Final Prosthesis – Occlusal View

**Fig (b):** Final Prosthesis- In occlusion

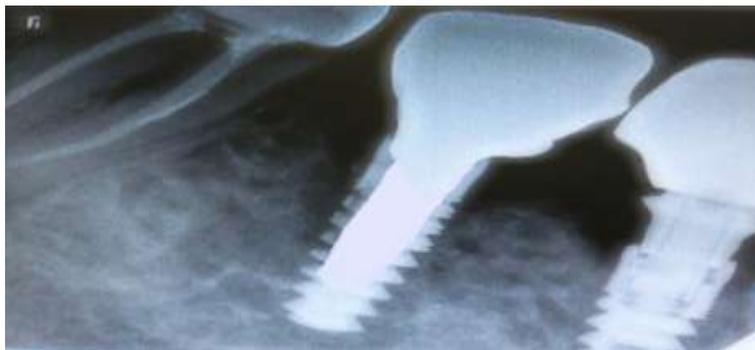
**Fig 10:** Recall Post Operative radiograph
