Vulnerability Assessment of Socio Economic Condition Due to River Bank Erosion: A Case Study on Khowai River, Tripura, India

Jatan Debnath¹, Nibedita Das (Pan)², Istak Ahmed³, Moujuri Bhowmik⁴
(Department Of Geography And Disaster Management, Tripura University, India)

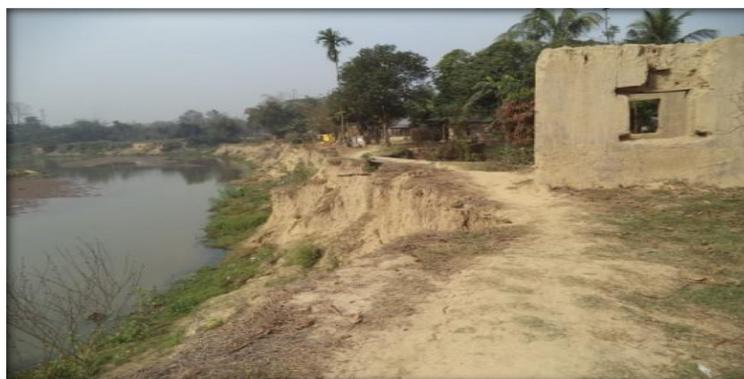
Fig 5: The vulnerable position of the houses along the Khowai River at Moharchhara

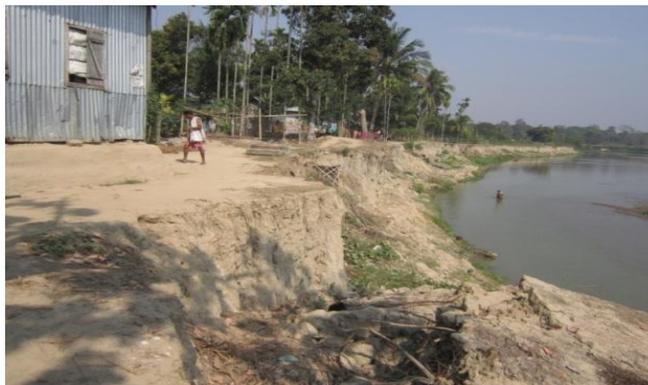
Fig 7: The vulnerable position of the houses along the Khowai River at Purba Kalyanpur.

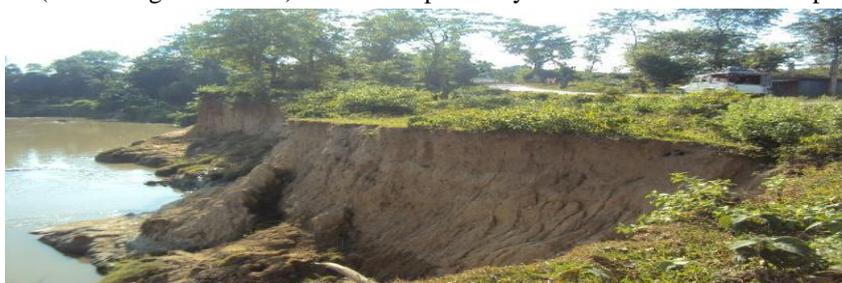
Fig 10: Teliamura-Khowai State Highway occupied by the River Khowai at Purba Kalyanpur.

due to this hazard (Fig. 9). The previous reports show many cracks on this road and some steps had been taken by the government. But the process of channel shifting is continuously going on. The channel shifting also influences another road from Teliamura to Khowai (Fig. 10). This road had to rebuild for three times but again the Khowai River is flowing only few meters away from the road. Maximum respondents have said that in this season the road may be captured by the river. Except these roads several metalled and unmetalled, katcha road have been damaged by the river.
