Investigation of Expected Seismic Performance on Existing Buildings: A Case Study

ABSTRACT: In India the Himalayan belt lies near the fault separating Indo-Australian and Eurasian plate. But it is natural that this area is seismically active and lies in earthquake zone IV. Beside this fact, most of buildings in Himachal Pradesh have poor structural and constructional quality. In this paper, an effort has been made for determining the study of different structural irregularities and construction defects of buildings situated in Solan and Shimla district of Himachal Pradesh, India. Various factors which were considered in the survey are cantilever slab loaded above, offsets, soft storey, unequal heights of the column, long column short column, overhanging beams, open ground storey etc. other factors those were considered like segregation, exposed bars, verticality of columns, poor bricks quality were also included in the study that cause damages in the structure during earthquake. At last some remedies had been suggested for the mentioned defects and irregularities of the structures.

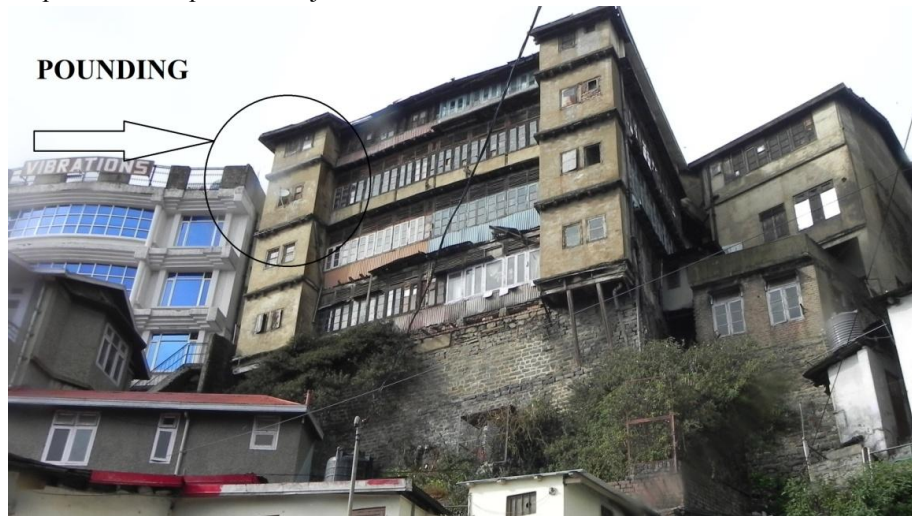
The term pounding has been one of the serious causes for severe building damages in earthquake. The non-structural damage involves movement across separation and pounding between two adjacent structures as shown in fig.1. The pounding has been occurred between two adjacent building during an earthquake is due to difference in dynamic characteristics between the buildings. For providing the minimum separation distance between the two buildings is according to either by international building code or by seismic design code. Lopez Garcia gives a formula for the separation of building or providing spacing by below formula

Fig 1: Pounding defect

- Pounding- As per IS 1893: 2002 two adjacent units or two adjacent buildings with separation joint in between them shall be separated by a equal distance to the amount R times the sum of calculated story displacement to avoid the collapse of the structure when two units of the buildings will be deflected towards each other. [12]

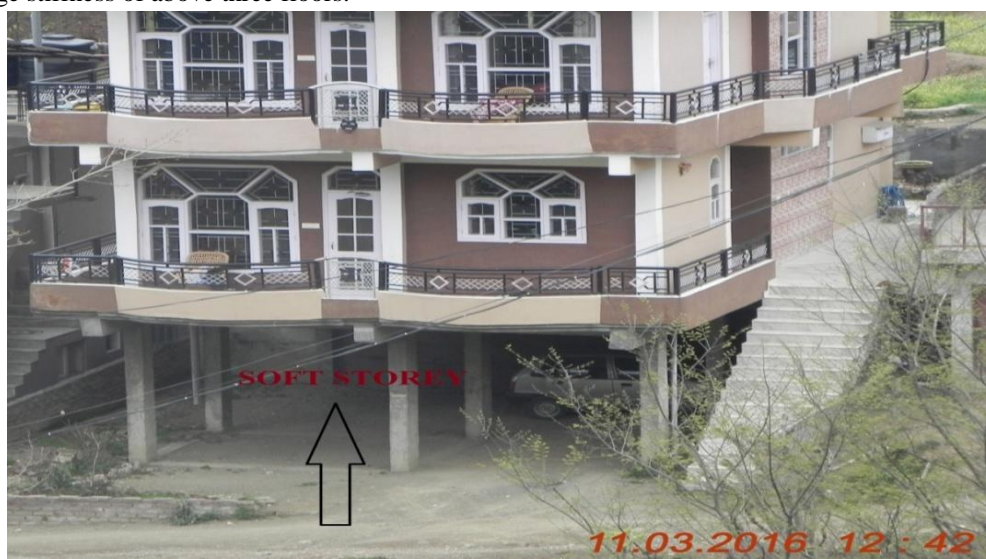
A soft story building is also called as a multi-story building which have one or more floors that includes windows, wide doors, unobstructed commercial space and openings where a shear wall be required to provide stability in earthquake engineering design. ^[12] fig. 2 shows that a soft story has level less than 70% or 80% from the average stiffness of above three floors.

Fig 2: Soft Storey Building

- Soft storey- As per IS 1893: 2002 provision has given for soft storey is that the lateral stiffness is less than 70% from the above storey and also less than 80% from the average lateral stiffness of the above stories. The columns of the soft storey are to be designed 2.5 times the storey shear and its moment should be calculated under seismic loads. [12]

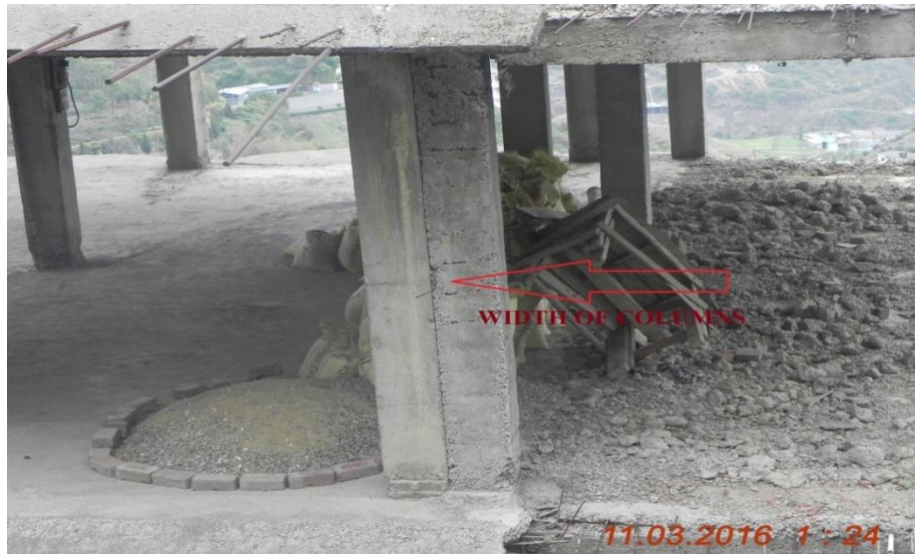
For providing a column in the construction some procedure or design requirement as per given in code has been followed. The structural defects in columns are shown in fig. 3. The minimum dimension of column shall not be less than (a) 15 times the largest beam bar diameter of the longitudinal reinforcement in the beam passing through or anchoring into the column joint, and (b) 300 mm. The basic thumb rule those had to be followed is:

Fig 3: Structural defects due to improper width of columns

- Column failure- As per IS 13920 :1993 provision special arrangements has been made to increase the adequate toughness and ductility which results in making the column capable of undergoing dissipating seismic energy and extensive inelastic deformation in a stable manner. [11]

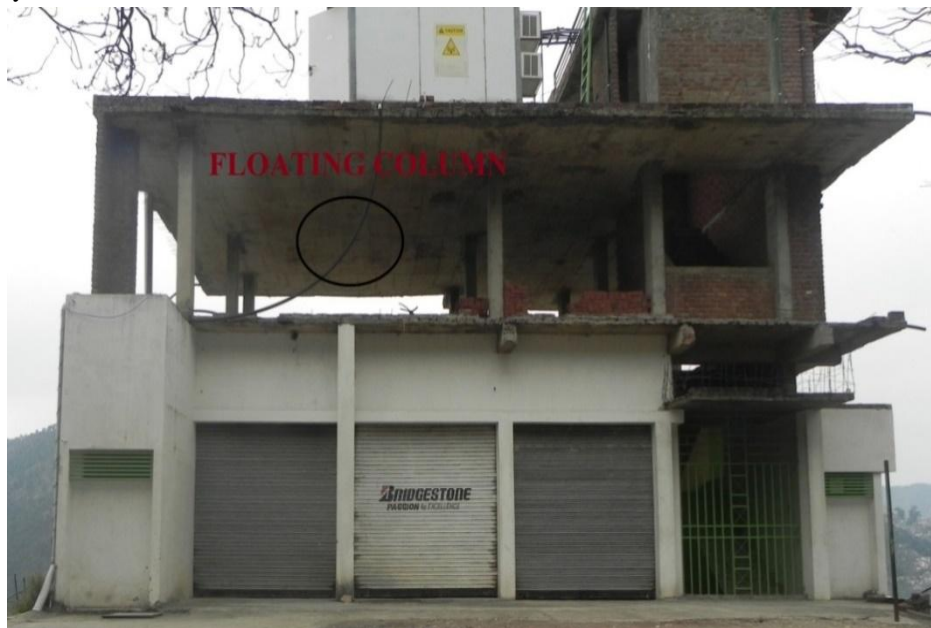
Floating column is considered as that column which is hanging on the structure and transferring its load to the ground level or the column is provided on the ground level but on the first floor no column is there and above that weight is there which result into collapse of the structure. It rest on abeam which is a horizontal member. Fig. 4 shows that the main drawbacks of this column are that it totally divert its load to below level where no column is provided that result into collapse of the structure. The column is hanging in the middle of the story which leads to the failure of the building due to shear and overturning. Floating columns has not been covered in any IS code.

Fig 4: floating columns

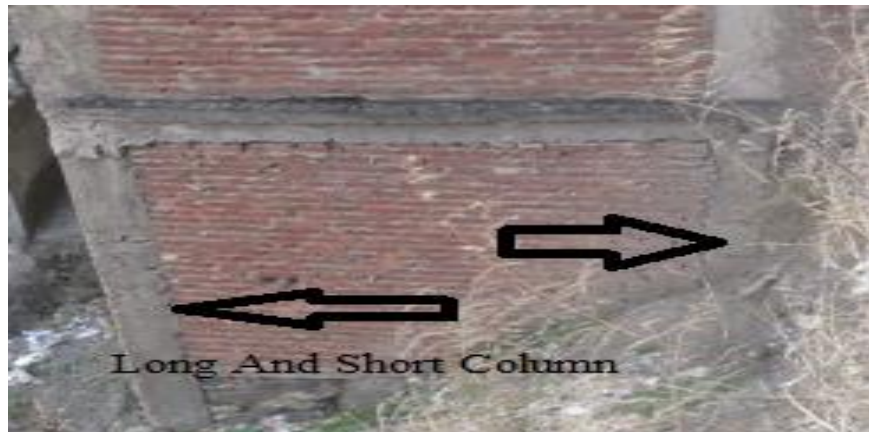
When the effective length of the column is less than 12 it is called short column and when the effective length of column is less than 45 it is long column. Figure 5 shows that the columns have unequal height along the slope that will cause structural effects like damage and twisting in shorter columns. These types of construction are generally occurred in slope ground that causes structural damage in the buildings during earthquake.

Fig 5: Long and short column defect

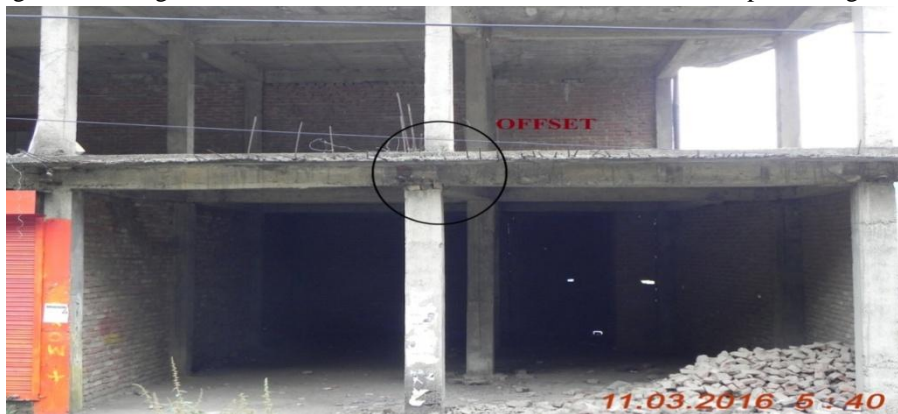
Offset is basically defined as the alignment defects in the column of the structure. The structure shown in the figure 6 is located in Solan district and is under construction. The building has three storeys and is constructed with brick infill panels. Figure shows that the column that is under construction has shown offset in them. The result of misalignment during construction between the two columns results in collapse during an earthquake.

Fig 6: Offset in layout of columns

- Workmanship: At the time of constructional phase of building it is necessary to execute work according to specifications as well as proper designing. Work should be executed under the presence of engineer. The foundation of the structure should be earthquake resistant.

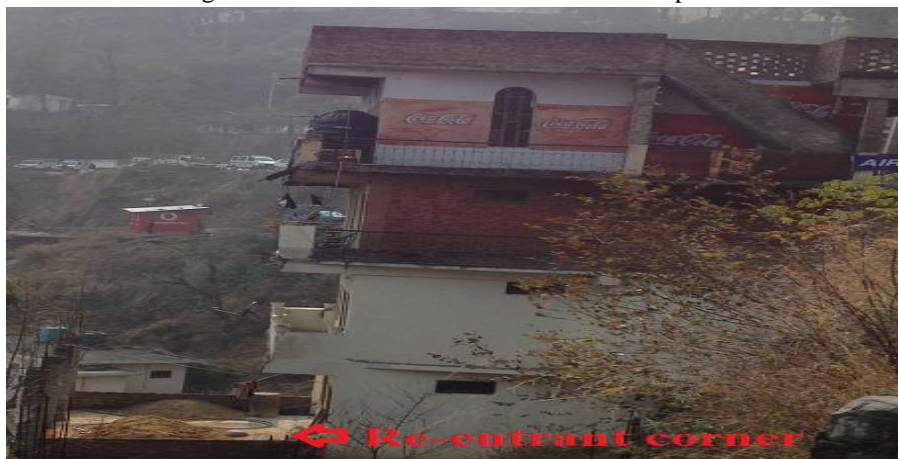
According to IS 1893 (PART 1) 2002, building with setbacks causes two types of problem that is immediate jump in earthquake forces at the phase of irregularity and torsion. Fig. 7 shows that only the half portion of the base of the building has been utilized which results in the collapse of structure.

Fig7: Re-entrant corner

- Re-entrant corners – As per IS 1893:2002 both of the projection of the structure for re-entrant corner are greater than 15 percent of dimensions in the given direction.[12]

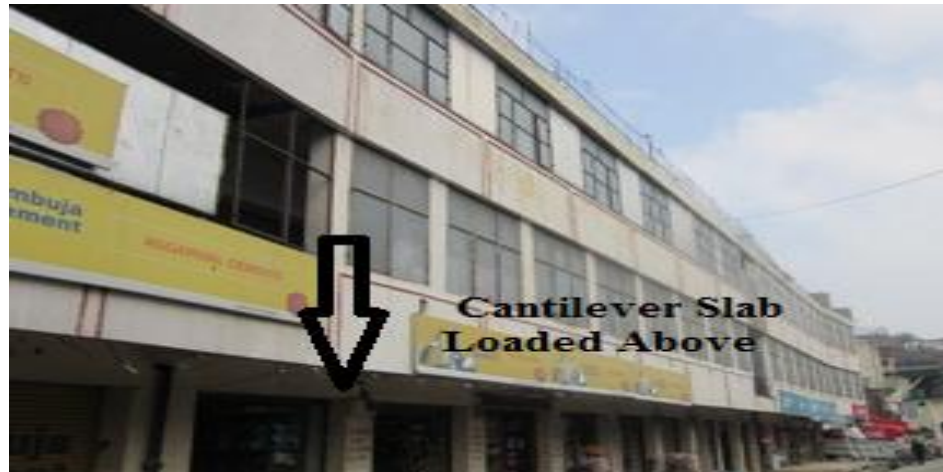
This is the portion in the building that has been used as a free space like balconies with low load capacity. Fig. 8 show the commercial building located in market of Solan district. The extra weight that has been loaded above will result in collapse during an earthquake. In order to rectify this column has been provided below the slab, so that the above load will be distributed on it.

Fig 8: Structural defect due to cantilever slab loaded above
