Efficiency of Ultrasonic pulse velocity test in life of concrete structure

Abstract: *Concrete is a basic material used for almost all the engineering projects. Concrete is a composite material, amalgamation of water, cement and aggregates. The concrete comprises of many influential building variables, such as the water/cement ratio, aggregate type and size, humidity and type of cement used in the process. Improper mixing, errors in preparation, excess of admixtures, inadequate workability, honeycombing are some of the major drawbacks of concrete while constructing a concrete structure. All these factors directly affect the quality of concrete and the compressive strength of the concrete. We find it always necessary to detect such trouble causing elements in the structure and to rectify them for long life of concrete structure. UPV test is one of the major tests practiced in order to assess the condition of a structure. This study thoroughly deals with the concept, methodologies, functioning, result of UPV test in understanding the condition of a structure. A random structure is taken and analysed with the Non-destructive testing (UPV), after the repair works carried out as per th

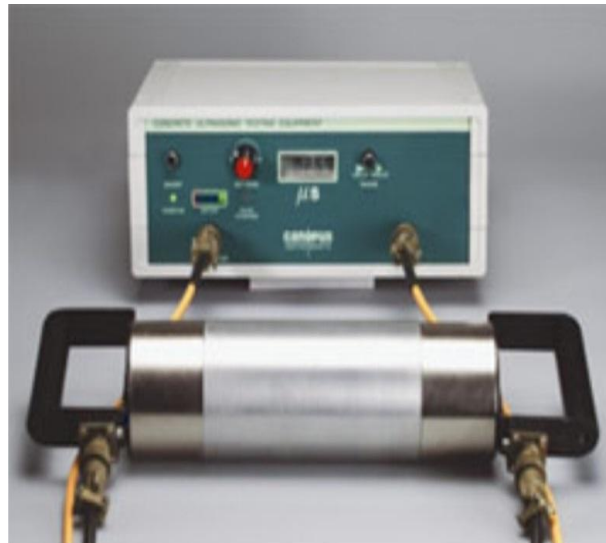
method is based on high frequency sound wave propagation which passes through the material. The speed of the wave varies in function of the density of material, allowing the estimation of the porosity and the detection of discontinuities.

The basic idea is to project the sound inside a material and measure the time necessary for the wave to propagate through it. Once the distance is known, it is possible to determine the average pulse velocity, which will depend on several factors such as the nature of the material and the presence of water in the pores, among others. The method is normally based on the use of portable equipment, composed by the source/detector unit and the surface transducers, which works in the frequency range of 25 to 60 kHz. The ultrasonic pulses depend on the density and elastic properties of the material.

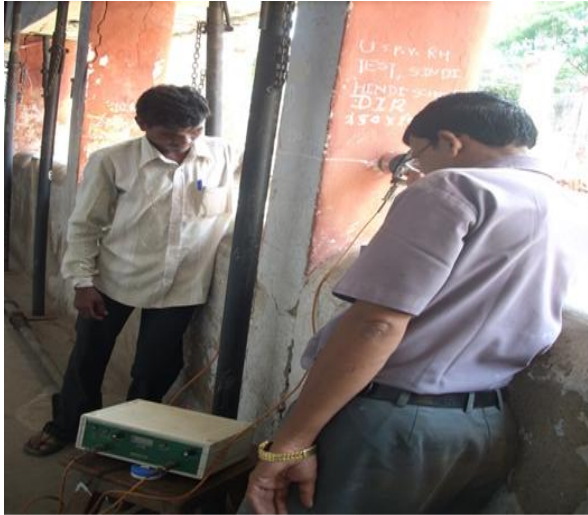
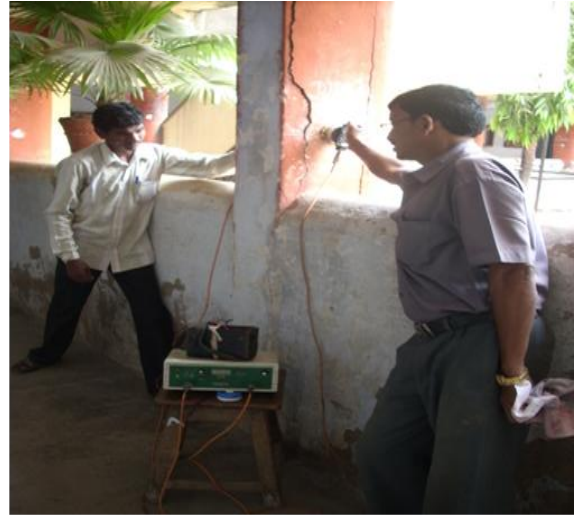
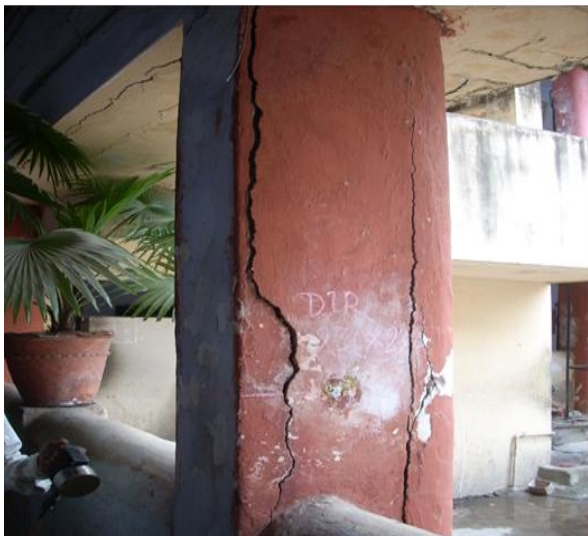
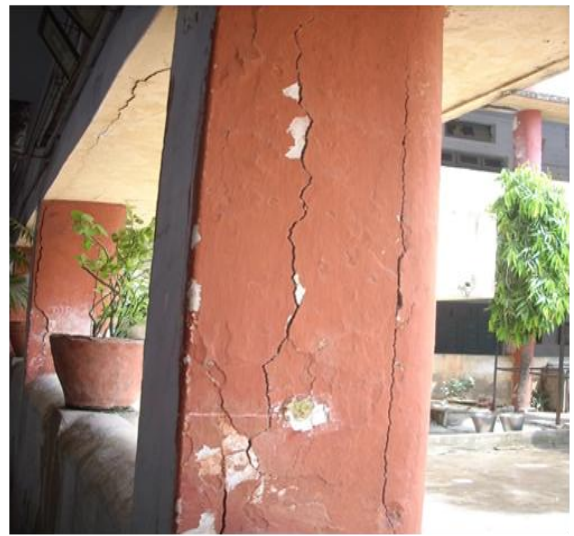
Deficiencies like voids, air gaps, corroded reinforcements, less uniformity, hollow spaces and structural cracks or other changes in concrete which are the results of frost, fire, chemical vicinity, environmental dysfunction or other imperfections, can be considered for retrofitting of the structure. The result indicates clear flaws in the concrete of the vertical structural member of the structure. With these results, the structural engineer suggested that the structure should be retrofitted in order to avoid collapse and to increase the life of the structure and to rectify the flaws that are developed over the years in the concrete.

1. As per the UPV report all the structural members need grouting at every junction point of the structural member. Grouting should be carried out as per the specifications.
2. Grouting for cracks less than 10 mm wide: All the cracks less than 10 mm wide should be grout with non-shrink free flow low viscosity solvent free epoxy grout.
3. All the vertical structural members should be jacketed and retrofitted. As per the UPV report, huge amount of honeycombing and major structural cracks and voids are detected. Columns need to be jacketed as per the specifications of jacketing for existing columns.

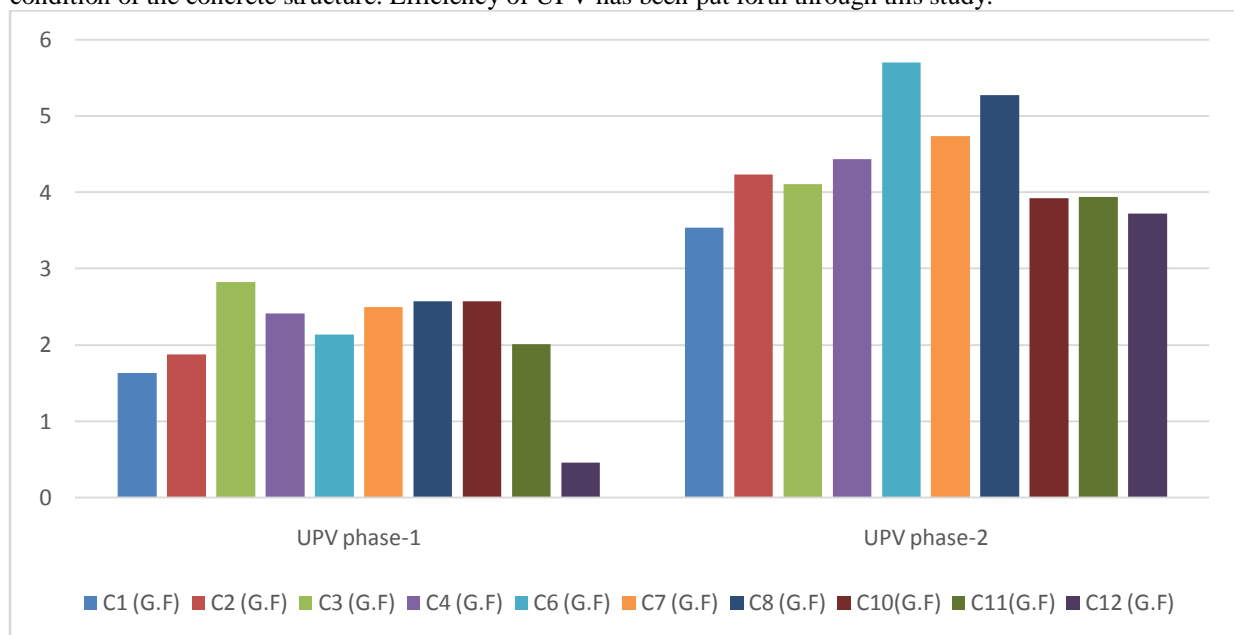
The graphical representation of the velocities of UPV test on each of the 12 columns of the ground floor pre and post retrofitting are shown. The graphical representation made it quite convincing that the use of UPV has proved to be a valuable as non-destructive equipment in order to detect flaws and assess the life and condition of the concrete structure. Efficiency of UPV has been put forth through this study.

Graphical representation of the UPV results of ground floor vertical structural members.

UPV Phase – 1 – Pre - retrofitting
UPV Phase – 2 – Post- retrofitting

The test results ends with a convincing graphical representation of two of the velocities of each floor before and after retrofitting and grouting repair work. UPV results for velocities of after repair works are relatively indicating a well nourished or good quality of concrete as compared to velocities of the test conducted before the repair works. The difference between the velocities in the graphs is stating that the UPV test is liable in detecting the flaws like structural cracks, voids, honeycombing and many more structural deficiencies in concrete structures. Complications and problems in the concrete structures can be detected and can be studied on for the repair works. The test results comprises the efficiency of UPV test throughout the technical paper. UPV test can be considered the best in obtaining the accurate condition of the concrete in concrete structures. The experiment carried out just portrayed the significance UPV test brought to the life of the structure. Before the application of an kind of repair work, it was thoroughly analysed and the structural calamities were brought in front with the help of the UPV test and on the base of those results the structure is retrofitted and repaired by Grouting in structural cracks and jacketing the vertical structural members. This paper technically proves the efficiency of UPV test in the life of any concrete structure.
