Aesthetic replacement of a vertically fractured anterior tooth using the natural tooth as a pontic : a Case Report

Dr Ankita Gupta¹, Dr Sunita Garg²

^{1,2}(Department of Conservative Dentistry & Endodontics, Government Dental College & Hospital, Ahmedabad, Gujarat University, India)

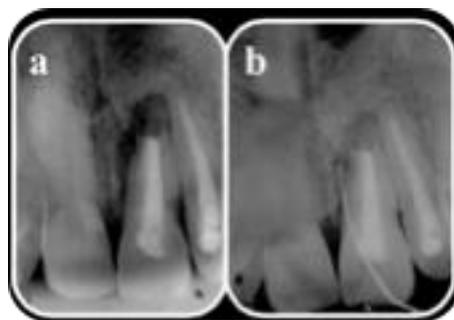
For radiographic evaluation, two intra oral peri-apical radiographs (IOPA) were taken (Fig. 1). The IOPA radiograph revealed a satisfactory obturation in 21 and 22 with an incomplete root resection on 21. However, a large J shaped periradicular radiolucency along with a double image of the obturation was noted with respect to 21 (Fig.1a). Gutta percha point tracing of the pocket in 21 showed the pocket to originate on the mesial aspect of the root (Fig. 1b). Left lateral incisor was root canal treated with normal periapical region. These findings were suggestive of a vertical root fracture in relation to 21 but the fracture per se could not be traced and thereby, a sectional cone beam computed tomography (CBCT) scan was advised.

Figure 1 : Preoperative IOPA radiographs showing; a) J shaped radiolucency in 21; b) gutta percha tracing of pocket in 21

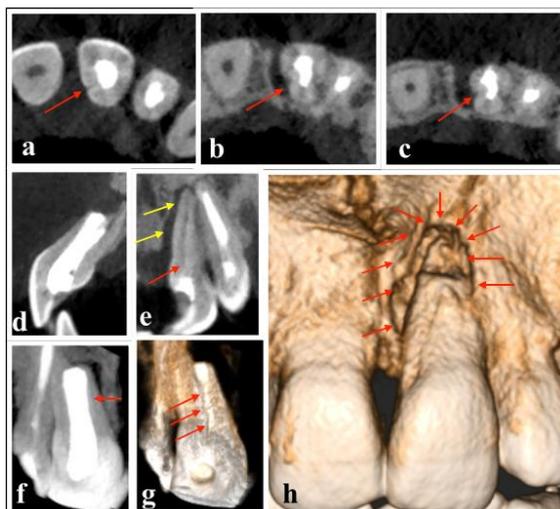
On CBCT evaluation (CareStream CS9300, SNAAP Imaging Centre, Ahmedabad, India), the suspected vertical fracture could not be visualised but associated factors like a break in the continuity of enamel at the cemento-enamel junction (CEJ) level, a depression on the root dentin at the cervical, middle and apical one thirds of the root and a lateral radiolucency on the mesiopalatal aspect on 21 could be confirmed. Another finding was the absent labial cortical plate in relation to 21 and 22 (Fig. 2).

Figure 2 : CBCT scan - (a) Axial slice at CEJ level with fracture line on mesio-palatal aspect (red arrow); (b) Axial slice at mid-root level showing fracture line (red arrow); (c) Axial slice at apical third root level showing fracture line (red arrow); (d) Saggital slice showing incomplete root resection from previous apicoectomy; (e) Coronal slice showing VRF (red arrow) and periradicular radiolucency (yellow arrows); (f) 3D reconstruction with MPR view showing VRF (red arrow); (g) palatal view of 3D reconstruction showing VRF (red arrow); (h) labial view of 3D reconstruction showing periradicular radiolucency in 21 (red arrows)

The tentative diagnosis provided was a vertical root fracture in relation 21 which would be further confirmed on surgical exposure.

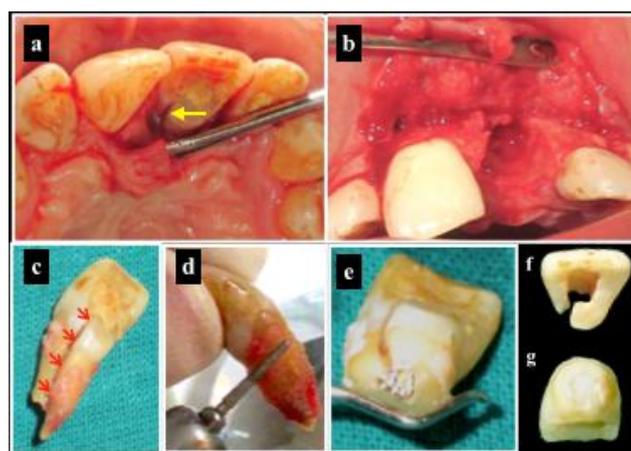
Palatal and labial full thickness muco-periosteal flaps were reflected using intrasulcular incisions with vertical releasing incisions extending beyond the mucogingival line. The papillae were dissected and reflected. Removal of granulation tissue revealed a VRF on the mesio-palatal aspect of 21 (Fig. 3). The fracture line propagated from the CEJ to the apex of the tooth. Removal of granulation tissue on the labial aspect revealed the absence of labial cortical plate upto the apical third of the roots of 21. This absence of the labial cortical plate along with a VRF convinced us to extract the tooth and treat the patient with an implant placement, but the extensive bone loss (poor implant recipient site) was the main limitation for the desired treatment plan. Hence, we planned a regenerative procedure with guided bone regeneration to preserve the ridge width for future implant placement, post extraction. Owing to the high aesthetic and phonetic demands of the patient's job, immediate bonding of the natural tooth pontic as a provisional restoration was performed which provided aesthetics and protected the extraction socket.

Figure 3: (a) Palatal flap reflection revealing VRF on mesio-palatal aspect of 21; (b) Extraction socket; (c) Extracted tooth showing VRF (red arrows); (d) Separation of the crown from the root; (e) Separated crown showing the communication of fracture line with the obtruded pulp space; (f) Cleaning of the crown portion; (g) Restoration of the crown with composite and shaping it to a ridge-lap pontic design.

For the preparation of the natural pontic, the crown was separated from the root by using a diamond bur . The apical opening of the pulp canal was cleaned by complete removal of gutta percha and restorative material. The access cavity and the apical opening in the crown were sealed with composite resin. The restored crown was shaped into a modified ridge-lap pontic to facilitate cleaning and to give an emergence profile to the natural tooth pontic (Fig. 3)

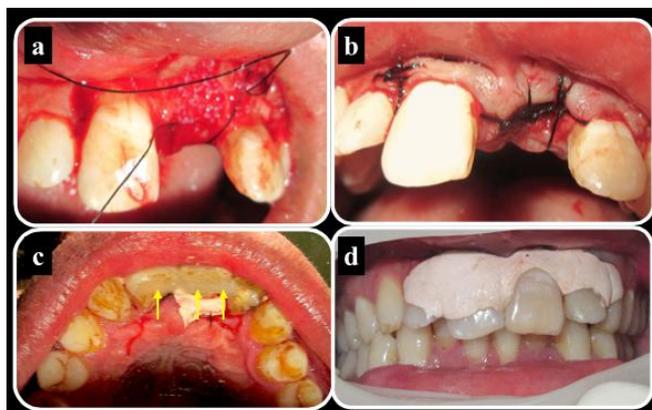
Figure 4 : (a) Bone graft in place in the extraction socket; (b) Sutures in place over the membrane; (c) Composite splinting of the natural tooth pontic over the coe-pack(palatal view); (d) Immediate post-op (buccal view)

Extraction was performed atraumatically to preserve adjacent bone and the socket was carefully curetted to remove granulation tissue. The extracted tooth was stored in saline. The blood-filled socket was grafted with a bone graft (PerioGlass®, Novabone) and carefully covered with aresorbable collagen membrane (Perioguide™). The flap was repositioned coronally using periosteal releasing incisions to achieve primary closure over the membrane and sutured with 4-0 Ethicon sutures (Johnson & Johnson, Himachal Pradesh, India).

Following satisfactory try-in and occlusal adjustments, the abutment teeth and the pontic were cleaned and dried. A horizontal groove was prepared on the pontic on the mid-palatal aspect with a round bur. Abutment teeth and the pontic were etched with 37% phosphoric acid for 30seconds, washed and dried, and bonding agent applied and light cured. A thin layer of flowable composite resin was placed across the abutment teeth and into

the horizontal groove on the pontic. A pre-cut round 0.001” braided stainless steel wire was roughly contoured to the palatal aspect of the maxillary incisors and thoroughly wetted using the unfilled resin. It was embedded into the horizontal groove in the pontic onto the uncured composite and cured. A further layer of flowable composite was placed over the wire, ensuring that all of it was covered by composite, and light cured. Excess composite resin was removed and occlusal interferences were again checked in protrusion and lateral excursions. Finishing and polishing procedures were carried out using composite finishing discs and stones. The surgical site and the pontic were covered with coe-pack (GC america, IL, USA) (Fig. 4). Oral hygiene instructions with chlorhexidine mouthrinse were given to the patient. The patient was put on an antibiotic regime of Amoxicillin 500mg and Ibuprofen 400mg, tid for five days each. First recall appointment was made 5 days later.

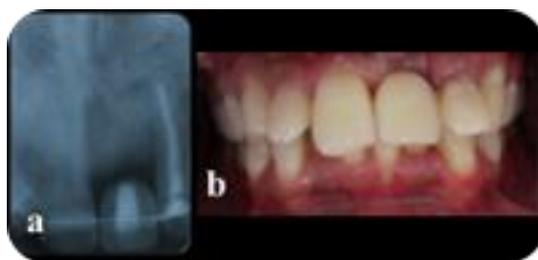
On recall, coe-pack and sutures were removed and the irrigated with saline. Surgical site was healthy with primary closure. The patient was psychologically satisfied and highly motivated by the aesthetic result as well as improved ease of biting with no discomfort. Two months recall showed adequate bone fill (Fig. 5a), gingival healing with acceptable aesthetics of the natural tooth pontic (Fig. 5b).

Figure 5 : 2 months post op (a) IOPA; (b) Photograph
