Prosthodontic Management of Malpositioned Implants in Anterior Maxillary Region: A Case Series

Abstract : Three cases of prosthodontic management of malpositioned implants have been reported. Case I presented with a severe faciopalatal and a deep apicocoronal position of the implant. Definitive restoration was planned using a UCLA type plastic abutment to fabricate a framework over which a cementable coping was made. Case II presented with severe faciopalatal angulation of the implant. The definitive prosthesis was fabricated using a custom cast abutment. Direct Ceramic build up was done over the abutment and it was attached to the fixture with the abutment screw. Case III also reported with severe labial angulation of both the implants and definitive restoration was done with the help of UCLA type plastic abutment to design a customized framework for the definitive prosthesis. Soft tissue management for all the three cases was done with the use of gingival porcelain on the cervical portion of the metal-ceramic restoration. The use of customized and UCLA abutments presents an easy and cost effective way of functional and esthetic rehabilitation of malpositioned implants.

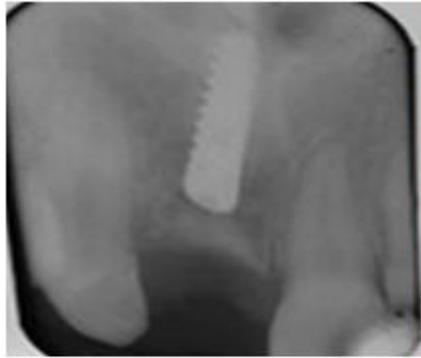
During treatment planning for definitive restoration, faciopalatal angulation, apicocoronal depth and position of the endosseous implant were evaluated clinically and radiographically. The clinical examination and IOPAR revealed a severe faciopalatal angulation and submerged implant position in apicocoronal direction (Figure 1, Figure 2, Figure 3).

Fig 1 : Radiographic evaluation

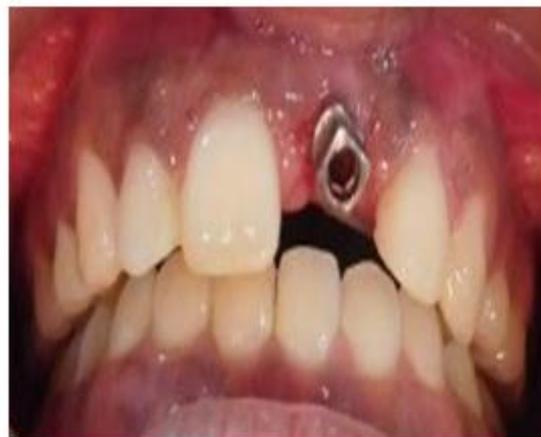
Fig 3 : Severe faciopalatal angulation

Case I presented with unfavourable faciopalatal angulation of the implant. The definitive prosthesis was fabricated using a custom cast abutment. Direct Ceramic build up was done over the abutment and it was attached to the fixture with the abutment screw. Soft tissue around malpositioned implants also poses a challenge to the clinician especially when the patient presents with a high smile line, when the screw access hole is above the gingival zenith of adjacent teeth or when the apicocoronal positioning of implant is submerged. In this case the screw access hole was labial and above the gingival zenith of adjacent teeth. This was managed with the use of gingival porcelain on the cervical portion of the metal-ceramic restoration, which is the easiest method of managing these problems^{2,7,8,10}.

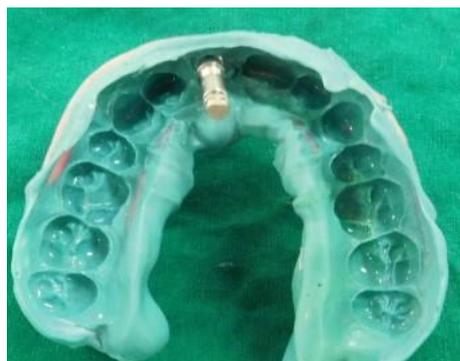
Fig 4 : Open tray implant-level impression

The patient was not willing for surgical procedures and opted for prosthodontic management by fabricating customized implant abutment. An open tray implant-level impression was made using an impression coping (Hi-tech) (Figure 4) and a polyether impression material (Impregum; 3M ESPE) and silicone resin (Ufi Gel P, VOCO) was applied all around the analog to mimic gingival tissue. The implant analog (Hi-Tech) was placed in the impression and type III dental stone (Kalstone; Kalabhai) was then poured, and models were made. A hexed UCLA burn out pattern sleeve (Hi-tech) was fitted to the implant analog.

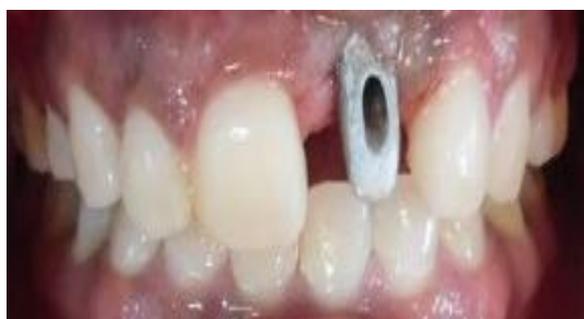
Fig 5 : Customized abutment trial

The obtained customized abutment was tried on the fixture in the patient's mouth and checked for fit, angulation, and clearance (Figure 5).

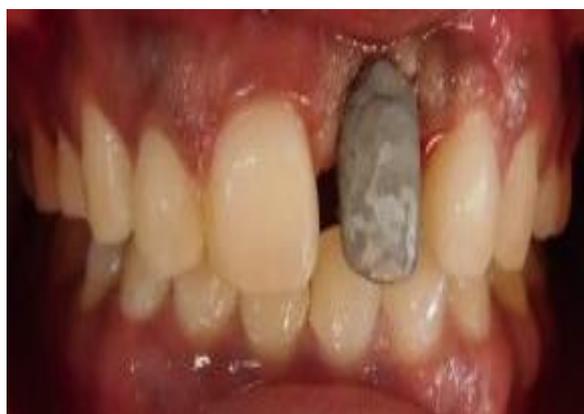
Fig 6 : Coping trial

The screw access channel was then blocked. Wax up was done over the framework directly using the inlay casting wax (Renfert; Germany) and casting was done to obtain the coping. The coping was tried (Figure 6) and shade selection (Vita toothguide 3D Master; USA) was done, and ceramic build-up was completed. This was followed by a bisque trial of the coping for the definitive restoration to evaluate and confirm the peri-implant soft tissue contour. The anterior guidance for the restoration was decided by the incisal guidance of the adjacent natural anterior teeth. The anterior guidance of restoration was kept as shallow as possible with no interferences in protrusive and lateral excursions with a clearance of 2 mm from the mandibular anterior teeth in centric occlusion.

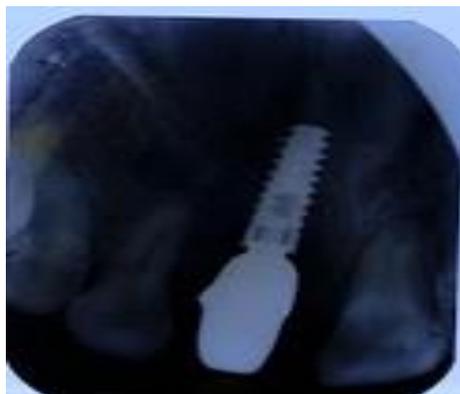
Fig 7 : Radiographic verification

The tooth and gingival-colored veneering porcelain (LAVA; 3M ESPE) were added to the coping and it was glazed. The definitive restoration was then evaluated intraorally, and a periapical radiograph was made to verify the fit of the abutment and the restoration (Figure 7). The abutment screw was torqued to 30 N-cm with a

torque wrench (Hi-Tech), and the abutment screw-access channel was blocked using gauze and interim restorative material (Cavit 3M ESPE; USA).

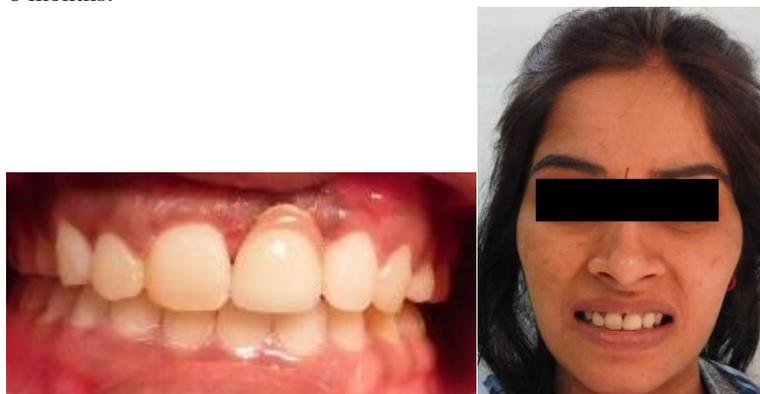
Fig 8 : Intraoral and extraoral view post cementation

The definitive restoration was then luted using Non eugenol temporary resin cement (Premier implant cement; USA) (Figure 8). The prosthesis was evaluated by regular followup at routine time interval of 1 month,3 months and 6 months.

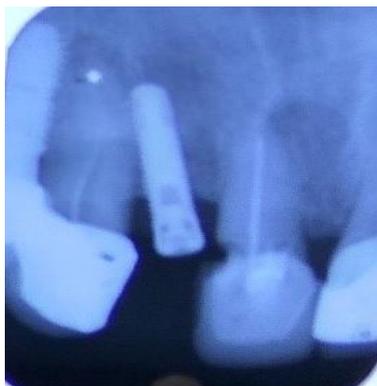
During treatment planning for definitive restoration, faciopalatal angulation, apicocoronal depth and position of the endosseous implant were evaluated clinically and radiographically. The placement of healing abutment showed severe faciopalatal angulation. (Figure9 ,Figure 10)

Fig 9 : Radiographic evaluation

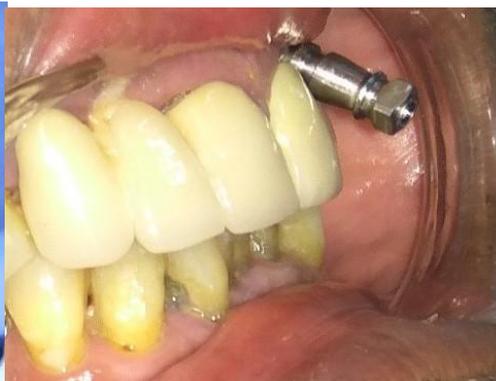
Fig 10 : Severe faciopalatal angulation

Case II presented with unfavourable faciopalatal and a deep apicocoronal position of the implant. Definitive restoration was planned using a UCLA type plastic abutment to fabricate a framework over which a cementable coping was made and soft tissue management was done with gingival porcelain^{2,9}.

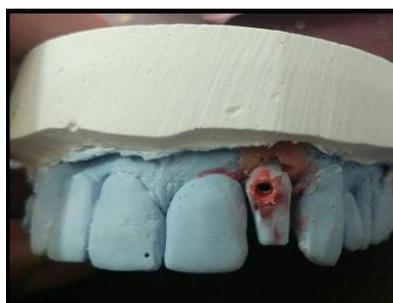
Fig 11 : Inlay wax pattern

Inlay casting wax (Renfert; Germany) was chosen for fabrication of wax pattern for custom cast abutment. Die lubricant was applied into the internal hex of the implant analog. A thin layer of wax was applied into the internal hex compartment, and the abutment screw was slowly screwed into place. This process was repeated couple of times till wax of adequate thickness was visible around the abutment screw. Inlay wax was then added to this incrementally to obtain a framework similar to the morphology of a maxillary left lateral incisor. [Figure 11].

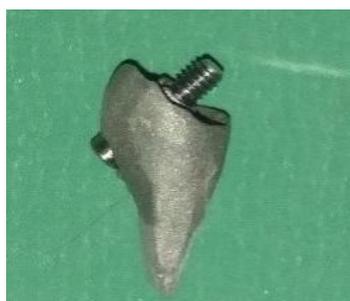
Fig 12 : Casting of the crown

The abutment screw was carefully removed, and the wax pattern was immediately invested and cast following standard casting procedures using Nickel-chromium alloy (SuperCast) [Figure 12].

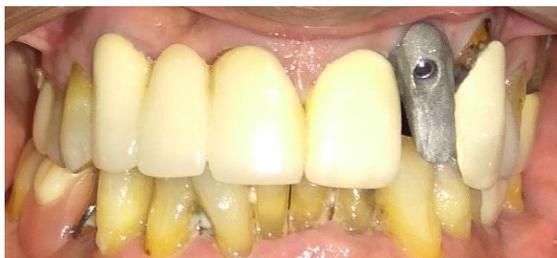
Fig 13 : Customized abutment trial

Due to malpositioning of implant, the screw access hole of framework was visible above the gingival zenith of adjacent central incisor. Hence it was decided to veneer that part of framework with gingival porcelain. The customized abutment trial was followed by shade selection (Vita toothguide 3D Master; USA), and ceramic build-up was completed. This was followed by a bisque trial of the abutment framework for the definitive restoration to evaluate and confirm the peri-implant soft tissue contour. The anterior guidance for the restoration was decided by the incisal guidance of the adjacent natural anterior teeth. The anterior guidance of restoration was kept as shallow as possible with no interferences in protrusive and lateral excursions with a clearance of 2 mm from the mandibular anterior teeth in centric occlusion.

The obtained customized abutment was tried on the fixture in the patient's mouth and checked for fit, angulation, and clearance (Figure 13).

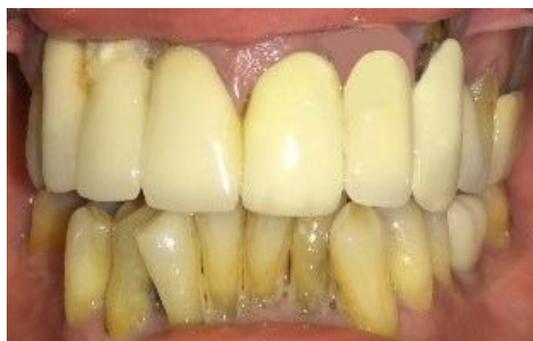
Fig 15 : Intraoral view post crown fixing

The definitive restoration was then evaluated intraorally and periapical radiograph was made to verify the fit of the abutment and the restoration. The abutment screw was torqued to 30 N-cm with a torque wrench (Hi-Tech), and the abutment screw-access channel was blocked using gauze and interim restorative material (Cavit 3M ESPE; USA). Composite resin(3M ESPE)was used to fill the access hole. The prosthesis was evaluated by regular followup at routine time interval of 1 month,3 months and 6 months.(Fig 15)

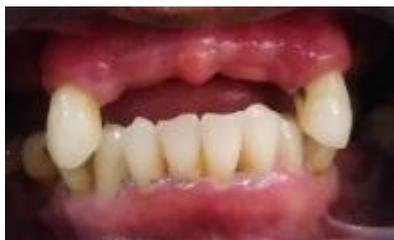
Patient history, clinical examination, revealed all missing maxillary teeth except the left and right canine and endosseous implant in maxillary left and right central incisor region (Figure 16).

Fig 16 : Pre op image

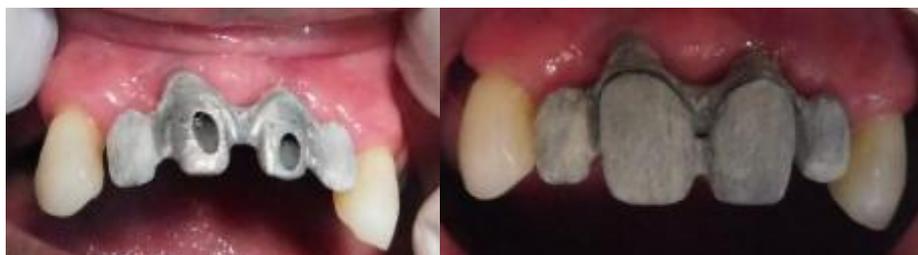
Fig 18 : Framework and Coping trial

The patient was not willing for surgical procedures and opted for prosthodontic management by fabricating customized implant abutment. The treatment plan was thoroughly explained to the patient and a written consent was obtained before the commencement of the treatment. A closed tray implant-level impression was made using two impression copings (Hi-tech) and a polyether impression material (Impregum; 3M ESPE) and silicone resin (Ufi Gel P, VOCO) was applied around the analog to mimic gingival tissue. The implant analogues (Hi-Tech) were placed in the impression and type III dental stone (Kalstone; Kalabhai) was then poured, and models were made. Two hexed plastic castable abutment burn out pattern sleeves (Hi-tech) were fitted to the implant analogues. The height of the sleeves were adjusted to obtain a 2mm clearance from the opposing dentition. Inlay casting wax (Renfert; Germany) was added in an incremental manner to obtain a wax pattern. The wax pattern was invested and subsequently cast to obtain a framework. The obtained customized abutment was tried on the fixture in the patient's mouth and checked for fit, angulation, and clearance. The screw access channel was then blocked. Wax up was done over the framework directly using the inlay casting wax (Renfert; Germany) and casting was done to obtain the coping which was tried in the mouth (Figure 18).'

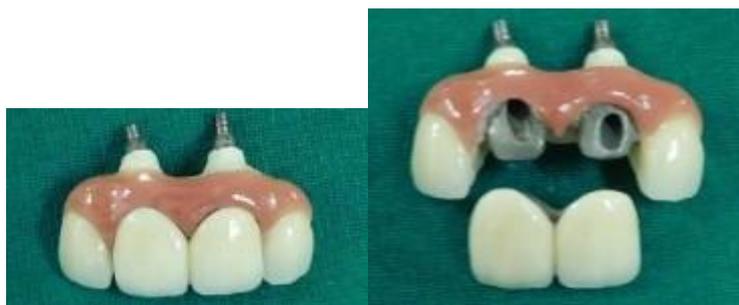
Fig 19 : Final coping with gingival porcelain

Shade selection (Vita toothguide 3D Master; USA) was done, and ceramic build-up was completed. This was followed by a bisque trial of the coping for the definitive restoration to evaluate and confirm the peri-implant soft tissue contour. The tooth and gingiva-colored veneering porcelain (LAVA; 3M ESPE) were added to the coping and it was glazed (Figure19).

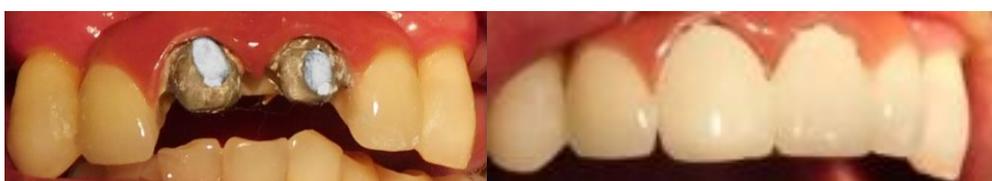
Fig 20 : Prosthesis delivery

The definitive restoration was then evaluated intraorally, and periapical radiograph was made to verify the fit of the abutment and the restoration. The abutment screw was torqued to 30 N-cm with a torque wrench (Hi-Tech), and the abutment screw-access channels were blocked using gauze and an interim restorative material (Cavit 3M ESPE; USA) (Figure20)

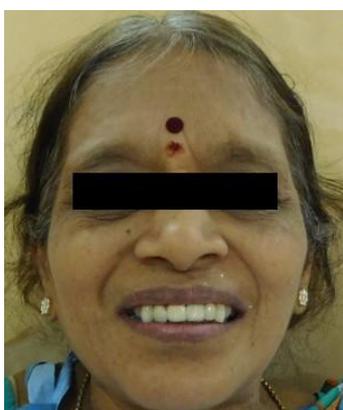
Fig 21 : Extraoral view post cementation

The definitive restoration was then luted using Non eugenol temporary resin cement (Premier implant cement; USA)(Figure 21). The prosthesis was evaluated by regular followup at routine time interval of 1 month,3 months and 6 month.
