Comparison Of Three Intraoral Ceramic Repair Systems To Evaluate The Shear Bond Strength Of Composite To Zirconia After Various Surface Treatments: An In-Vitro Study.

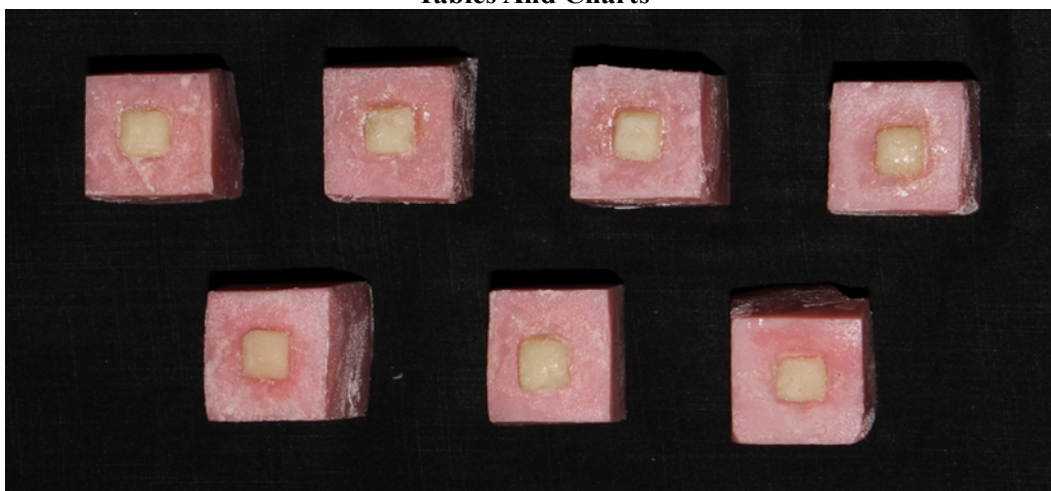
The zirconia specimens after sintering were then layered with porcelain (Ivoclar,vivadent) to a thickness of 0.5mm by applying opaque, dentin, enamel and glaze layers respectively as per the manufacturers instructions. The porcelain was layered with a brush which was used to paint the layers over the fabricated samples. Then the layered disks were fired at 930 degrees in a porcelain furnace (VITA VGO,i-line)the specimens were then be finished using carborundum disks and abrasive paper to obtain the uniform final dimensions. The samples were divided into two groups according to the surface treatment. (Fig 1)

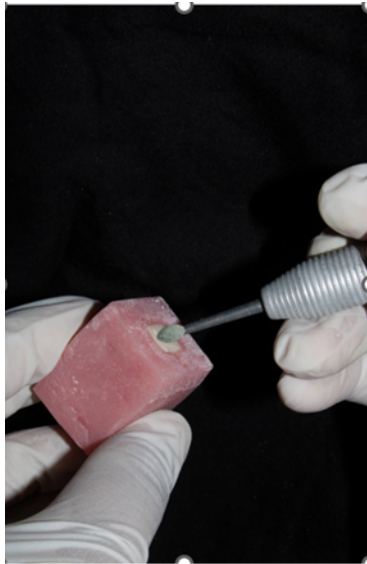
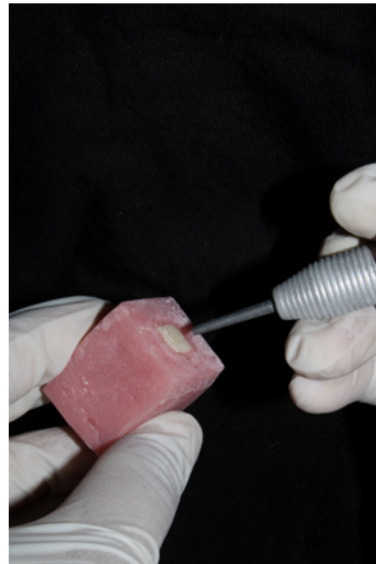
The test surfaces of both the group specimens were divided into two groups according to the surface treatment employed silicone carbide bur or air borne particle abrasion.(Fig 2a and 2b)

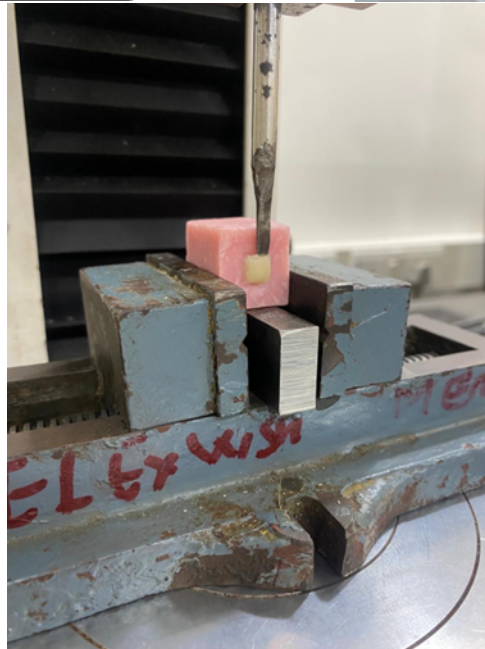
Shear testing of all groups was performed on a universal testing machine (Instron®5960, U.S.A. Model No.3345R3092 at a crosshead speed of 0.5mm/min. A knife-edge blade apparatus was used to direct a parallel shearing force as close as possible to the interface of the ceramic and the composite cylinder. The shear debonding forces was recorded in N. The failure loads (N) was divided by the bonding areas (25mm²), and then the shear debonding forces was converted into MPa. If debonding occurred before the shearing tool touched the cement, the bonding strength was defined as 0 MPa.(Fig 3)

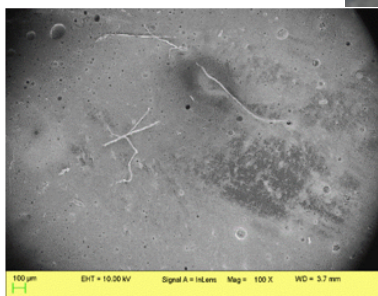
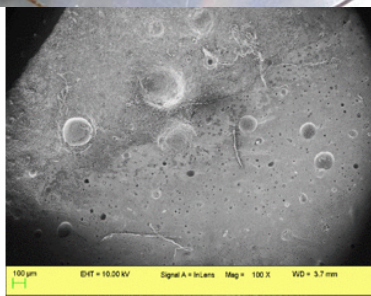
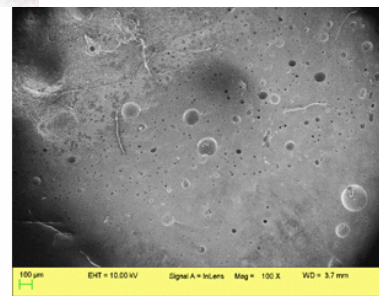
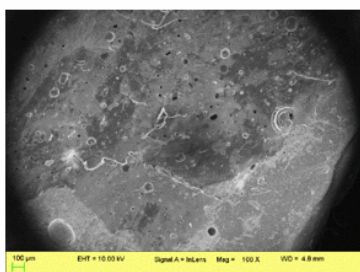
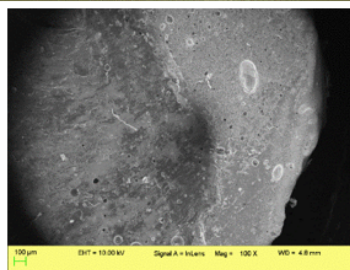
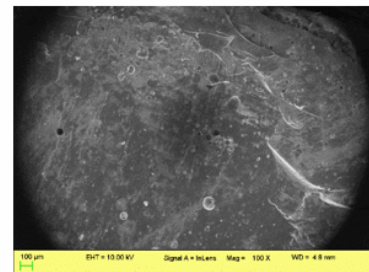
The effects of the surface treatments and different repair systems was examined in a SEM Carl Zeiss Supra 55, Germany at 100 X magnification. Failure types was categorized as adhesive between ceramic and composite (ADHES), and cohesive failure (COHES) and cohesive failure of the ceramic accompanied by adhesive failure at the interface (MIX). Fig 4)

There are three modes of failure of layered ceramic or repaired composite over zirconia core. They can be adhesive, cohesive or mixed. The SEM examination of the specimens in the current study showed adhesive failure to be the common mode of failure for the specimens. This finding is in line with Kocaagaoglu et al.'s⁽²⁵⁾ research findings on ceramic repairs, Adhesive failure occurred when the repaired composite separated from the zirconia core, possibly due to vertical wedging forces during testing.

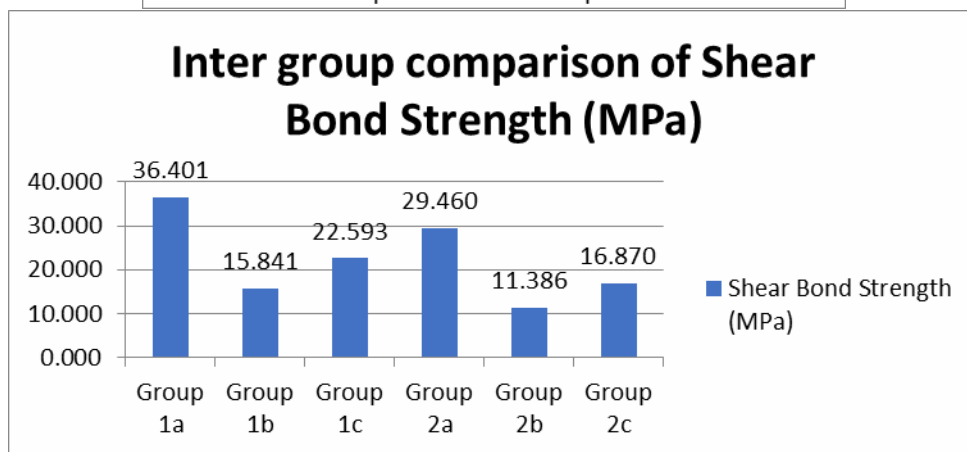
Thus, suggesting best bond strength between zirconia samples surface treated with silicone carbide bur and then repaired using A.C.E. prevest repair system followed by zirconia samples surface treated with alumina particle abrasion and then repaired using A.C.E. prevest repair system. The graph also depicts a statistically insignificant difference in the strength of samples surface treated with SiC bur when compared to Alumina particle abrasion. (fig 6) (graph)
