Management Of A Horizontally Fractured Central Incisor By Intra-Radicular Splinting -A Case Report

This case report discusses the endodontic management and six-month follow-up of a horizontally fractured central incisor using the intra-radicular splinting technique. Thus, presenting a conservative approach in the management of horizontal root fractures & to allow for retention of natural dentition.

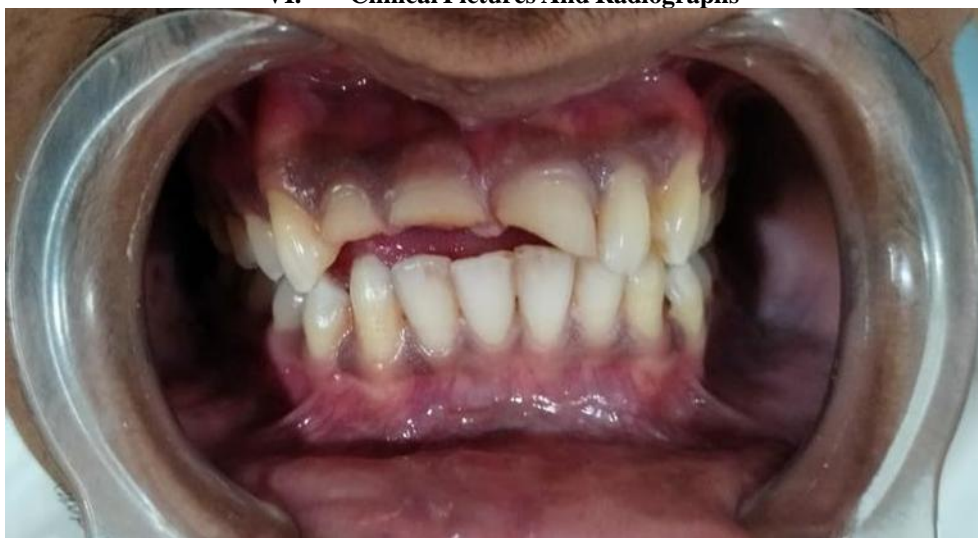
Clinical examination revealed complicated crown fractures w.r.t 11,12, 21 (maxillary right and left central incisors & maxillary right lateral incisor). Grade 1 mobility was observed with 11, and it was non-tender to percussion. No mobility and no tenderness on percussion was observed with 12,21. The electric pulp vitality test gave a negative response for teeth 11,12,21. While remaining anterior teeth were clinically normal. (Fig1)

Fig 1: Pre-operative clinical photograph

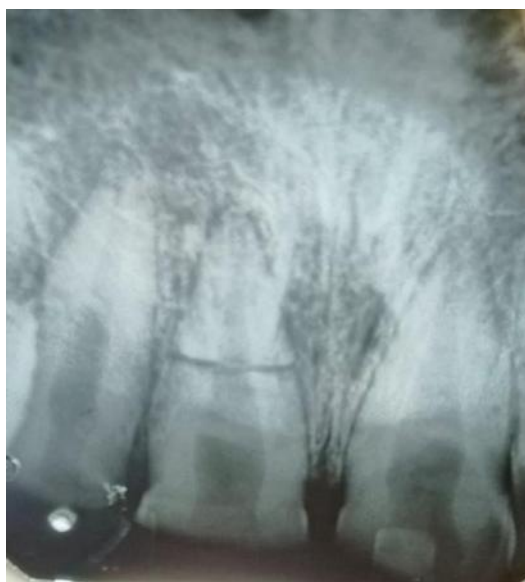
On radiographic examination, a horizontal fracture located in the mid-root segment w.r.t 11 was detected separating the coronal and apical root fragments from each other by about 1mm. Minimal displacement of fracture fragments was noted. Periapical rarefaction and PDL space widening was seen with 11. Also, coronal fracture involving enamel, dentin, extending into the pulp chamber was noted with 11,12,21. (Fig 2)

A diagnosis of ELLIS CLASS VI fracture w.r.t 11 and ELLIS CLASS III FRACTURE w.r.t 12,21 was made.

Fig 2: Diagnostic IOPA radiograph

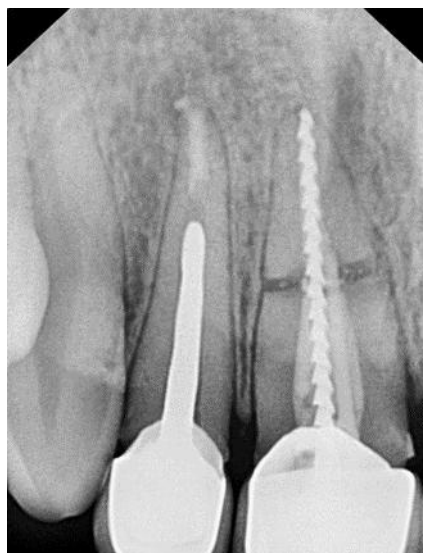
At the 1-month recall, the tooth was asymptomatic and the mobility of the tooth was normal. On 6-month follow-up, the patient was comfortable with no complaints with the treated teeth. Pain on percussion was negative and no mobility was detected clinically. Also, radiographic healing of the attachment apparatus was evident as lamina dura formation was seen along the distal root outline. Also, no untoward periapical changes

had occurred indicative of any resorptive activity (Fig 20).

Fig 20: 6-month follow-up radiographic showing healing of the attachment apparatus & no untoward periapical changes w.r.t intra radicular splinting of 11.
