Structural Redemption- Rebuilding A Fractured Tooth Using Interlig Fibres: A Case Report

This case report describes the use of FRC in an endodontically treated tooth with weakened walls and additional reinforcement using an LS2 crown.

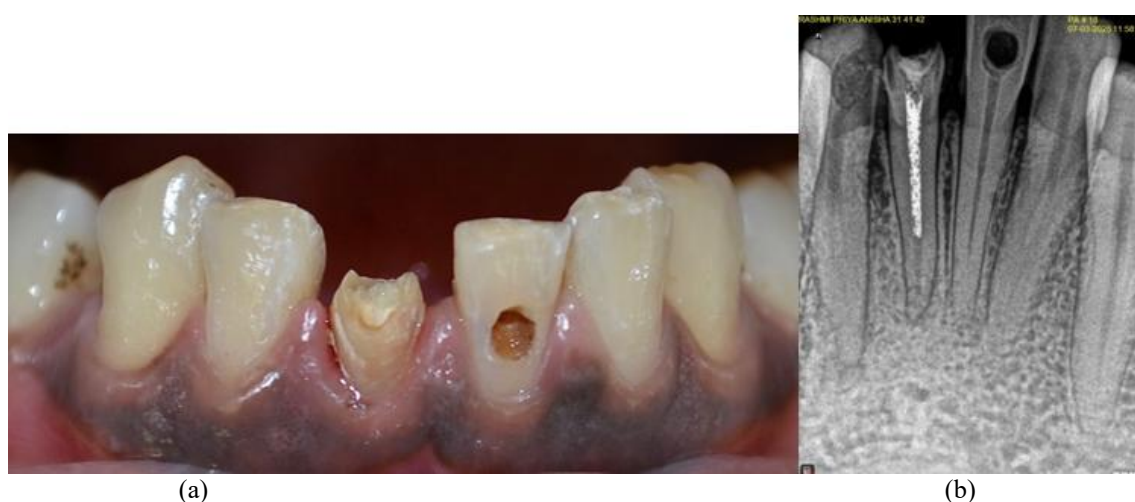
Fig 1. Pre-op photograph and radiograph

On intraoral examination, carious labial perforation of 31 was noted. Tooth preparation along with an incompletely restored access cavity was noted on 41. 42 had an access cavity that was temporarily restored [Fig 1(a)].

Radiographic evaluation showed incomplete endodontic treatment on 31 and 41. Presence of intracanal material was noted inside 41. Apical calcification of the canal was noted on 31. Fast-break appearance was noted on 42, suggestive of 2 canals [Fig 1(b)].

After a round of oral prophylaxis, the treatment proposed to the patient was to complete endodontic treatment and post-endodontic restoration of 31 and 42 and post-endodontic restoration followed by crown on 41.

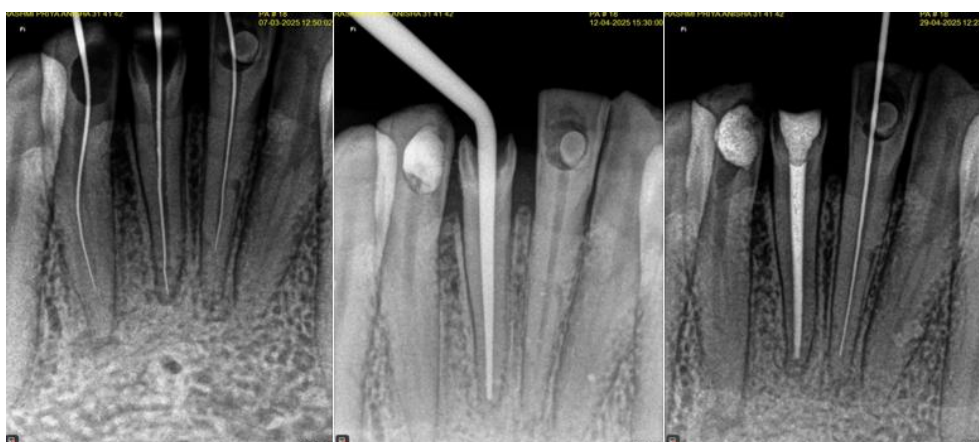
Fig 2. WL determination-41 Fig 3. Master cone- 41 Fig 4. WL determination- 31

#41- Cleaning and shaping were done on 41 using rotary files (GenEndo, Coltene) upto 35-6% accompanied by copious irrigation using 5.25% NaOCl (Coltene) and EDTA. Master cone was selected (Fig 3) and obturation was completed using Bio-C bioceramic sealer (Angelus, Londrina, Brazil) (Fig 6).

#31- To achieve a complete glide path and a line of patency of the canal, re-negotiation was carried out using #10 D-finder files which was supplemented by copious irrigation using 17% EDTA. Radiographs were repeatedly taken to verify if complete canal patency was achieved. After negotiation of the apical calcification, working length radiograph was repeated. Patency was achieved till 2mm short of the apex. Attempts to negotiate further did not lead to complete achievement of patency. This working length was finalized (Fig 4), and chemo-mechanical preparation was done upto 25-6% using rotary files (GenEndo, Coltene) accompanied by copious irrigation using 5.25% NaOCl (Coltene) and 17% EDTA. Master cone was selected (Fig 5) and obturation was completed using Bio-C bioceramic sealer (Angelus) (Fig 6). Access restoration was done using composite (Tetric-N-Ceram, Ivoclar Vivadent).

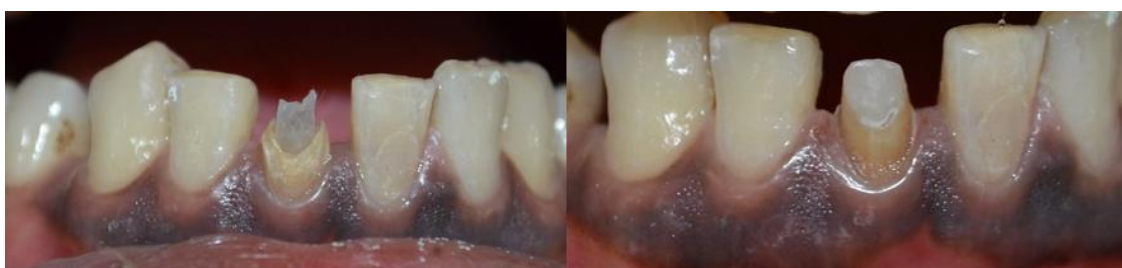
Fig 7. Placement of Interlig fibres on 41

The pre-determined length of the Interlig (Angelus, Londrina, Brazil) fibre was cut. The base of the access cavity of 41 was etched with 37% phosphoric acid (Eco-Etch, Ivoclar Vivadent, Liechtenstein) for 20s and then washed and dried. This was followed by placement of a bonding agent (Tetric-N-Bond, Ivoclar Vivadent, Liechtenstein). A thin layer of flowable composite was placed on the base of the access cavity. The interlig fibre was then carefully placed along the labial wall of 41, with half of the fibre within the tooth and the other half

emerging from the access cavity (Fig 7). It was then light cured for 30s (Fig 8). Composite (Tetric-N-Ceram, Ivoclar Vivadent, Liechtenstein) build-up was done around the Interlig fibre, followed by tooth preparation for an LS2 crown (Fig 8). Shade selection was done using Vita 3D Master Guide (VITA). The shade was 4M2. Putty impression was made, and the patient was recalled after 4 days for cementation of the LS2 crown.

In the present case, the prolonged placement of calcium hydroxide intracanal medicament led to the weakening of the root canal walls. This necessitated the placement of Interlig to allow for the reinforcement and offsetting the vertical stresses. Since the tooth had full coverage PFM crown that dislodged, a new LS2 crown was chosen as the material of choice owing to its excellent aesthetics and biocompatibility.

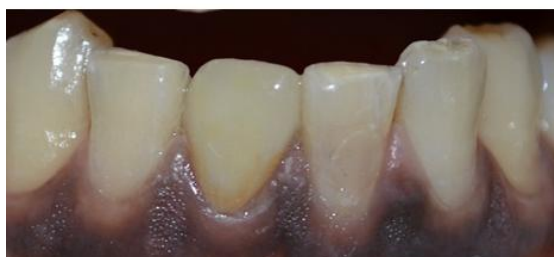
Fig 9. Post cementation of LS2 crown on 41

The crown was evaluated for marginal and interproximal adaptation, confirming a precise fit with no rocking or gaps. The ceramic surface was cleaned with alcohol, followed by etching the intaglio surface with 5% hydrofluoric acid gel (porcelain Etch, Ultradent) for 30 seconds. After etching, the crown was rinsed in water and then dried using an air/water spray. A silane coupling agent (Porcelain Silane, Ultradent) was applied for 60 seconds, and excess was blown off with a strong air stream.

The tooth was etched with 37% phosphoric acid (Eco-Etch, Ivoclar Vivadent, Liechtenstein), rinsed, and gently dried. A universal adhesive (Tetric-N-Bond, Ivoclar Vivadent, Liechtenstein) was then applied to the etched tooth for 20 seconds and light-cured. The crown was cemented using adhesive resin cement, followed by tack-curing for 2s to facilitate removal of excess semi-set cement with a scaler. Finally, each surface was polymerized for a minimum of 20 seconds. After cementation, final evaluation of the fit was confirmed (Fig 9,10).
