## Rehabilitation of Damaged Reinforced Concrete Beams

**Abstract:** The concrete structures are often exposed to damaged as a result of several factors including, environment, design, and other factors, and because of the high cost and long time needed for reconstruction of the damaged buildings, it become necessary to consider techniques for rehabilitation of the damaged structural members in the building.

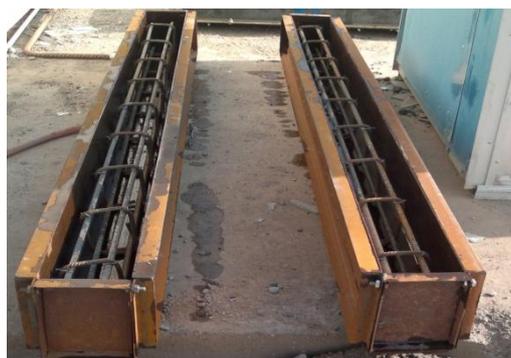
**Photo (1)** Steel moulds for casting the all reinforced concrete beams.

All tested beams were cast with mixing ratio of cement/ fine aggregate/ coarse aggregate 1:1.5:3 respectively by weight with water/ cement ratio of 0.4. It was designed to achieve a concrete cube compressive strength of 32 N/ mm<sup>2</sup> at 28 curing days according to B.S. 116:1989. The mixing of concrete was carried out in a rotary pan type mixer of 0.1 m<sup>3</sup> capacity. In all mixes of concrete, the aggregate and cement were first mixed dry for about 60 seconds and for further 120 seconds after the addition of water. Steel moulds with inner dimensions 150x200x2200 mm as shown in photo (1) were prepared for casting all the beams.

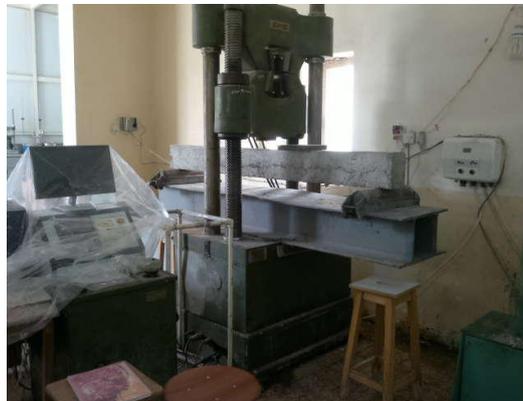
**Photo (2)** Beam under the test.

The beams were tested up to failure load in a Universal Testing Machine under point loading at mid-span. As it was mentioned earlier, all beams were design for flexural failure, in which 4-12 mm diam. bars (2-bars at the top and 2-bars at the bottom) as the reinforcement with 10mm bar dia. At 250mm c/c as stirrups were considered as shown in the Figure (2) and Photo (2).

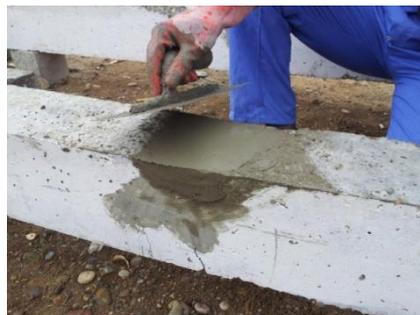
**Photo (3)** View of the crushed part of the beam after flexural testing.

The collapsed beams removed from the testing machine and loose debris were first removed. Then water was sprinkled on the crushed part of the beams to remove the loss particles. Then cement mortar with ratio of 1:1 as cement/ sand passing sieve 2.36 mm is used with water/ cement ratio = 0.4 for plastering the crushed parts of the tested beams as shown in photo (3).

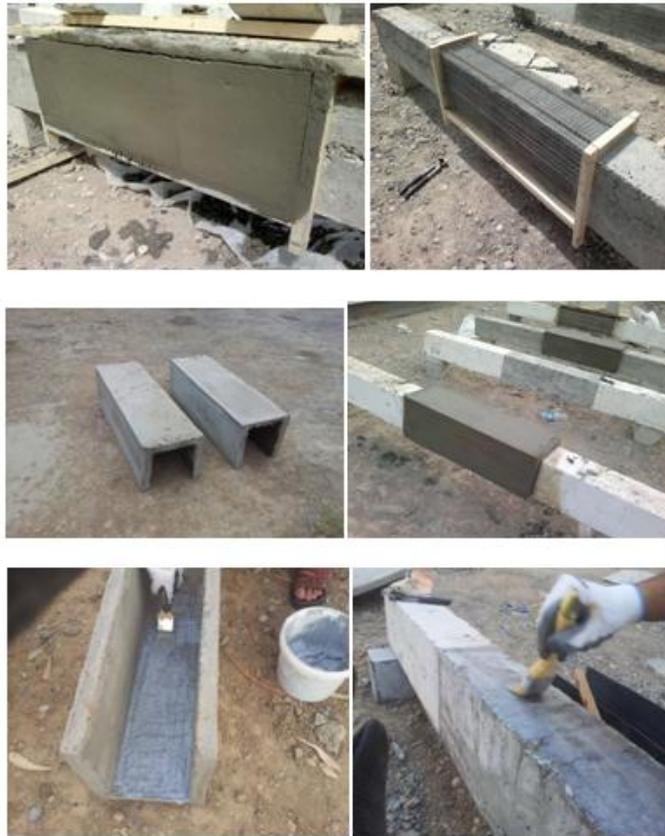
Photo (4) Methods of casting and fixing the ferrocement sections.

- (a) Rehabilitation of the damaged part of the tested beam using ferrocement composite technique. Three U ferrocement cross section as shown in Fig. (4) were cast with length of 700 mm and mixing ratio of the cement mortar (cement: sand = 1:1) and water :cement ratio = 0.4 prior to fixing the sections to the damaged part of the beams. Fig. (5) and photo (4) show the methods of fixing the elements.

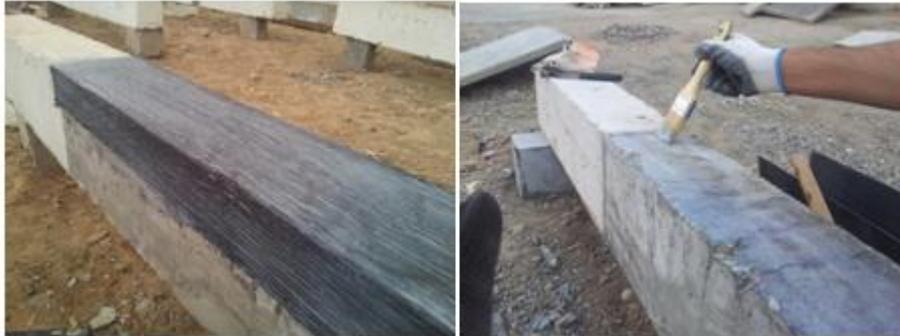
Photo (5) Method of rehabilitate the damaged beam using carbon fiber.

- (c) Rehabilitation of the damaged part of the tested beams using carbon fiber technique. Fig. (7) and photo (5) show the methods of fixing the element.

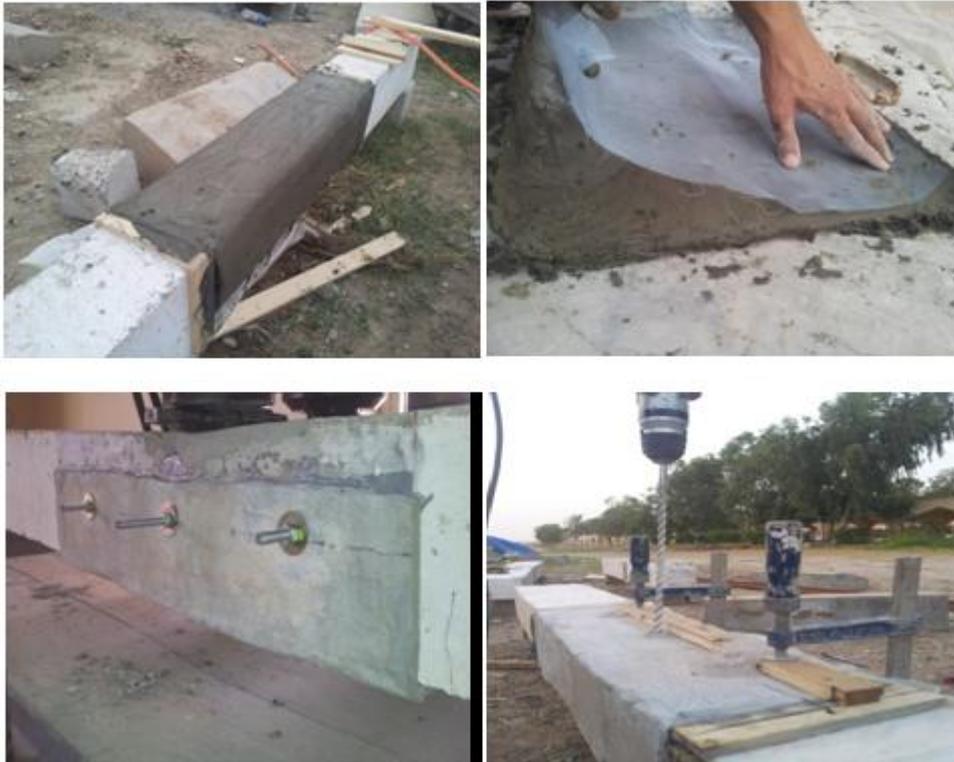
**Photo (6)** Casting and fixing the developed nano ferrocement section.

- (d) Rehabilitation of the damaged part of the tested beam by U section cast by the developed nano ferrocement, see Fig. (8) and photo (6).

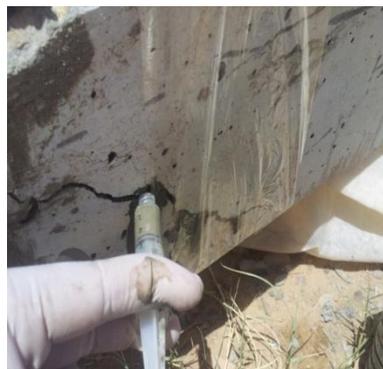
Cracks of the damaged beam were injected as shown in photo (7), by the following mixture.

1. 60% of micro cement.
2. 40% of nano fumed silica.
3. Super plasticizers (2% x weight of cement).
4. w/c ratio = 0.4.

**Photo (7)** Beam during repairing using the injection technique.

(e) Rehabilitation of the damaged part of the tested beams using injection technique by nano materials.
