## Structural Degradation of Masonry Buildings in Bambili Due to Rising Damp (Humidity)

In order to investigate the effects of humidity on structures in Bambili, a total of 216 concrete specimens measuring 220mm x 110mm x 65mm each were produced for the compressive strength test using three cement dosages of 300Kg/m<sup>3</sup>, 350Kg/m<sup>3</sup>, and 400Kg/m<sup>3</sup> for Cimaf cement concrete (CICC), Conch cement concrete (COCC), and Dangote cement concrete (DCC) for both buried and unburied samples. After each day's moulding, the test specimens were de-moulded after 24 hours and cured in a water tank by immersion for 28 days. A total of 18 different sets of samples were then buried beneath the earth in Bambili at a humidity-conditioned environment of 48.25% moisture content. After removing test specimens from the curing tank on each day, they were allowed to dry off for 30 minutes in the laboratory environment. Crushing then followed for 28 days, 56 days, 84 days, and 112 days, respectively for each cement type. The concretes dosed at 300Kg/m<sup>3</sup> suffered the greatest strength loss considering buried and unburied samples, followed by concretes dosed at 350Kg/m<sup>3

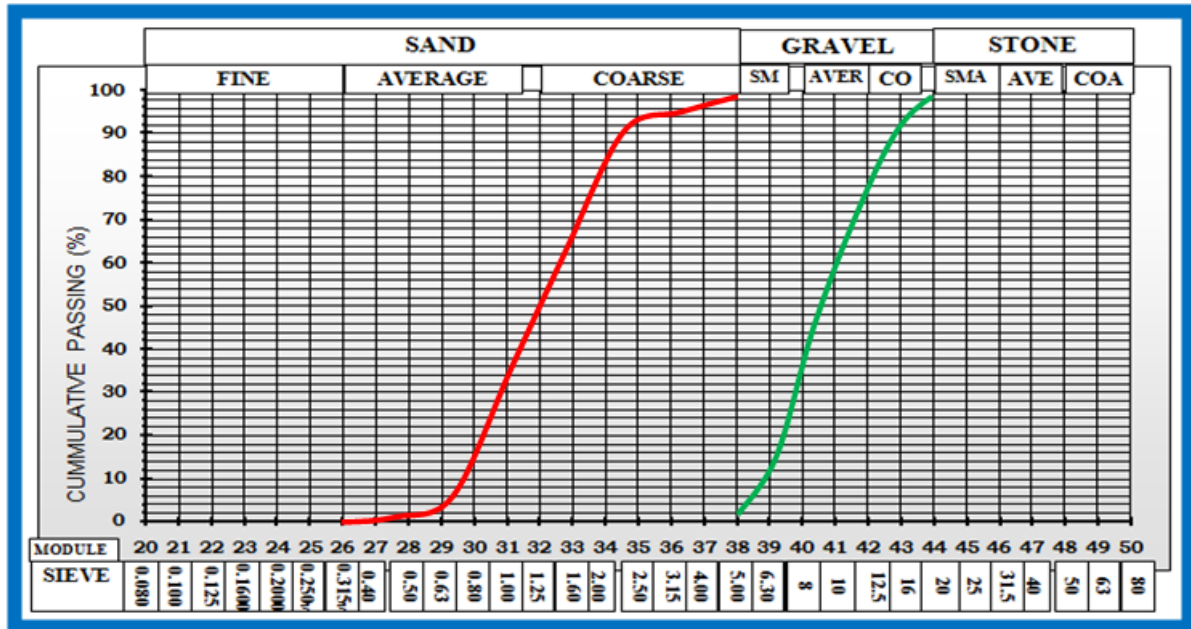
Fig.3: Grain size analyses curves of aggregate

The grain size analysis was performed in accordance with BS 933-Part 1<sup>5,6</sup>. The aggregate samples were placed successively in different columns of sieves and agitated for 5minutes. Thereafter, the samples were weighed. Percentage passing and retained were then computed and the results recorded. The results of the dry sieve analysis displayed in fig.3 revealed that sand and gravel have coefficients of uniformity of 7.03 and 4.16, respectively. Thus sand and gravel were well- graded according to (Vandavelde, 2008) and the Unified Soil Classification System (Holtz and Kovacs, 1981). These showed that the aggregates were suitable for making concrete, unlike a gap-graded or poorly graded aggregate having coefficient of uniformity less than 1.00.

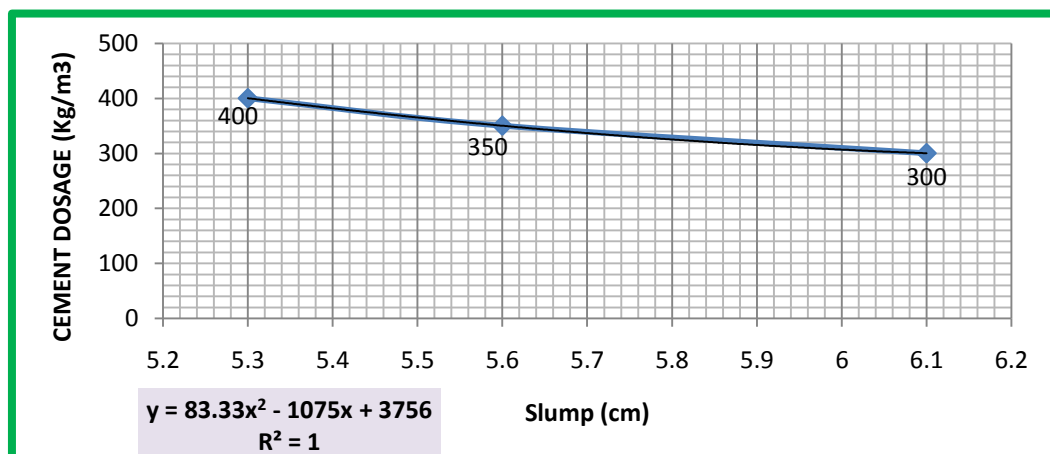
Fig.4: Interpolation graph of slump versus Cement dosage

The results of the slump test indicating the workability of concrete are indicated in fig. 4. For concrete dosed at 300Kg/m<sup>3</sup>, 350Kg/m<sup>3</sup> and 400Kg/m<sup>3</sup> the slump values were 6.1cm, 5.6cm, and 5.3cm respectively. When a slump ranges from 3cm to 5cm, it means that the concrete is stiff and should be given a good vibration. When the slump is from 6cm to 9cm, it means that the concrete is plastic and should be given normal vibration. A slump ranging from 10cm to 13cm implies that the concrete is watery or soft and the vibration mode is pricking.

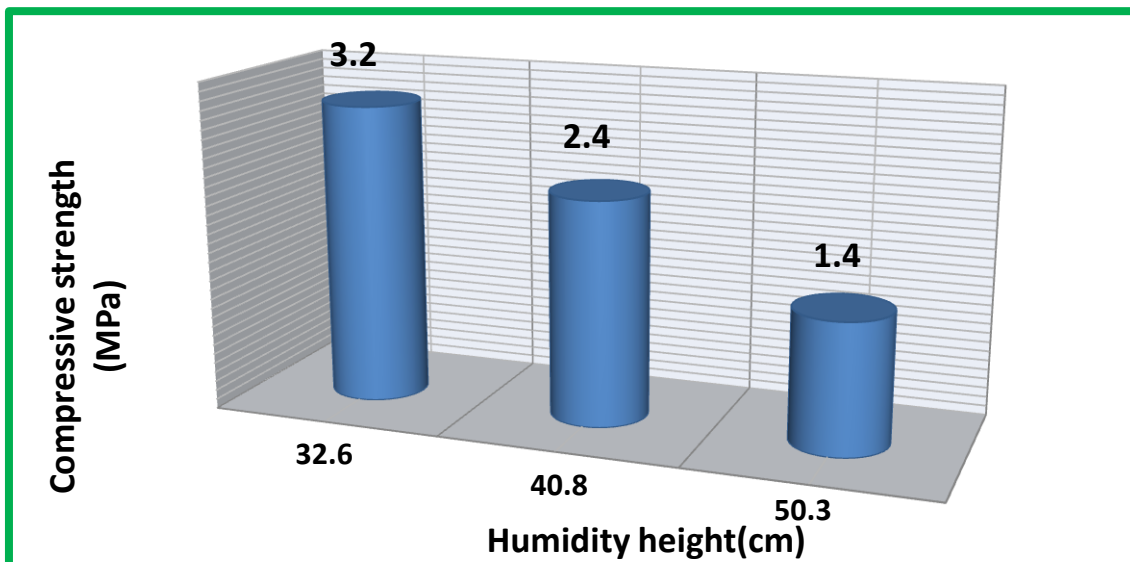
**Fig.5:** Graph showing the relationship between the compressive strength of blocks(MPa) and humidity height(cm)

Fig.5 shows the relationship between the compressive strength of blocks(MPa) and the humidity height (cm). It can be observed that the strength of blocks reduces with increase in humidity height. In order words, the height of damp increases when the compressive strength of blocks reduces. This can be ascribed to the fact that the lesser the compressive strength, the greater the cement content which is the chief binding ingredient responsible for mortar strength.

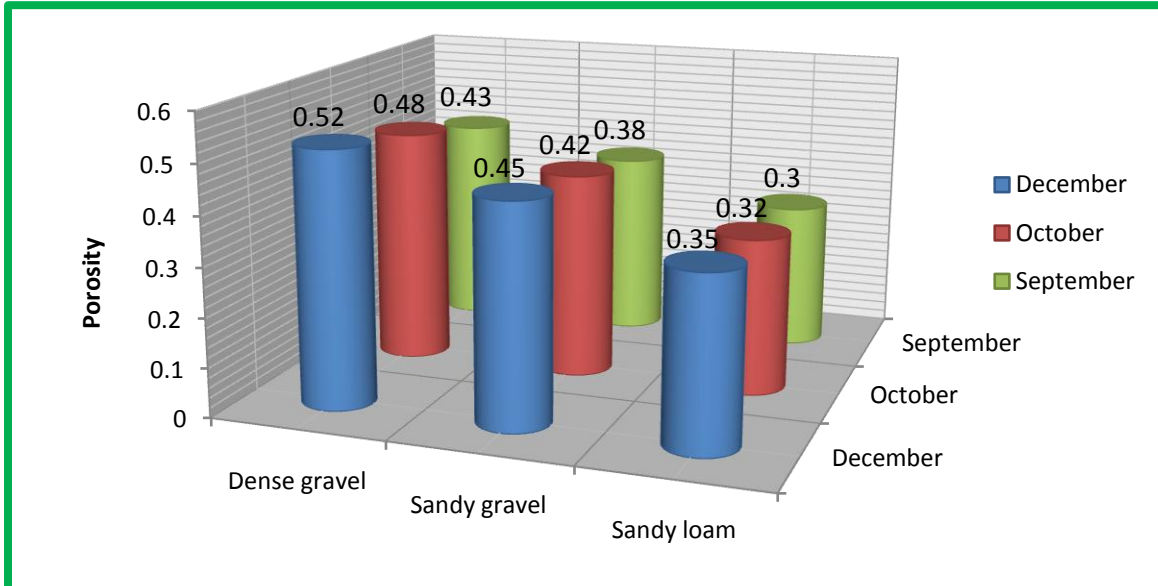
Fig.6: 3D Column graph showing soil porosity variation with respect to soil type and three months of the year

Table 2 and fig.6 portray the variation of humidity height(cm) with respect to porosity, soil type and different months of the year. It can be observed that the density and compacity has a dramatic influence on the porosity and humidity height on walls. Dense gravel witnesses the greatest porosity followed by sandy gravel and sandy loam. It should be noted that the greater the porosity, the greater the humidity height. Since the humidity height increases with an increment in porosity, it is advisable to compact the soil around buildings in order to curb the effect of damp penetration within buildings.

Furthermore, as we progress from the rainy season into the dry season, there is a rise in soil porosity. This phenomenon can be attributed to the fact that towards the dry season, water begin to dry off from soil masses, causing the soil to shrink in volume. Meanwhile, in a rainy month like September, the soil voids still comparatively have some amount of water, causing the soil to swell or expand. From the formula of porosity ( $\frac{V_v}{V}$ ), it can be shown that as the volume increases, the porosity drops. This explains why during the rainy season there is a decrease in soil porosity.

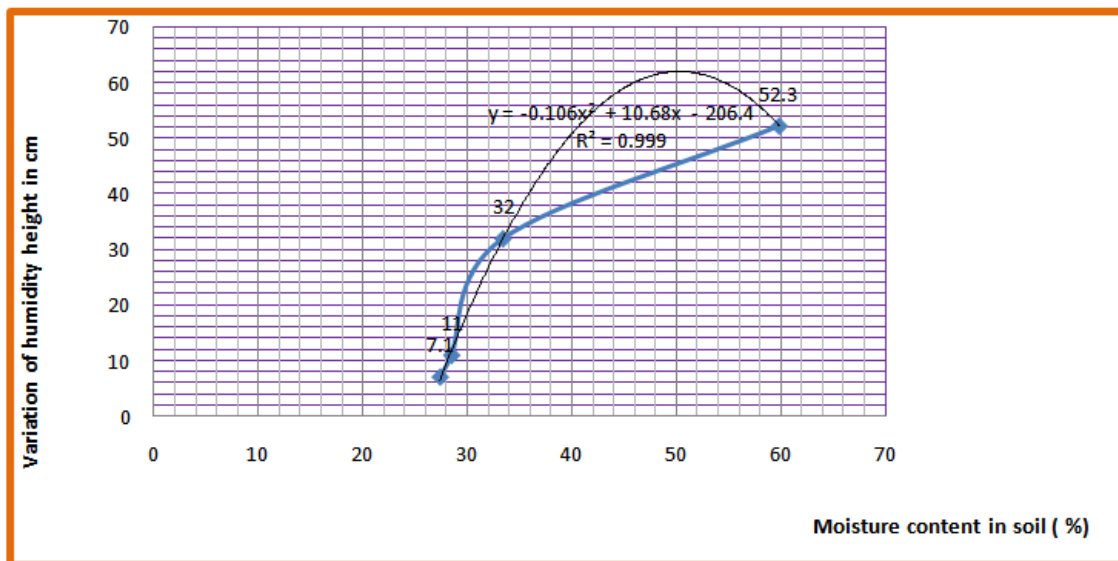
Fig. 7: Graph showing variation of humidity height with moisture content at test point 1

Fig.7 portrays the graph of moisture content versus variation in height of humidity at test point 1 located at the right edge of the back orientation of the building under study(see fig.8). The values were obtained in January, February, March, and April 2016 respectively. Results reveal that at height of rising damp of 7.1cm, 11cm, 32cm and 52.3cm, the moisture content values were 27.4%, 28.5%, 33.4%, and 59.8% ,respectively.

It can therefore be clearly seen that the greater the moisture content in the soil, the greater the height of rising damp. Moreover, the month of April witnessed the highest percentage of moisture content; this can be attributed to the fact that April also has greater rainfall.

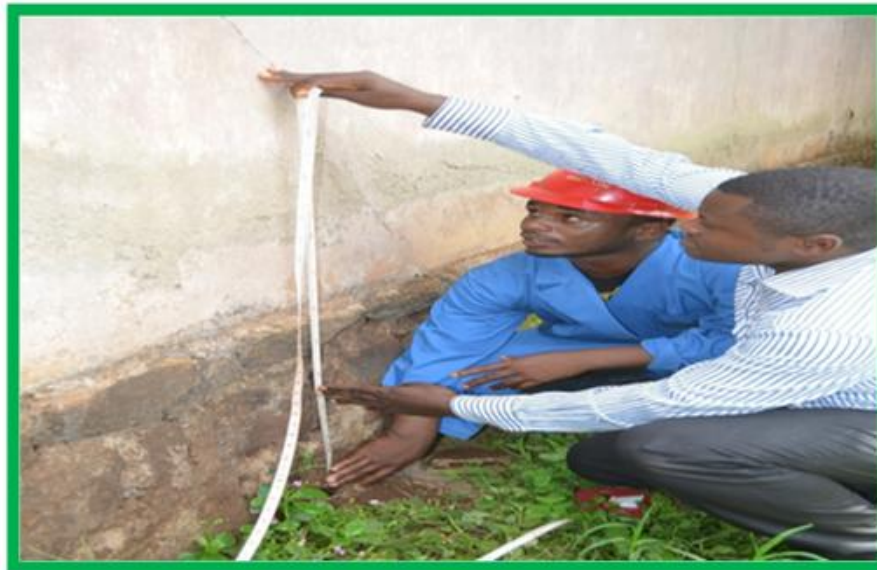
**Fig. 8:** Researcher and assistant measuring humidity height at back orientation

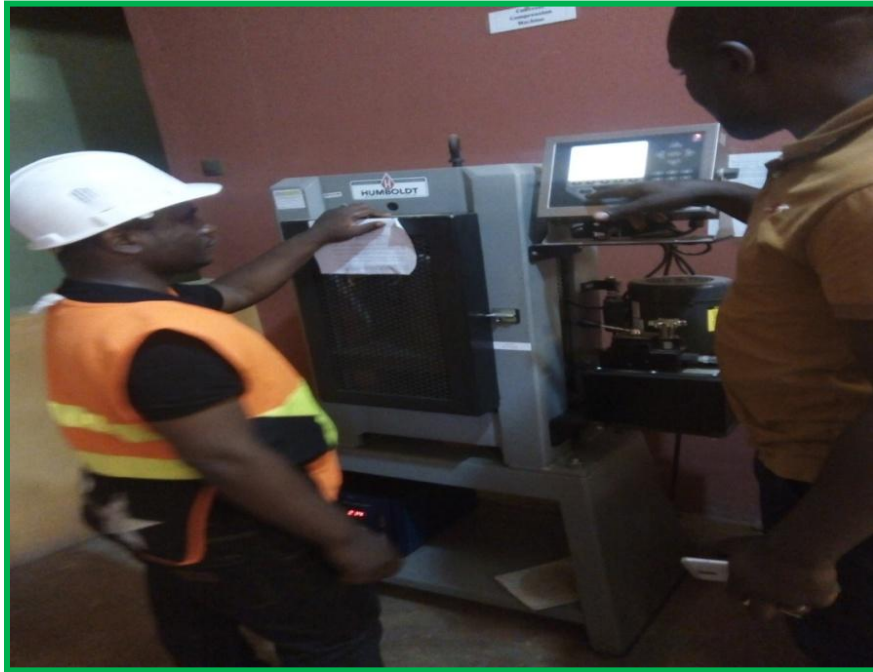
**Fig. 10:** Researcher with assistant crushing test specimens at Digital compression test machine at Bambuiy Geotechnical Laboratory

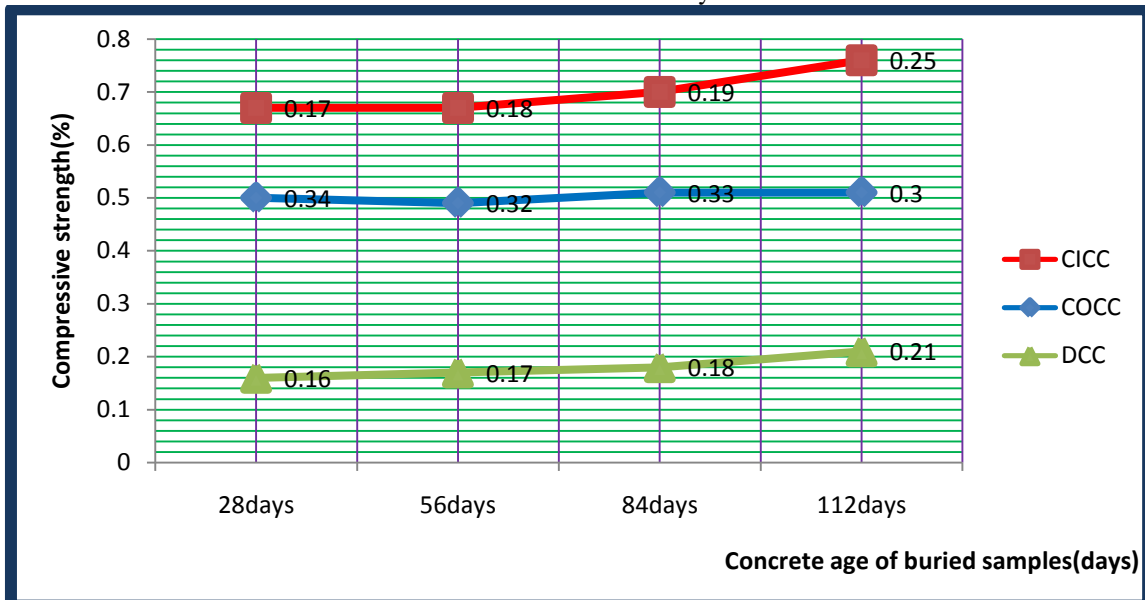
**Fig.11:** Comparative variation of compressive strength losses(%) of CICC, COCC and DCC at highest dosage (400Kg/m<sup>3</sup>) and considering buried and unburied samples.

Figure 11 depicts the comparative compressive strength losses of CIMAF cement concrete, CONCH cement concrete, and Dangote cement concrete with variation in cement dosage, and concrete age of buried samples, considering a fixed water/cement ratio of 0.5 and a prescribed mix proportion of 1:2:4.

At 28days, the compressive strengths of CICC, DCC, and COCC are 0.17%, 0.16%, and 0.34%, respectively. At 56days crushing, the compressive strength losses of CICC, DCC, and COCC are 0.18%, 0.17%, and 0.32%, respectively. At 84days crushing, the compressive strengths of CICC, DCC, and COCC are 0.19%, 0.18%, and 0.33%, respectively. And at 112days, the compressive strength losses are 0.25%, 0.21%, and 0.3, respectively.

The general trend reveals that the compressive strength losses for the concrete increase with increase in concrete age and decrease with increase in dosage. The result further reveals a significant drop in the compressive strength of COCC compared to its CICC and DCC counterparts.

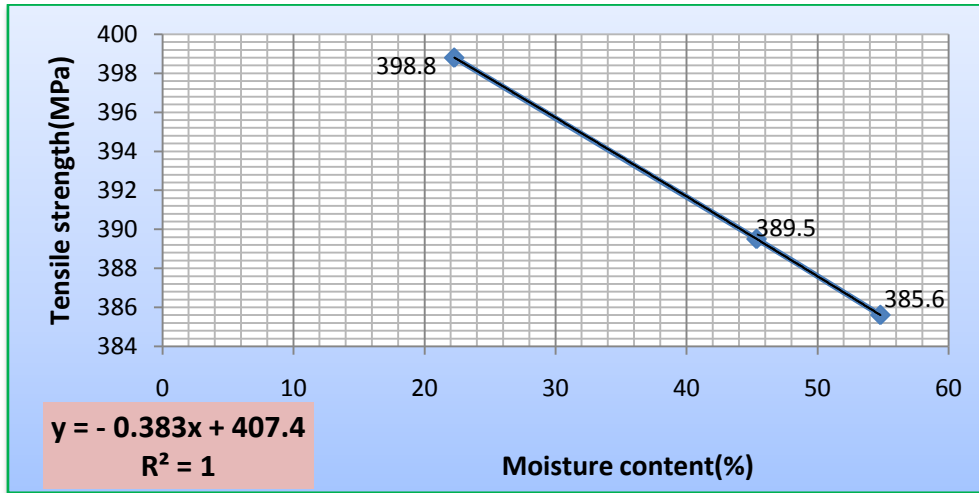
**Fig.12: Tensile strength variation of steel rods with respect to moisture content**

It can be shown from fig.12 and table 3 that with increase in humidity, the tensile resistance of steel rods drops. The decrease in the tensile strength can be attributed to the weakening of the molecular structure of steel due to the corrosive effect of moisture. When the tensile strength reduces, other mechanical properties of the material will also be affected such as the visco-plasticity, the elasticity, compressive resistance, and the Poisson ratio.
