Flexural Behavior of Reinforced Concrete Beams Contained Nano Silica with Internally Injected by Epoxy

Key Word: Nano-Silica; Internally Injected by Epoxy; flexural behavior.

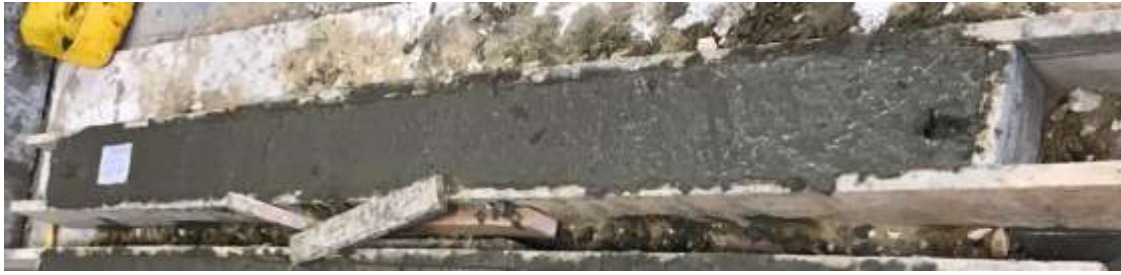
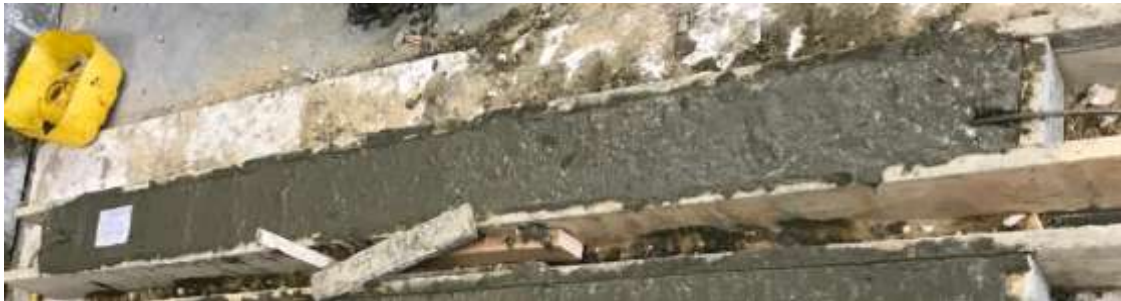
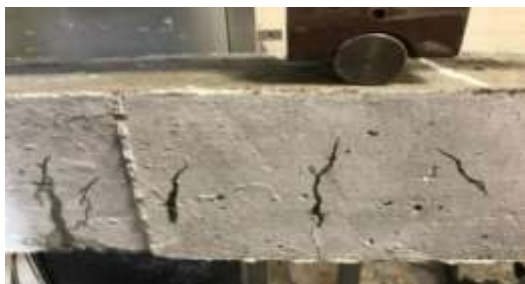
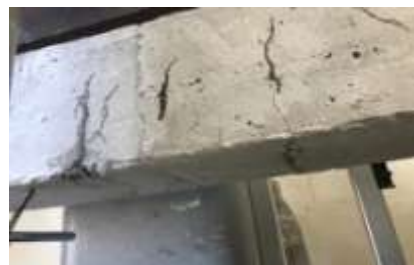
(a) Boreholes have been kept open during casting

(b) Epoxy injection

Fig. 2. Stages of repairing RC beams using epoxy injection technique

(c) Filling cracks with epoxy

The normal and nano-silica concrete mixture has been casted in the formwork and the required boreholes have been kept open during casting. Boreholes of a suitable diameter were drilled along the entire length of the reinforced concrete beams to allow the internal injection mixing to pass through the cracks and fissures. The bore hole diameter that are used are (5 mms.). Butting a pipe inside the concrete works by using a soft rubber pipe with a diameter of 5 mm is the most commonly used piping work operation.

The injection operation is performed by pressing the injection mixture through the concrete Specimens special boreholes to fill the voids, cracks, and joints in the concrete Specimens body. To withstand abrasion and the maximum grouting pressures, the hose pipe used to transport the injected materials was made of a pliable soft rubber. Then, the required holes have been cleaned with an air blower to remove all dirt and other impurities before injection beams by epoxy. The rubber hose is used to connect the supply line to the manifold (header) at the hole to facilitate shifting of the grout line from one hole to another. The Specimens were subjected to a sustained loading level at which small cracks started to appear with a width of about 1 mm; it was observed to be about (70%) of the ultimate load of the previously tested specimens under the same conditions. And then inject them with epoxy through a small 5mm longitudinal hole using a rubber pipe with the same diameter; after being sure that the epoxy filled all cracks, specimens were left to achieve full hardness after 7 days of epoxy injection before finalizing the test. The epoxy injection technique as shown in Fig. 2.

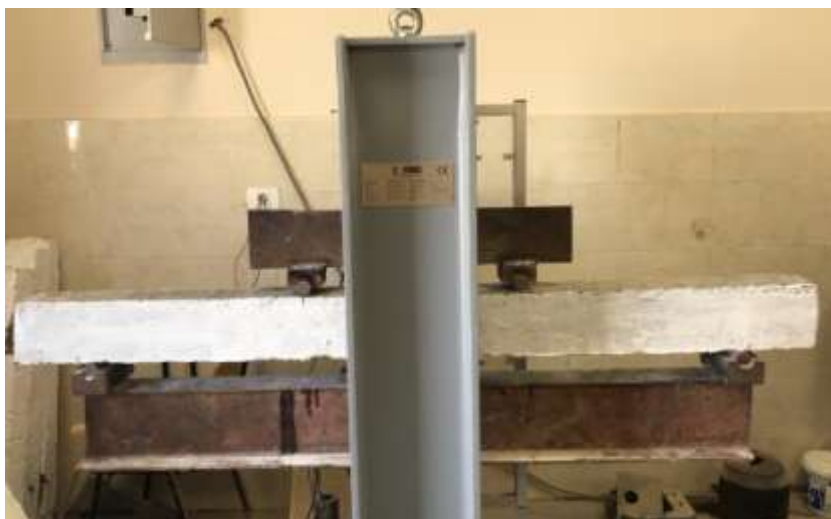
Fig. 3. Test setup

The beam specimens have been subjected to a four point loading up to failure using a hydraulic machine of deflection control at a rate of 0.25 mm/min as shown in Fig. 3. Vertical deflections have been measured using one linear variable differential transducer (LVDT) at the mid-span of the beam specimens. The tested beams have been tested after 28 days of casting concrete mixture.

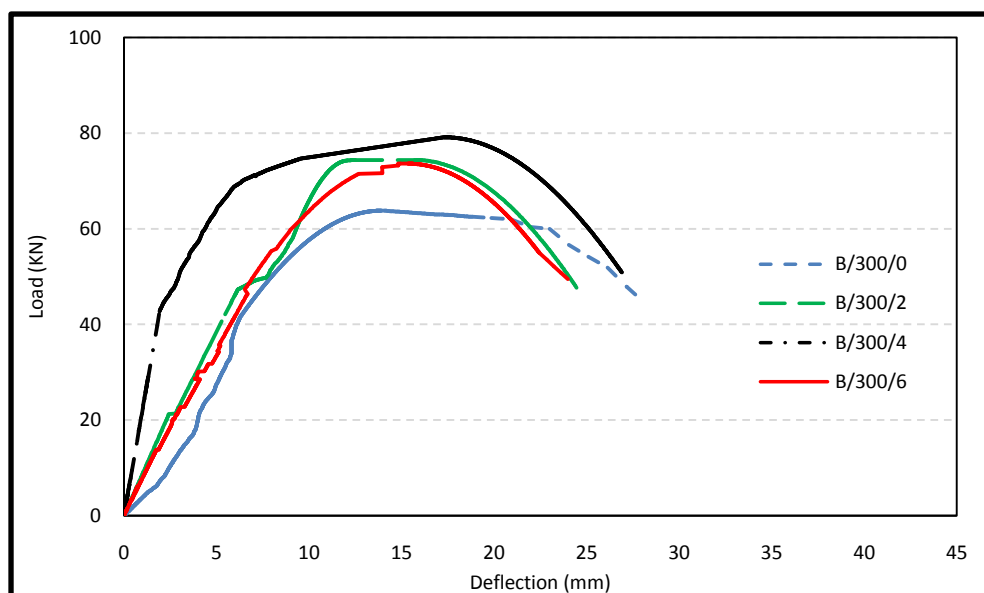
Fig. 4. Load deflection relationship for specimens B/300/0, B/300/2, B/300/4, and B/300/6.

In order to evaluate the influence of the nano-silica in a concrete mixture, the load versus deflection curves for the beam specimens B/300/2 (2% nano-silica), B/300/4 (4% nano-silica) and B/300/6 (6% nano-silica), are presented in Fig. 4 as well as B/450/4 (4% nano-silica) and B/600/4 (4% nano-silica), are presented in Fig. 5 along with B/300/0, B/450/0 and B/600/0 respectively. From the figures, it is obvious that nano-silica dosage up to 2 to 4% could improve mechanical, durability properties, and behavior of the strengthened beams. This could be due to pozzolanic action, filling effect, and pore structure refinement. However, the strength may reduce if the dosage of nano-silica exceeds 4% or more.

For the beam B/300/2, where a nano-silica ratio of 2% has been used, cracking and ultimate loads are approximately 1.25 and 1.17 times those of beam B/300/0, respectively. Moreover, as compared to beam B/300/0 the increase in ductility, and toughness of the beam by 1.13, and 1.72 times, respectively. The ultimate load of B/300/4 is just around 1.06 times greater than that of B/300/2. In addition, its toughness and ductility is higher than B/300/0's one by 2.00 and 1.24 times. Furthermore, B/300/4's cracking and the ultimate loads are greater than B/300/0's ones by around 1.32 and 1.24 times, respectively. On the contrary, the ultimate load of B/300/6 is lower than that of B/300/2 and B/300/4. In addition, its toughness and ductility is higher than B/300/0's by 1.61 and 1.10 times. Furthermore, B/300/6's cracking and the ultimate loads are greater than B/300/0's ones by around 1.07 and 1.15 times, respectively.

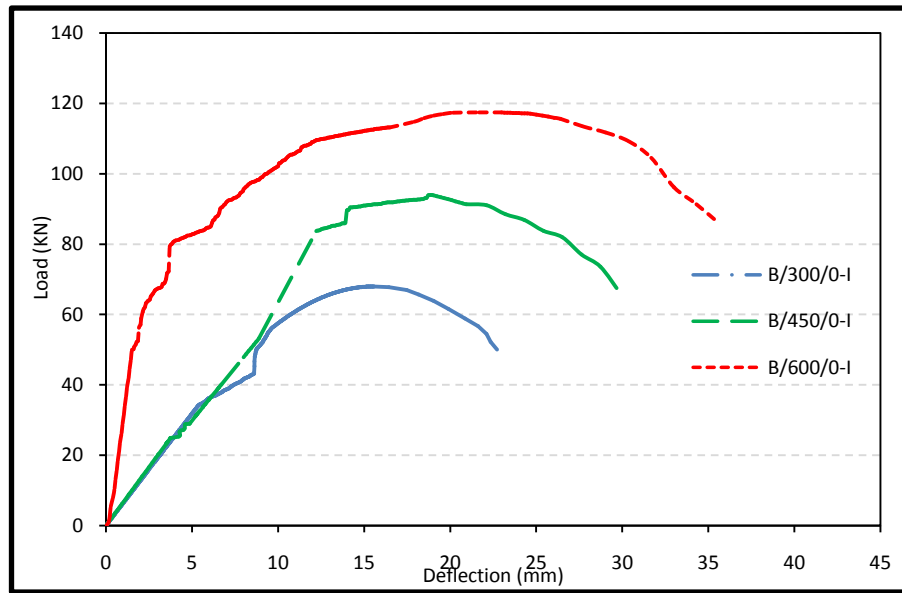
Fig. 6. Load deflection relationship for specimens B/300/0-I, B/450/0-I and B/600/0-I.

Repairing by epoxy internally injected procedures have been utilized in this research work. Crack injection provided an increase in stiffness in the linear region of the load–displacement curves for all of the RC beams. In order to investigate the effect of the repairing technique, the load versus deflection curves for the beam specimens B/300/0-I (compressive strength 300 kg/cm²), B/450/0-I (compressive strength 450 kg/cm²) and B/600/0-I (compressive strength 600 kg/cm²), as shown in Fig. 6, respectively. From the figure, it is observed that the epoxy injection technique has been successfully effectively used in the repair of cracks in beams. When compared to the beam B/300/0, the ductility, toughness, cracking, and ultimate load of the beam B/300/0-I are 1.12, 1.39, 1.07 and 1.06 times higher; respectively, whereas the beam B/450/0-I 's ones are 1.11, 1.20, 1.21, and 1.19 times greater than the control beam B/450/0. For beam B/600/0-I, the ductility, toughness, cracking, and ultimate load are 1.05, 1.10, 1.17, and 1.06 times higher than those of B/600/0; respectively.

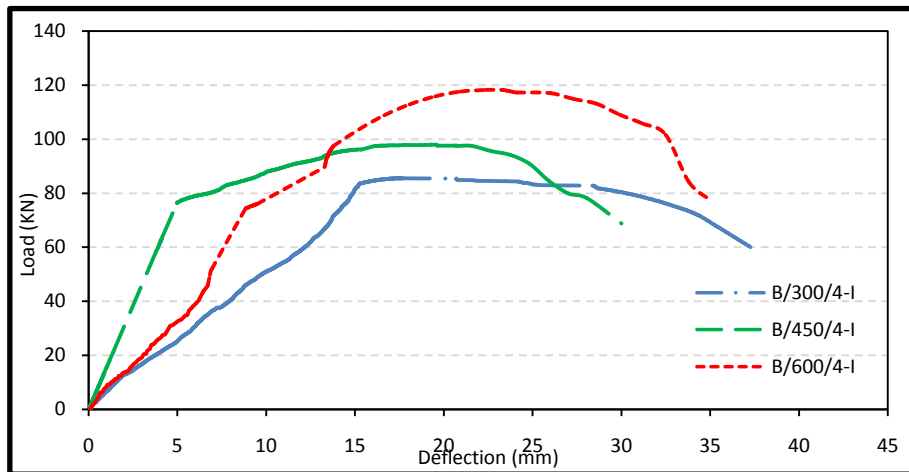
Fig. 7. Load deflection relationship for specimens B/300/4-I, B/450/4-I and B/600/4-I.

For the epoxy injection technique with nano-silica, the load versus deflection curves for beams B/300/4-I (F_{cu}= 300 kg/cm² with 4% nano-silica), B/450/4-I (F_{cu}= 450 kg/cm² with 4% nano-silica) and B/600/4-I (F_{cu}= 600 kg/cm² with 4% nano-silica), as shown in Fig. 7. When compared to the beam B/300/4, the ductility, toughness, cracking, and ultimate load of the beam B/300/4-I are 1.02, 1.26, 1.27 and 1.08 times higher; respectively, whereas the beam B/450/4-I 's ones are 1.02, 1.35, 1.24, and 1.06 times greater than the beam B/450/4. For beam B/600/4-I, the ductility, toughness, cracking, and ultimate load are 1.01, 1.10, 1.11, and 1.06 times higher than those of B/600/4; respectively.
