Reducing and Optimizing Tailgate Closing Effort in Automotive Car

S.Thavamani¹, G.Devaradjene¹, K.Yogeshkumar²

¹(Dept. of Automobile Engineering, Madras Institute of Technology, Anna University, Chennai, India ²FORD India P Ltd, Chennai, India

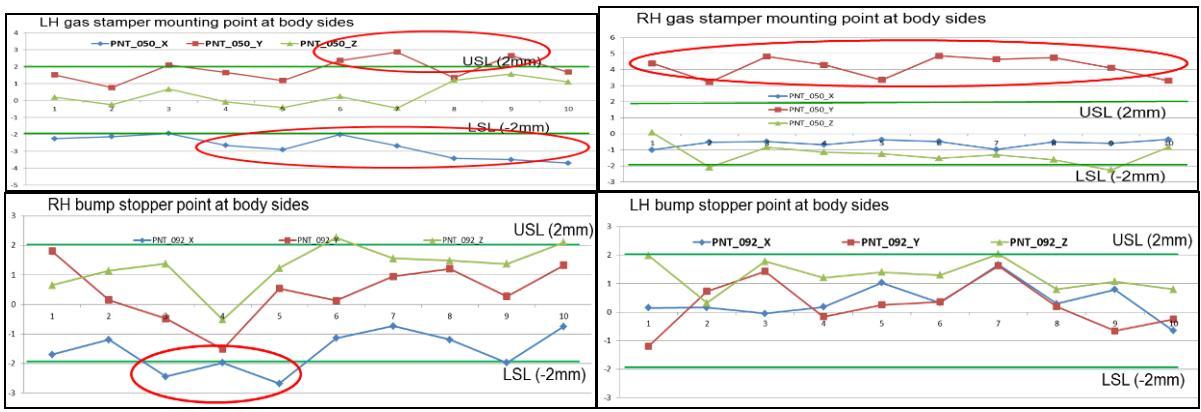
Figure 6 - Body Sides Points Trend

Above dimensional deviation in gas stamper sphere and bump stopper points is because of incoming level child part deviation which has been corrected at supplier end parts fixtures results shared in Fig 7. Gas stamper mounting deviation restricts easy piston movement results hard to close tailgate.

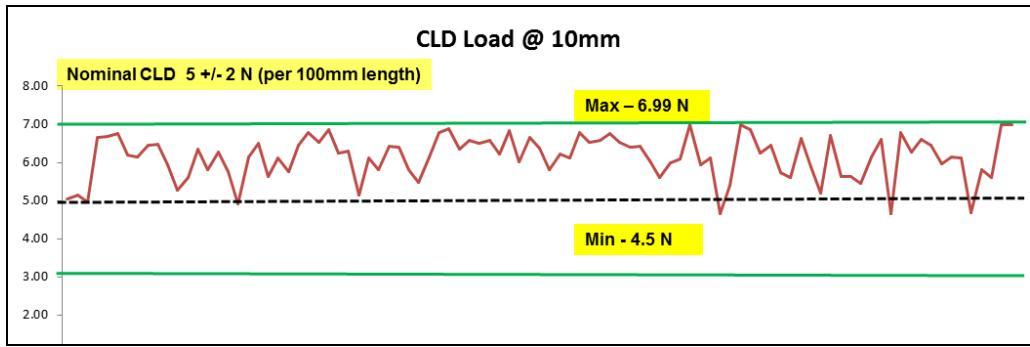
CLD data shown in Fig 16 describes 100 samples giving very good repatability but upper band of CLD range. Refer Fig 17. It can be brought to nominal by increasing number of gas out holes in weather strip pulb.
