Common Problems in Bridges on Baddi-Nalagarh-Swarghat Road

N.P.Singh¹, Alok Panday²

¹Hamirpur Division, HPPWD, Himachal Pradesh, India)

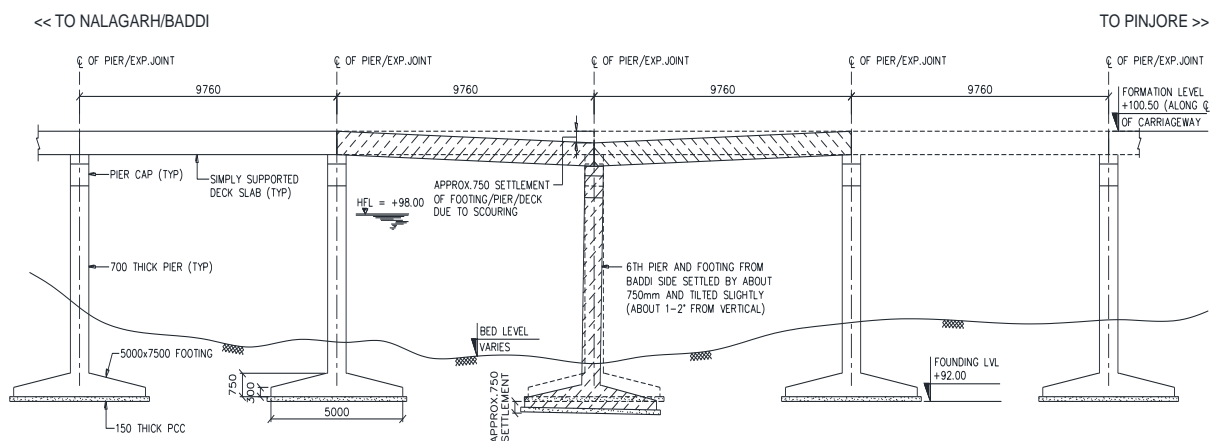
Fig.1. Typical elevation of Balad bridge adjacent to settled pier and foundation

In addition to the deep scouring and sunken/tilted pier & foundation (Photo 1 & 2, Fig.1), the following were noticed at the bridge site:

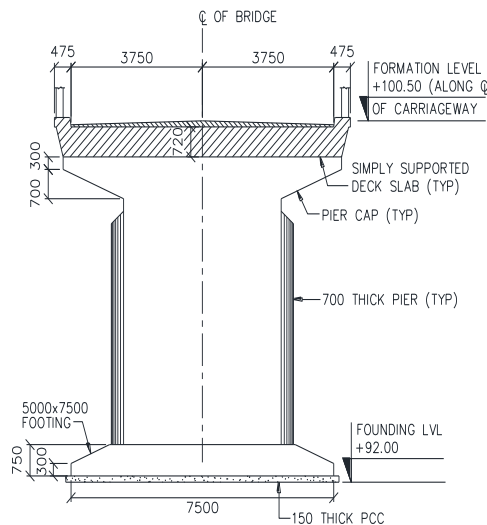
Fig.2. Typical cross-section of the Balad bridge

Total width and thickness of deck slab was 8450mm and 720mm respectively to accommodate the carriageway width of 7500mm (Fig.2). Width and thickness of wall type pier was 5200mm and 700mm respectively which was supported over 5000mm wide x 7500mm long x 750mm thick open foundation (Fig.1 & 2). The formation level and founding level of the bridge of was +100.50m and +92.00m respectively. The original bed level (at the time of construction of bridge) was +95.93m i.e. about 3.5-4m above the founding level. Though the bridge was serving to the traffic without any sign of distress, during one of the high floods in 2007, one of the piers & supporting foundation (sixth from one end) settled by about 750mm and tilted by 1-2 degree (Photo 1, 2 & Fig.1). As the bridge was designed for maximum anticipated discharge of 2024 m³/sec & corresponding scour depth and because similar problems occurred in last 5-10 years in the nearby old and new bridges, detailed investigations were done to know any other possible reasons of scouring. These have been discussed and presented below in the paper along with the findings, methodologies, proposed protection works and actual site photographs.
