## Assessment of water supply facilities in Owo Local Government Area, Ondo State, Nigeria

**Abstract:** The current study was carryout to investigate the status of water supply facilities in 24 rural communities of Owo local government area of Ondo State, Nigeria. Former and informer interview, questionnaire and physical assessment conducted. Secondary data from Nigeria National Population Commission (NNPC) were used in this study. The major water supply facilities used by the communities were mostly hand dug well and boreholes which in most cases were fitted with either electric or hand pump. It was observed that all the boreholes fitted with hand pump were failed while 86 % of those fitted with electrics pump were also failed. In the case of the hand dug well more than 37 % of all the hand dug well were failed. Borehole failure was due to people ignorance, non availability of spare parts, constant water failure, poor maintenance skills and attitude of the communities. The failures of the hand dug well were mainly due to low water table or aquifer region. The survey assessment results revealed that sustainable water supply to the community could be enhancing through the use of h

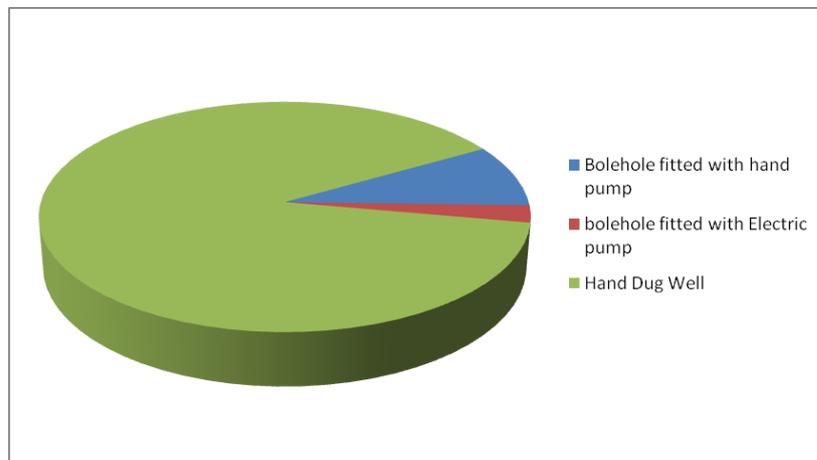
**Fig 1: Showing the entire water facilities in all the communities**

The communities depended on boreholes mostly fitted with hand pump, electrical pump and hand dug well. There were 993 of such facilities in the entire 24 communities. Hand dug well were 882 in number, while boreholes fitted with hand pumps and the one fitted with electrical pump are 87 and 24 respectively as shown in Fig 1.

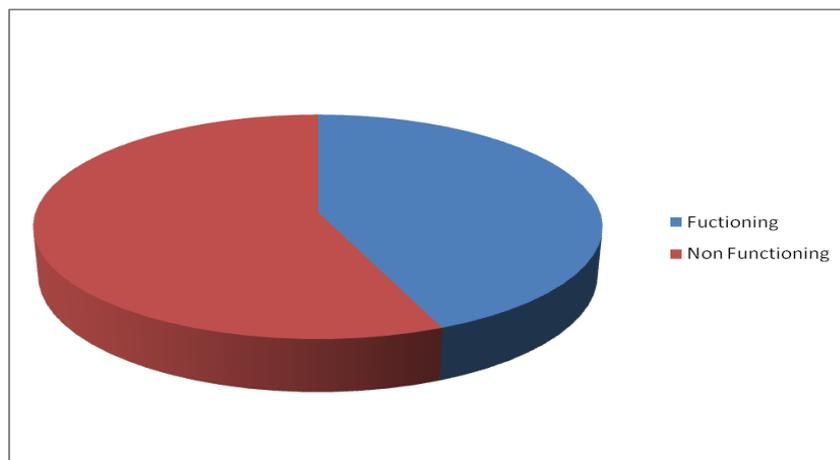
**Fig 2: Showing Functioning and none Functioning of Hand Pump Well**

From observation, all the 87 boreholes fitted with hand pump available in the communities 49 were functioning while, 38 were none functioning as shown in Fig 2 and Plate 3.

However, boreholes failure could also be attributed to corrosion of hand pump and misuse. Out of 24 boreholes fitted with electrical pump, only 12 were functioning, while 12 were out of order. The Fig 3 shows the mode of failure of borehole fitted with electrical pumps.

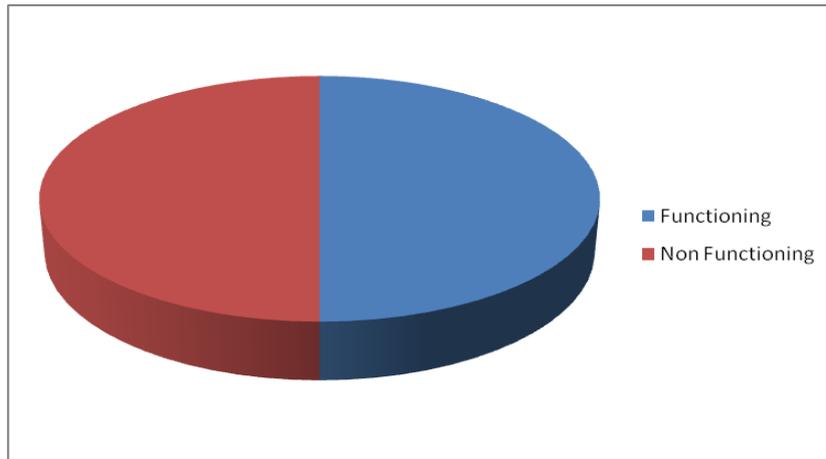
**Fig 3: Showing Functioning and non Functioning of Electric Pump Borehole**

Common reason for failure include faulty pumps, no source of power, absence of pumping machine, uncompleted and abandoned as shown in plate 5.

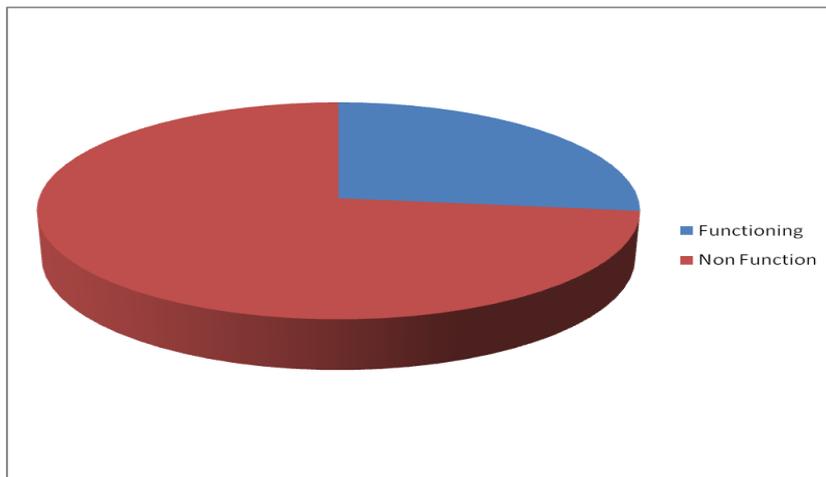
**Fig 4: Showing Functioning and non Functioning of Hand Dug Well**

In Fig 4, 37 % of hand dug well were not functioning due to low water table or aquifer region which created a dug well situation while 63 % were functioning, it was also observed that the people resulted to hand dug wells due to failure of government and water supply scheme through boreholes.
