Full Mouth Rehabilitation of a Patient with Severely Worn Dentition – A Systematic Clinical Approach

II. Case Report

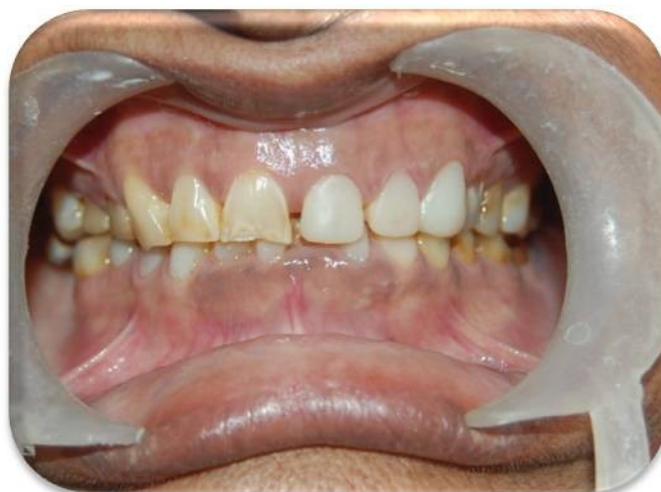
Extraoral examination revealed no facial asymmetry or muscle tenderness. The mandibular movements were normal. Intraoral examination revealed overclosure, generalized severely worn dentition (Figure.1). The patient's facial appearance showed signs of collapsed VDO. The preoperative interocclusal rest space (IRS) was 5.8 mm. Periodontal and soft-tissue examination showed pocket depth of < 2mm and no mobility of remaining teeth(Figure.2,3). Radiographic evaluation showed excellent bone support for all teeth (Figure4). The patient was explained about the treatment plan. The aim of the treatment was to improve esthetics and restore occlusion so as to achieve optimum oral health.

Figure.1 Oral examination- A Frontal view

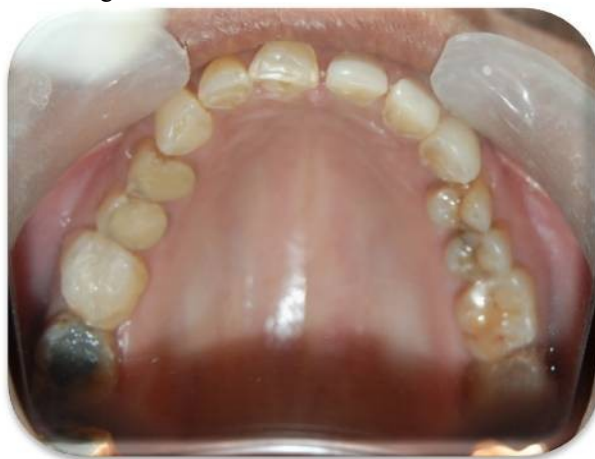
Figure.2 Maxillary occlusal view

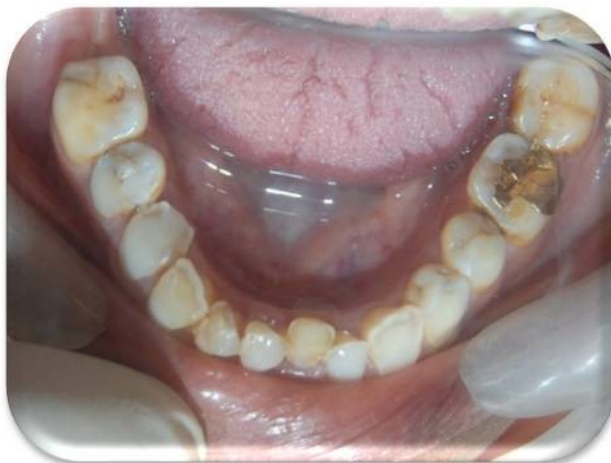
Figure.3Mandibular occlusal view

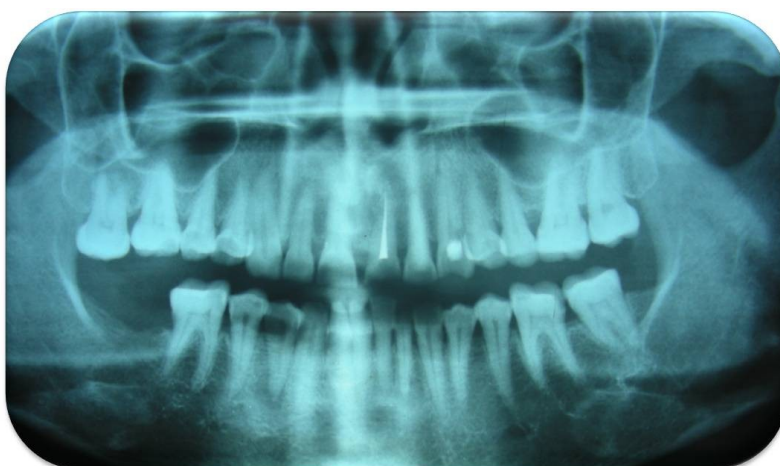
Figure.4 Panoramic radiograph

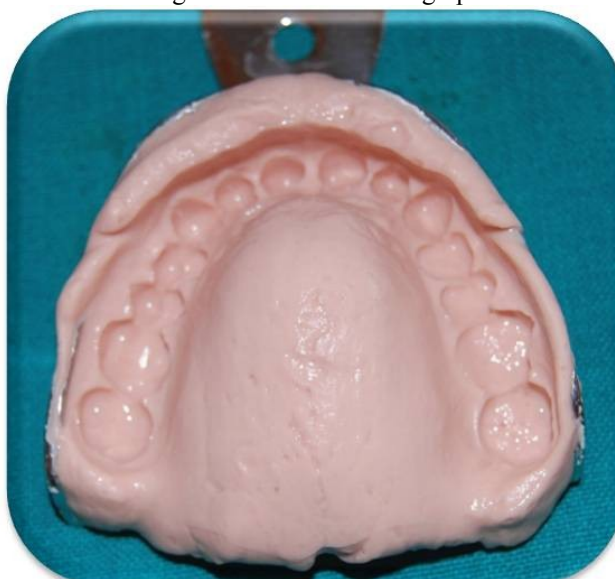
Figure.5 (a) Maxillary Diagnostic impression

Two sets of irreversible hydrocolloid impressions were made in stock trays (Figure.5a,5b). The patients existing Vertical Dimension of occlusion (VDO) and Physiologic rest position (PRP) were recorded. Diagnostic casts were mounted on a Hanau semi-adjustable articulator using a face-bow transfer and a centric relation record was made at the existing VDO. A diagnostic wax up was done at the estimated restored VDO (Figure.6). The patient's interocclusal rest space (IRS) was determined by taking the difference between the patient's existing PRP and the VDO. The diagnostic wax up of teeth was done with an estimated increased in VDO of

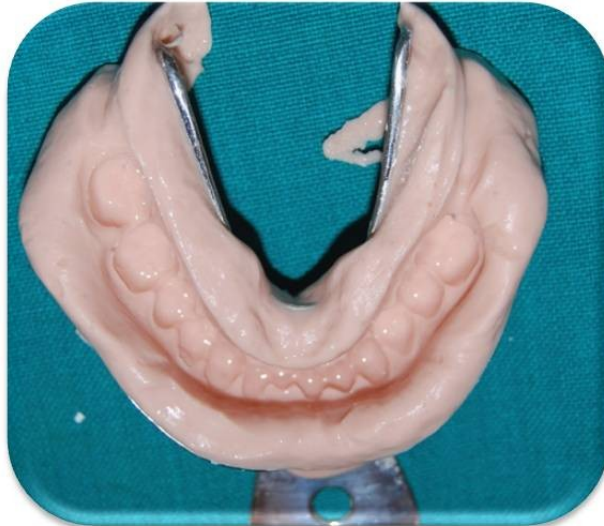
Figure.5(b)MandibularDiagnostic impression

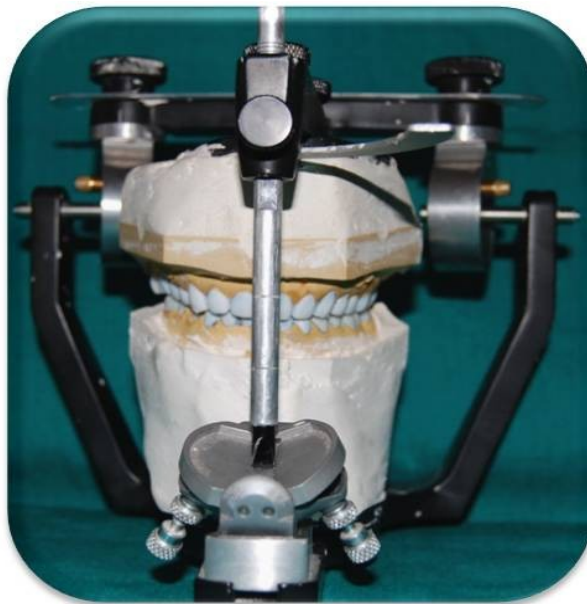
Figure.6 Diagnostic wax-up.

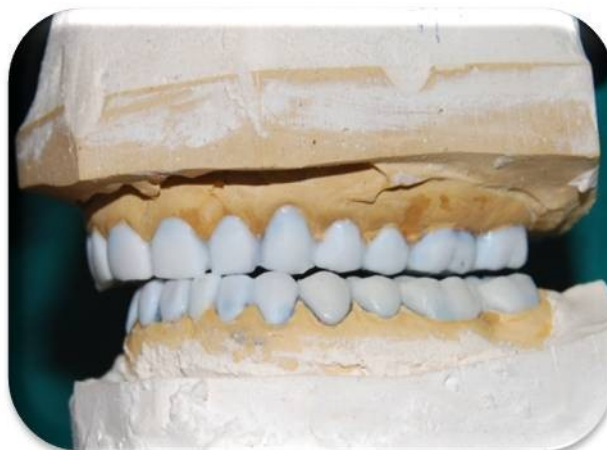
Figure.7Group Function occlusion

3mm to achieve a mutually protected occlusion (Figure.7). Permissive occlusal splint was constructed to allow the patient to adapt to the new vertical dimension.

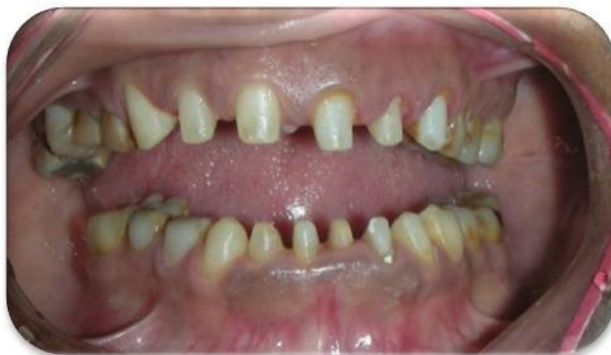
Figure.8 Tooth Preparation

The patient was then referred to endodontic department for root canal therapy with #17, #16, #15, #14, #21, #22, #23, #31, #32, #33, and #44. Tooth preparations were done (Figure.8) and provisional restorations were cemented with zinc oxide luting cement. For three months, interim restorations were adjusted, and used as a guide for the definitive oral rehabilitation. During this period, the patient's condition and functions, such as muscle tenderness, discomfort of TMJ, mastication, range of the mandibular movements, swallowing, and speech, were evaluated. Improvement in mastication, speech, and facial esthetics confirmed the patient's tolerance to the new mandibular position with the restored VDO. The final prosthesis was constructed after the provisional has been used for 3 months(Figure.9). After insertion of interim prosthesis, the patient reported a slight difference in her pronunciation of the ch,jh,s" sound; however, this problem resolved itself after 15 days. The patient reported with no muscular or temporomandibular joint discomfort. Follow-up treatments were done to evaluate the patient's comfort, arch form and potential VDO problems. The PRP was accommodated, and the patient presented with a 4 mm IRS within a few months. Impression for the mandibular and maxillary final prosthesis was made using polyvinyl silicones with a double mix double impression technique. Cast of the prepared teeth were mounted on the Hanau articulator and a centric relation record was made at the predetermined restored VDO. Finally the restoration were polished and cemented with glass ionomer cement. Oral hygiene instruction and regular check-up were administered.

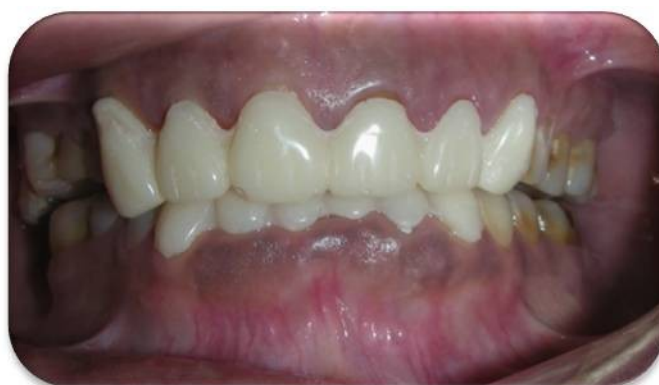
Figure.9 Definitive prosthesis
