Prosthetic Management of Implants Placed In Anterior Maxilla: A Case Report

This is a case report describing the management of off axis placed implant in anterior maxillary region.

NishthaAgrawal, "Prosthetic Management of Implants Placed In Anterior Maxilla: A Case Report" *IOSR Journal of Dental and Medical Sciences (IOSR-JDMS)*, vol. 17, no. 9, 2018, pp64-67.

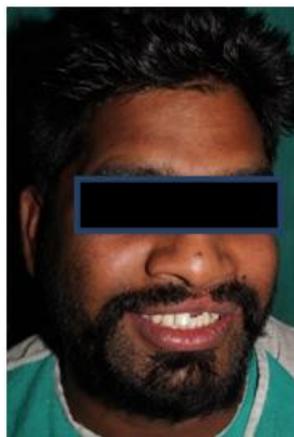
A 28 year old male patient presented to the Department of Prosthodontics, Government College of Dentistry, Indore, with chief complaint of loss of upper front teeth since 2 years due to trauma. Detailed intra oral examination revealed that there is missing teeth on 21 and 22 regions (Fig 1).

Fig 1: Pretreatment extraoral photographs

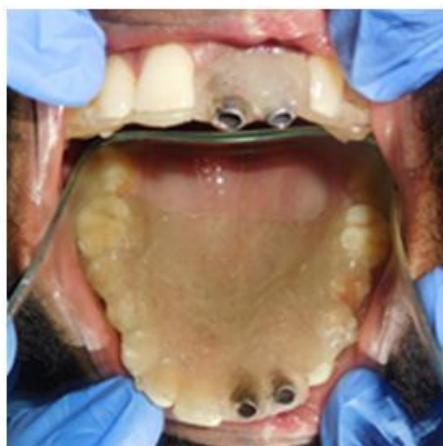
Fig 2: Osteotomy drilling with the help of surgical splint

Following an injection of 2% lidocaine with 1: 80,000 anaesthetic agent in the area of the missing central and lateral incisor. Flapless implant procedure was performed. Soft tissue punch was used to create access opening. Osteotomy drilling was done with the help of the surgical template (Fig 2).

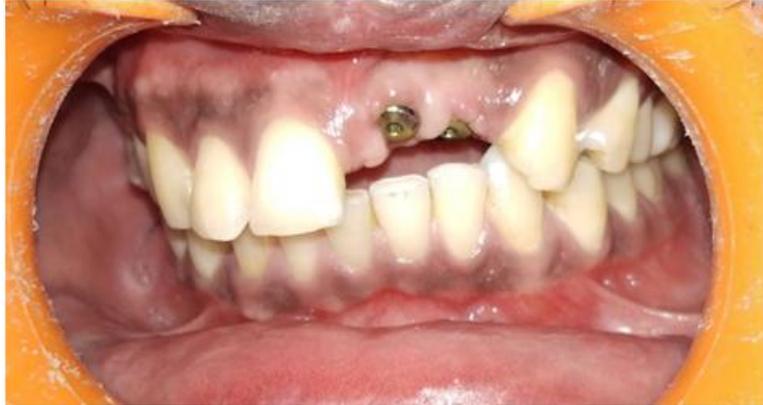
Fig 3: Healing cap placement after second stage surgery

A parallel sided, threaded, rough surface implant was then placed and primary stability was achieved at 35N and cover screw was placed. The patient was seen post-surgically after 1 week for follow up and no untoward sign or symptom was noted. Four months after implant placement cover screw was removed and the healing abutments were placed (Fig 3).

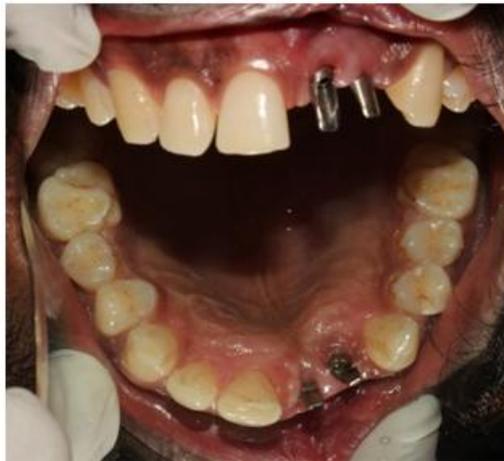
Fig 4: Customised abutment try in

After 15 days once the gingival collar was formed, impression copings were placed and Poly Vinyl Siloxane close-tray impression was made to capture the implant position. The impression copings were removed and the healing abutments were replaced. The case was then sent to the laboratory for the fabrication of custom abutment using UCLA abutment. Cement retained all ceramic crowns were fabricated (Fig 4,5,6,7).

After the fabrication, custom abutments were seated onto the implant and x ray was done to verify the complete seating of abutments. The final crowns were then tried in. The proximal contacts and occlusion was checked. In maximum intercuspation there was light contact with no contact in protrusive and lateral excursions. The crowns were then cemented using a noneugenol based temporary cement. Oral hygiene instructions were given to patient and recalled after 3 months for regular check-up.

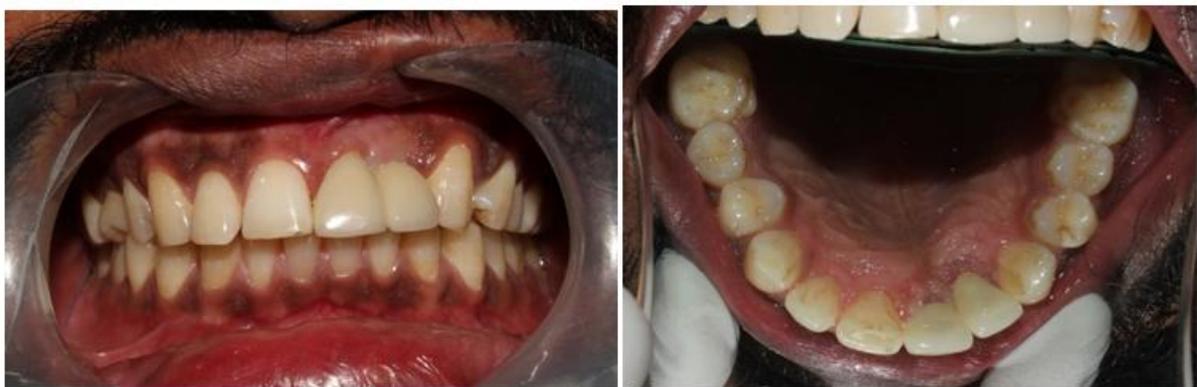
Fig 5 & 6: Crown cemented over customized abutment

In this case there was thin buccal plate resulted in off axis placement of dental implant. Because of the position of the implant it was impossible to provide angled abutment or screw retained prosthesis as it resulted in placement of screw hole on labial surface. Presence of screw on labial surface compromises the esthetics of prosthetic rehabilitation so we planned for customize abutment with cement retained crown so as to provide better esthetic results.

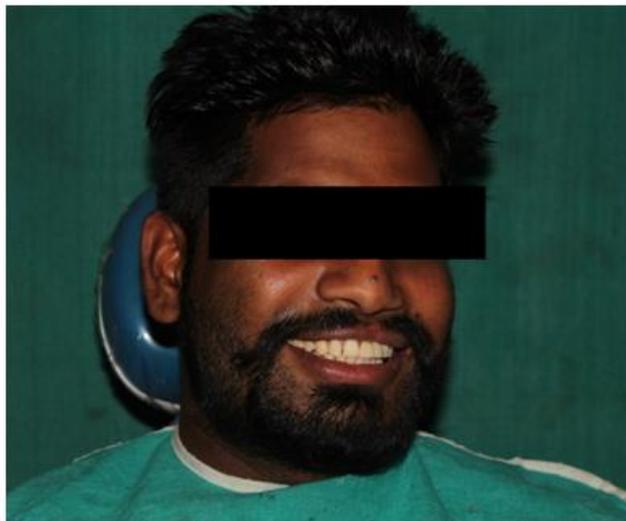
Fig 7: Post op extra oral photographs
